Experiences of consolidation on archaeological UNESCO sites in Sultanate of Oman: The Fortress of Al Balid and the Citadel of Sumhuram

Marco Andreini, Chiara Cei, Giorgio Mariani & Mauro Sassu

Department of Structural Engineering, University of Pisa, Italy

1 AL BALEED FORTRESS: RESTORATION ACTIVITIES

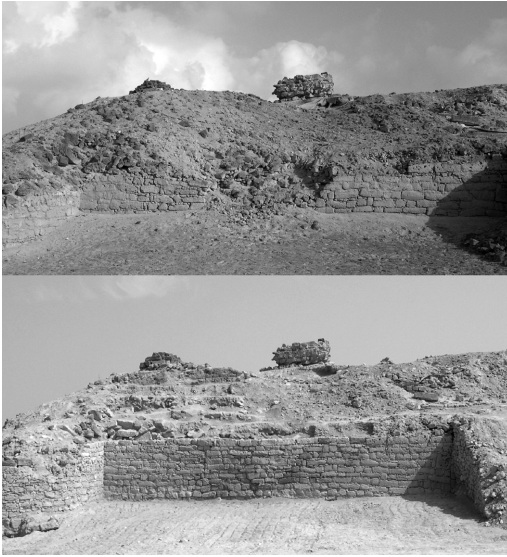
Figure 1. A case of Al Balid wall before and after restoration.

It has been individuated and restored typical local collapsing zones on external walls, situated in the southern and in the eastern sides of the fortress. The reconstruction phases has been arranged starting from removing the not structural materials (earth, clays, disaggregated stones etc.) on the top and around the sliding surface.

Bricks in collapsing conditions (tilt – rotations), around the sliding surface, has been removed and placed nearby in order to a further reuse; this dismantling phase last until a masonry course with a proper arrangement has been found.

Earth embankment behind the wall had been excavated for a depth of about 1 m, in order to get a proper space for placing small stones as drainage, to avoid penetration of clay particles between brick joints with

Reconstruction of wall face and retro-filling with small stones proceed in same time, step by step. After two or three layers of masonry, according to height of blocks, small stones has been placed until the last course was reached.

The lacking part of each zone has been rebuilt, as over described, using blocks without mortar, with the caution to pose the inferior side with a small opposite inclination respect to possible sliding movements and with a set of small stones forced into the joints to give proper equilibrium and pre-compression to each block. Bricks that have been used for reconstruction had been chosen in order to obtain a masonry texture similar to the adjacent.

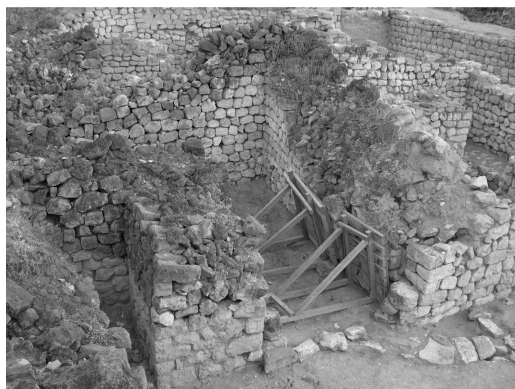
Figure 10a. Example of collapsing walls (type a).

- a) expulsion of the outer facings caused by the transverse pressure exerted by the random inner clay-sand mixture, due to loss of cohesion and meteoric washout. These extrusions are visible as vertical bulges as well as rigid rotation of single bricks or groups of bricks starting at the top;
- b) expulsion of the outer brick layers and the internal mixture of the thicker walls. These appear as surfaces collapsed into the spoon shape typical of the landslide mechanics of soil subsidence in presence of transverse loads, as earthquakes, joined with repeated monsoon seasons.

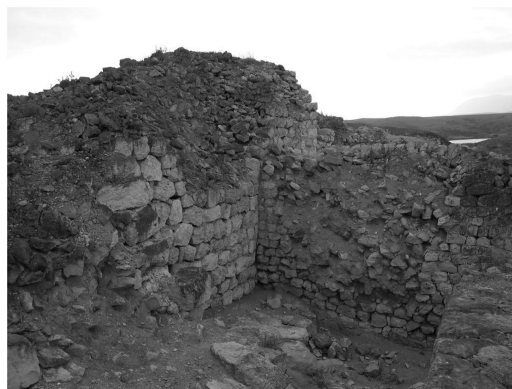
Figure 10b. Example of collapsing walls (type b).
