Structural Restoration and Adaptation to Modern Architecture of the Baroque Oppersdorf Palace, Wrocław, Poland

Abstract This paper is an overview of structural interventions which should be made to the Baroque Oppersdorf Palace during its renovation. All main technical problems were analyzed and proper constructional solutions were presented. Several characteristic types of destruction were detected, caused by natural deterioration and also by mechanical influences (war destruction, lack of conservation etc.). The main building structure has survived from the Baroque period, except for the wooden roof. Some of the cellar vaults and some of them over the first floor were also not destroyed. However, some main reconstruction work was done, probably in the last few years of the 19th century. For example, a break with a new staircase and some masonry vaults over the cellar were changed to ones of Klein type on steel beams. The main aim of the reconstruction was to strengthen the historical structure of the building and adapt it to the modern architecture and to reorganize the buildings inner space, but keeping the external proportions, architectural details and ornaments unchanged.

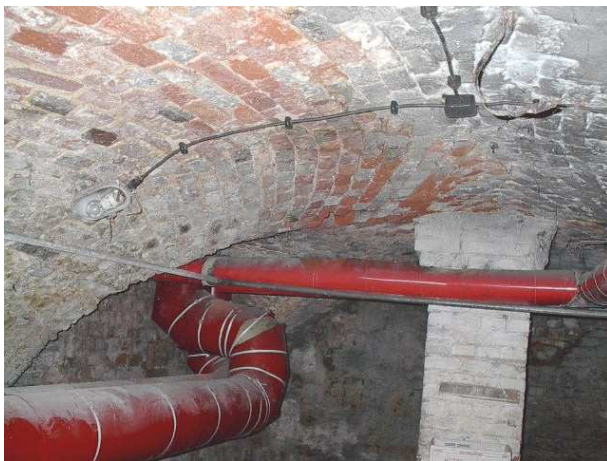
Figure 3: View of existing vaults over cellar Figure 4: Cross vaults over ground floor

The existing vaults and arrangement of basement walls from the eighteenth-century period should be preserved (Fig. 3). The ground floor vaults situated in a northern part of building and the Neo-baroque vault above the entrance hall should remain unchanged (Fig. 4). The staircase should remain unchanged, subject only to essential conservator's treatments (floor, railing, stairs) (Fig. 5).

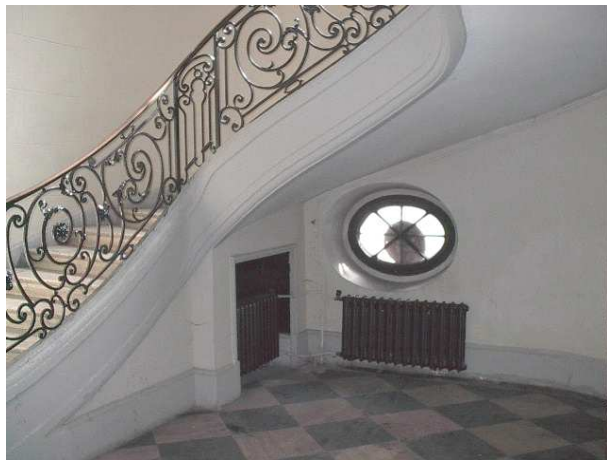
Figure 5: Original staircase Figure 6: Original staircase
