Protecting the Tangible and Intangible Heritage of Rani ki Vav: a Unique Subterranean Step Well in Gujarat

PRIYA T.Lakshmi^{1, a}

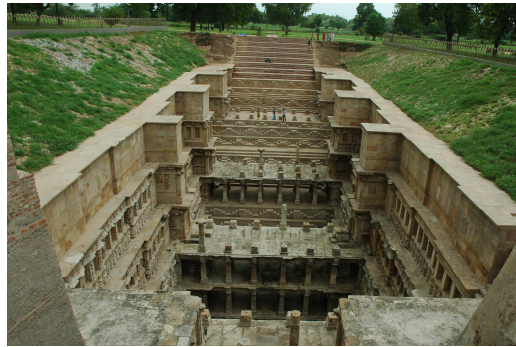
Figure 1: View of the Stepwell

It is constructed of bricks and decorated with stone sculptures. It measures 64m long 20m wide and 27m deep. It has the four essential components which are seen in completely developed stepwells : a staircase leading from the ground level to the underground basin, intercepted at regular intervals with multistoreyed pillared pavilion, a well at the rear end, and a large tank or kund to store the surplus water from the well. This Vav also has bracing structures just above the tank, as an extra precaution against lateral thrust. The side walls of the staircase have niches and the wall surface of the well are adorned with beautiful sculptures.

The Rani ki Vav is oriented in the east west direction , with the well in the west and the entrance in the east. It is built of bricks and decorated with stone sculptures. It measures 64m long 20m wide and 27m deep. It has four essential components: a staircase leading from the ground level to the underground basin, intercepted at regular intervals with multistoreyed pillared pavilion, a draw well at the rear end, and a large tank to store the surplus water from the well. Additionally this Vav also has bracing structures just above the tank.

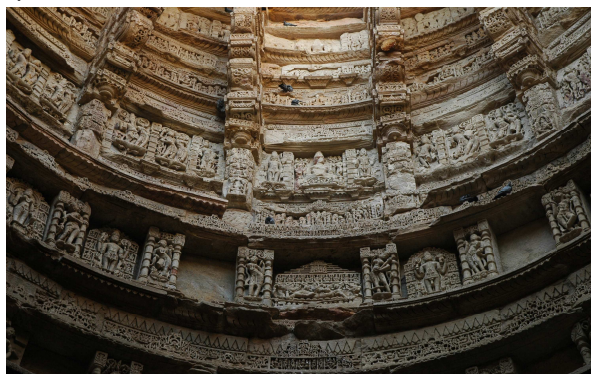
Figure 2: The Wall of the well adorned with sculptures

are seven terraces on the corridor's walls. The side walls of the corridors with niches and the wall of the well are decorated with beautiful sculptures.

The shaft of the well is divided into seven horizontal levels. The Vav is decorated with most exclusive sculptures. The pillars of the corridors carved with vase-foliage motif add to the beauty of the Vav. More than 800 large sculptures were planned to decorate the seven terraces on the walls. The sculptures in this monument can be categorized according to the three aspects they highlight; the images of Visnu which attribute to the Vaisnava character of the Vav, the images of Parvati's penance which emphasizes the memorial character of this stepwell and "the images of conjunction".
