## Research, Planning and Interventions Guide for Historic Roof Structures with Baroque Character

MAKAY Dorottya<sup>1, a</sup> and OLOSZ Emese<sup>2, b</sup>

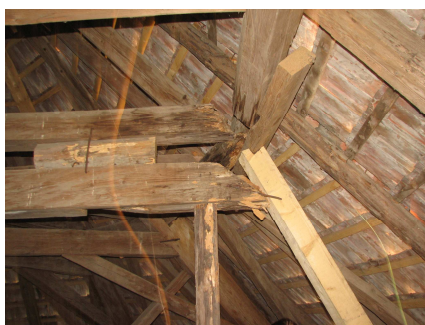
Figure 1: (a) Unprofessional interventions on a baroque roof structure, Unitarian church Bădeni, Cluj county; (b) Decay of the tiling – Reformed church, Kogalniceanu street

The other extreme is the lack of the research and planning phase, with “craftsmen” who can deal with almost everything, executing ad hoc “repair works” (Fig. 1)

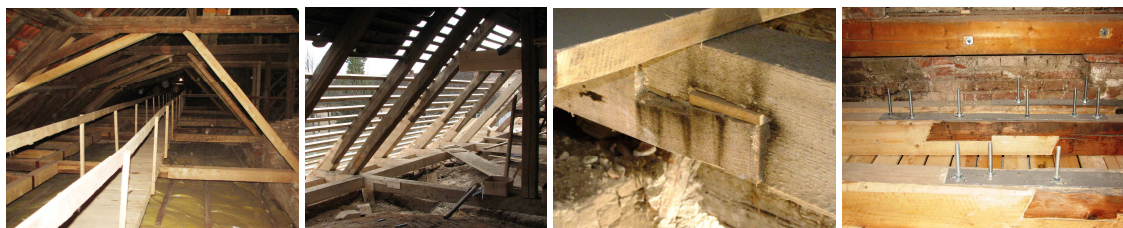
Figure 6: (a) Consolidation with element insertion – Tileagd 2008; (b) Minimum intervention – conservation Nusfalau 2010; (c) bad quality lap-joint under execution; (d) good quality lap-joint

Execution technologies and details – describes the steps of joint-dismantling, where partial element replacement is needed, including solutions for temporary, local propping and lifting of elements, sub-ensembles. Needed accuracy-level, order of re-assembling the joints, etc are given. The typical mistakes and bad practices are also exemplified in order to avoid their repeated use. (Fig. 6)

The examples present different levels of practices coexisting in Romanian conservation industry: (a) the sub-contractor was not specialised in carpentry-repair, after a high number of site visits offered by the designer, finally an acceptable overall quality for the retrofitting work was achieved, but (d) bad quality carpentry joints had to be replaced by engineering ones. (c) A craftsmen team specialised within the BHCT 2002 programme assures a constant high quality of work, site visit is needed only in unforeseen situations; (b) in some cases, good quality can be achieved with a small number of site visits and good quality craftsmen, even if not specialised in specific training courses.
