A Methodology for Approaching the Reconstruction of Historical Centres Heavily Damaged by 2009 L'Aquila Earthquake

Abstract The paper illustrates the preliminary results of a research carried out on a historical centre heavily damaged by 2009 L'Aquila earthquake; in particular it presents shortly the Rubble Removal Plan realized and more in detail, the analysis conducted on a sample block. The detailed knowledge of the block is essential for identifying probable causes that led to the present damage scenario and for planning consciously the reconstruction and restoration of the historical centre.

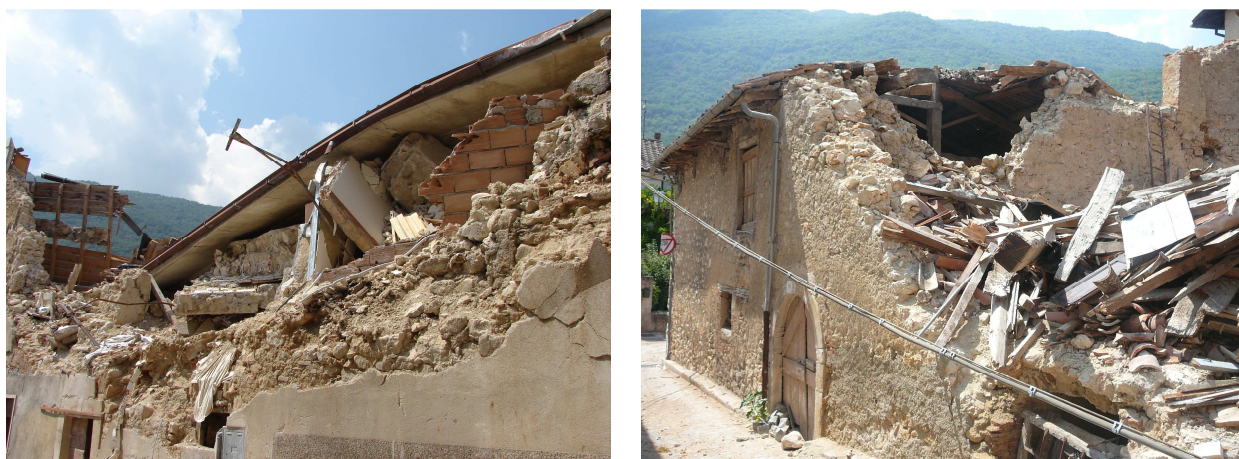
Figure 4: Vulnerability (heavy r.c. roof structure) and resistance (anchored trusses) factors

with heavier r.c or steel structures – as well as, on the contrary, the resistance factors that may have reduced the effects of the earthquake – eg., the presence of anti-seismic historical protections (Fig. 4).

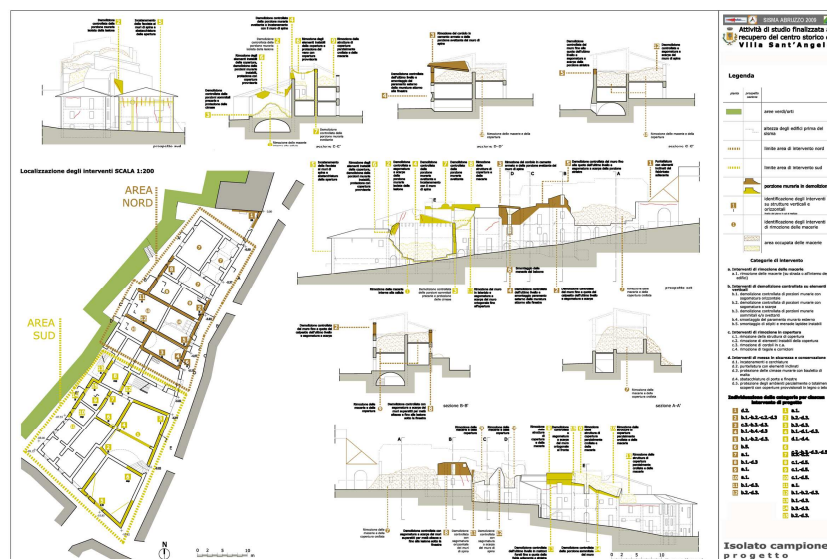
Figure 6: Project state of the sample block

The comparison between the actual and the project states (Fig. 5, Fig. 6) allows controlling the amount of demolition to be carried out; such an aspect is of significant importance for the overall situation of the historical centre of Villa Sant'Angelo, where – given the widespread state of collapse (more than 50% of the urban texture) – could easily be implemented more extensive demolition than those effectively necessary.
