Recommendations for the Conservation of Earthen Architectural Heritage in Chile

MONTES Cecilia Aldunate^{1, a} and GIESEN Clara Guzmán^{2, b}

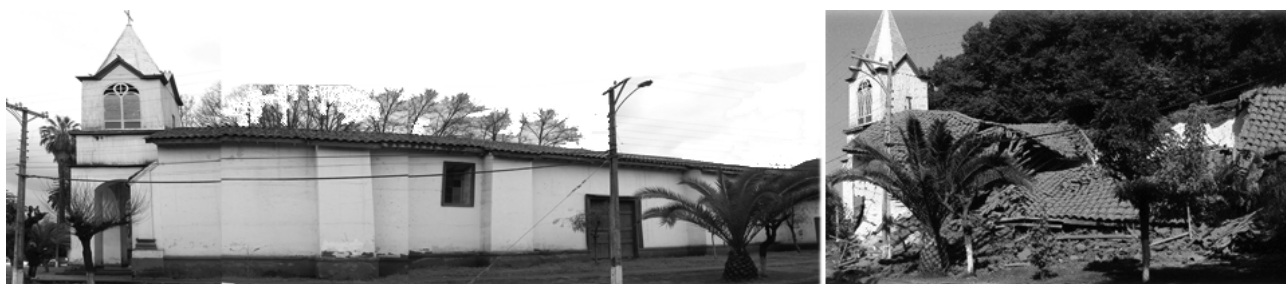
Figure 3: a) Guacarhue Church before the 2010 earthquake, b) Guacarhue Church after the 2010 earthquake

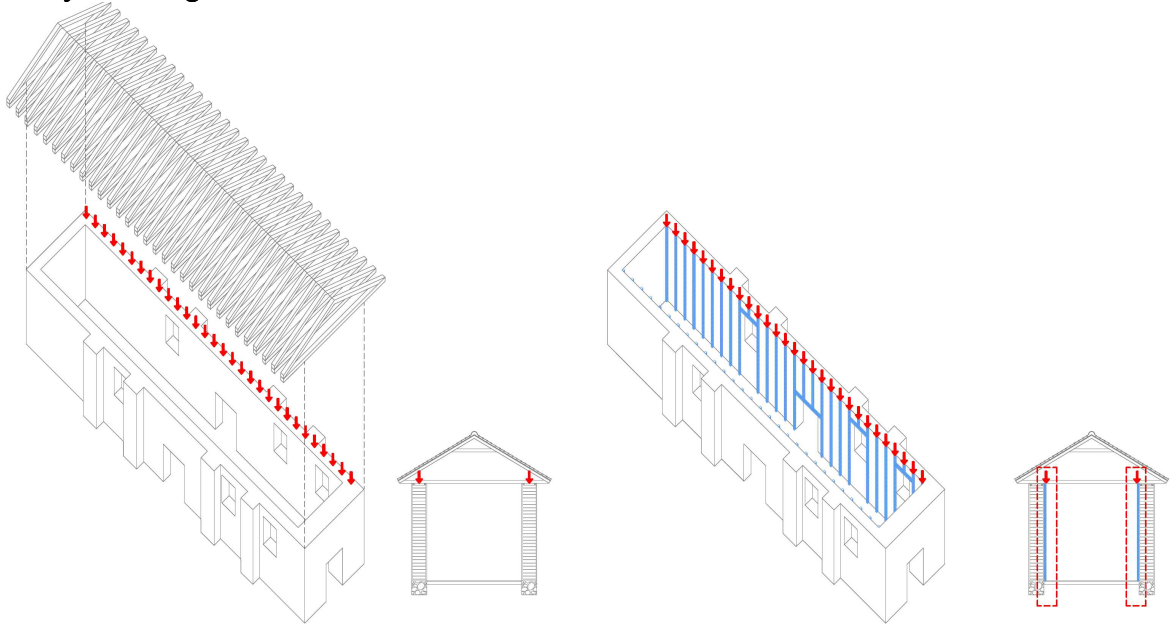
1. Eliminate the weight of the cover on the walls to reduce considerably the horizontal strengths directly affecting the adobe.

2. Reinforce existing buttresses to give effective support to the vertical faces, to increase its inertia as far as possible.
3. Reduce the horizontal deformation by incorporating a rigid horizontal diaphragm at the level of the cover, which joins and ties the structure.

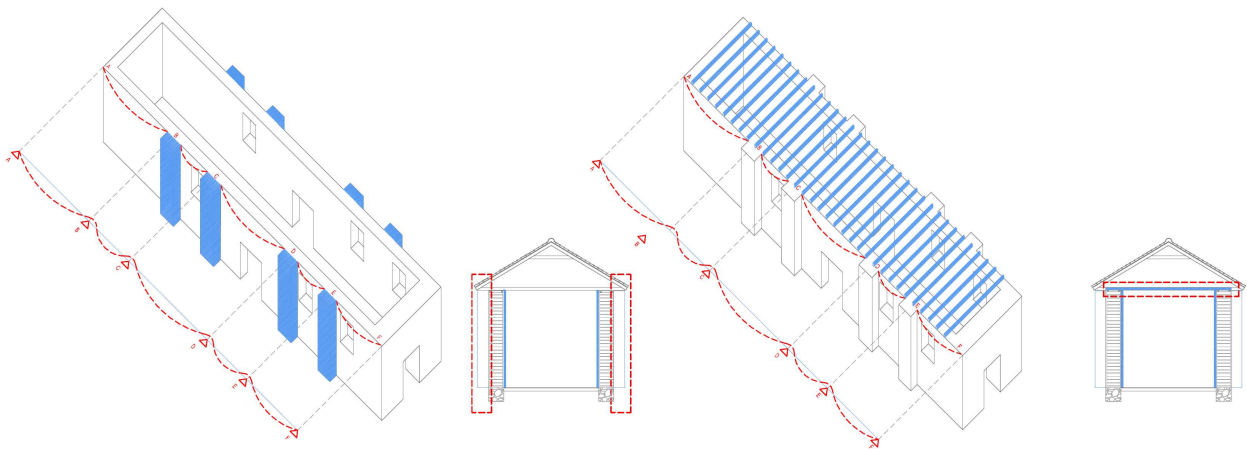
4. Avoid tumbling down of the walls by fixing the corners.
5. If the walls are very cracked, it is recommended to fix them from the outside, so as to avoid its collapse and give their structural capacity to the new elements.

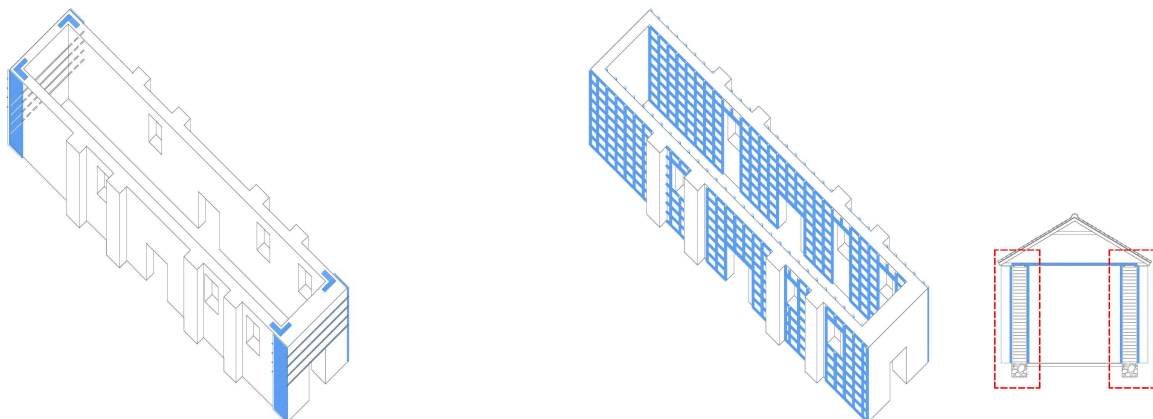
6. Eliminate humidity, protect foundations from underground water, protect walls from the rain and capillarity by mad plaster and repair of the cover.

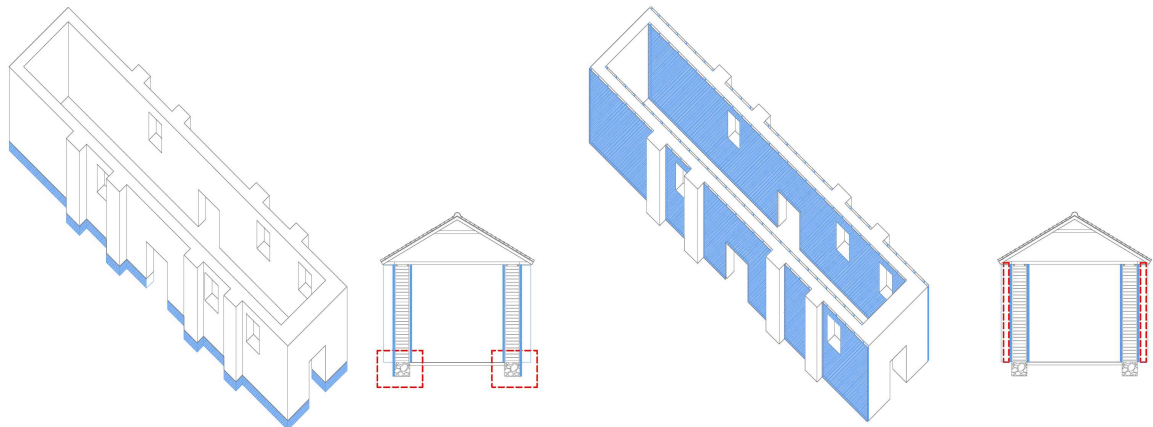
7. Avoid collapse and favour disassembly.
