## Timber Structure in the Mission Churches of Chiquitos (Bolivia): Origins, Evolution and Restoration

**Abstract** A group of churches of the 18th century in the Lowlands of Bolivia and Paraguay are characterized by a very special timber skeleton frame structure. Most of these churches belong to the famous former Jesuit missions of Guaraní, Chiquitos and Mojos, in densely wooded regions at the edge of the Spanish colonial empire. The best preserved and most important of these buildings are the six churches of Chiquitos in Eastern Bolivia, declared World Heritage sites by the UNESCO. In these villages and small towns, many traditions of colonial time have survived. The old churches are still the spiritual centers for the Chiquitanos, the Christian Native Americans of the region. The typical plan of these churches is a rectangular interior space with three naves, adobe walls, entrance hall, lateral corridors and a huge and long gable roof. The timber structures of these buildings are very simple, with free standing carved wooden columns that are anchored in the ground, using a pre-Columbian indigenous technique. It is combined with the European ways of constructing roof structures

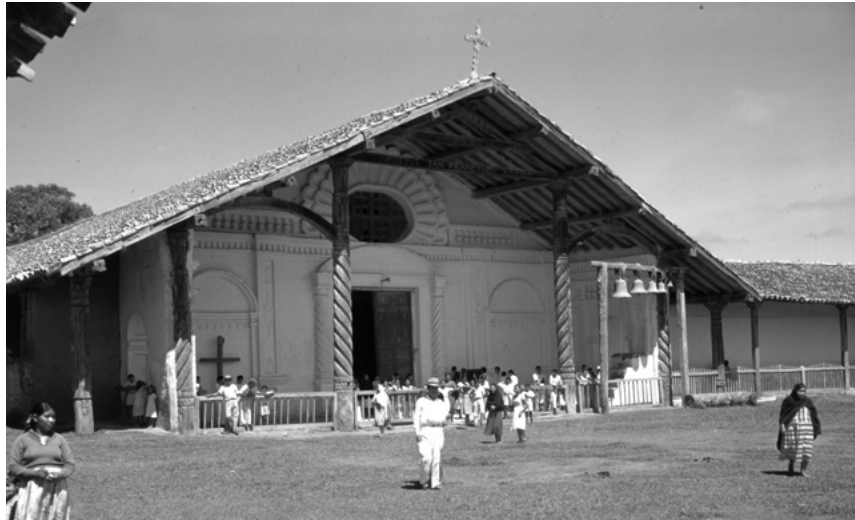
Figure 1: Church of San Javier, Chiquitos, Bolivia, in 1957 (© SJ-Bild/Plattner.)

Six churches of the former ten reductions of Chiquitos still survive. Five churches have a similar configuration with a rectangular interior space subdivided into three naves by two rows of carved timber columns. The roof is a long, simple gable roof with visible structure from inside the church. Two rows of timber columns are embedded in the adobe walls, and two other rows form porticos at

both sides of the church. The entrance is protected by a hall or portico that consists of an extension of the timber structure of the church (Fig. 1).

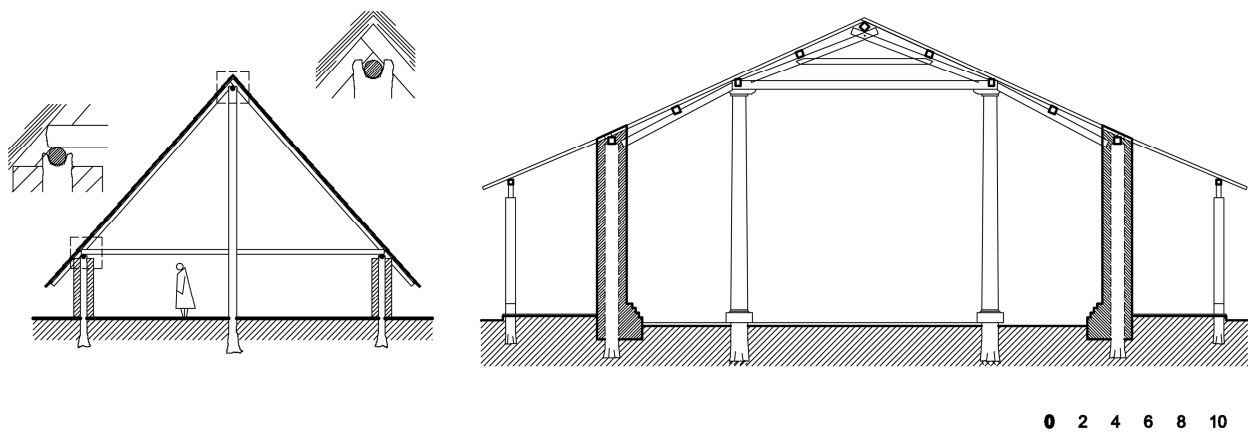
Figure 2(a): Cross section of primitive church (b): Typical Chiquitos missionary church (Rodríguez, 2009)

The Jesuits used similar constructions to build the first churches (Fig. 2a). Thus, the natives, who knew well to work with wood, were responsible to erect these primitive churches, a situation that

helped to the Jesuits to introduce a deep cultural change. Adapting elements of the traditional culture was a way of persuasion the native, so that they remained in the reductions and did not return to the forest. The temporary huts were modified progressively according to the human and technical skill available in the consolidating village. The new church was larger than the first one and had a skeleton timber structure with trusses and wood joints according to European models; the construction was improved with the introduction of burned tiles and non-supporting adobe walls that were erected after the roof (Fig. 2b). The rich decoration was in baroque style.

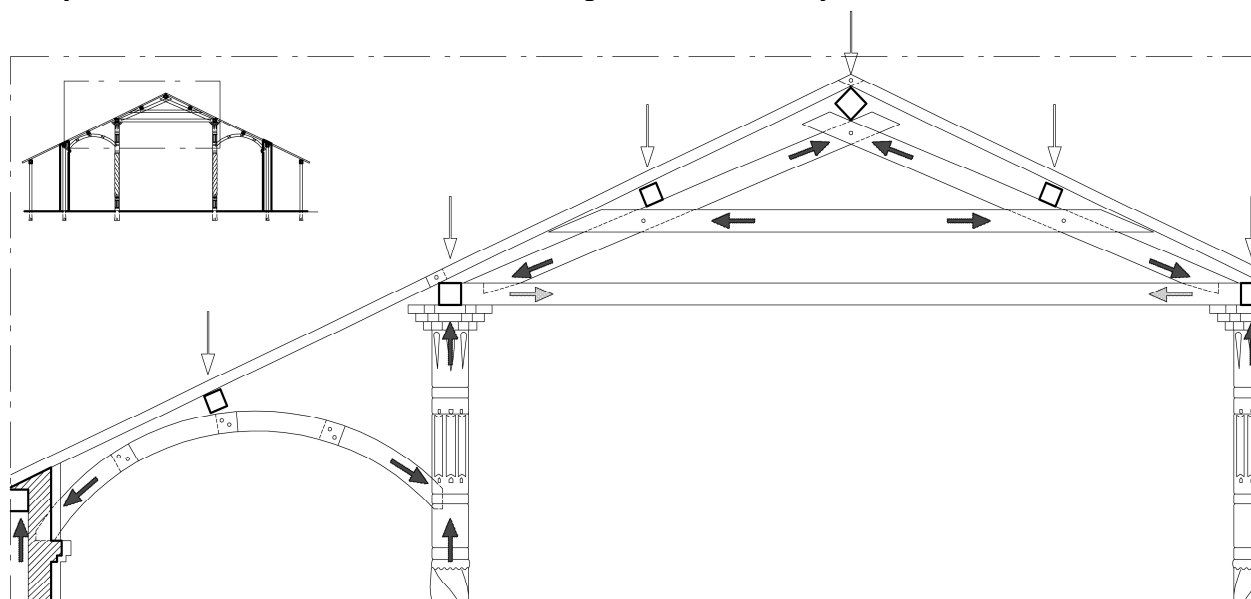
*Figure 3: Detail of roof truss with member stress. Compressive stress (dark arrow); bending stress (light arrow) (Rodríguez, 2009)*

The central truss has two rafters that form together with a collar beam and a tie beam a triangulated, not deformable structure. This kind of truss stands in a Roman tradition, is common in little medieval churches in Spain and was also used the missions of Paraguay. The upper part of the column is connected by a wooden pin with the capital, the lengthwise beam and the truss. There are pegged mortises and tenon joints. The roof structure has lengthwise beams above the columns and a ridge beam above the central trusses. In the lateral aisle, arched braces or rafters support additional lengthwise beams. The roof structure is completed by inclined purlins placed without joints above the lengthwise beams (Fig. 3).

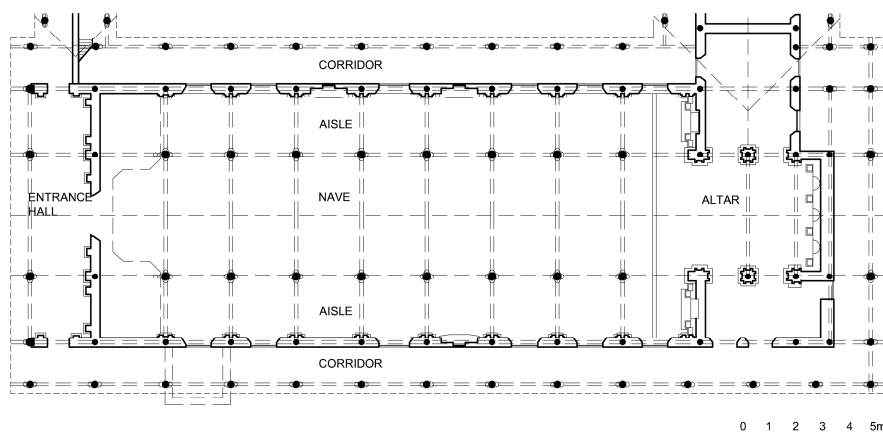
Figure 4: Typical plan of Chiquitos Church (Rodríguez, 2009)

All Chiquitos churches have a similar architectural plan with a rectangular interior space subdivided by rows of timber columns in a central nave and two aisles (Fig. 4). Two external rows of columns form lateral corridors. The entrance hall portico is protected by a roof that is an extension of the interior timber structure. These porticoes help to protect the walls from water in raining season. The adobe walls had no structural function and embedded two rows of columns of the timber skeleton structure.

The longitudinal axis connects the main entrance to the altar. The internal length of the six Chiquitos churches is between 50 m. and 62 m., with a transverse distance between the central posts of 7,70 m. to 10,30 m. The aisles are 4,00 m. to 5,15 m. wide from the post center to the inside of the exterior wall, giving a total internal width between 15,70 m. to 20,60 m.

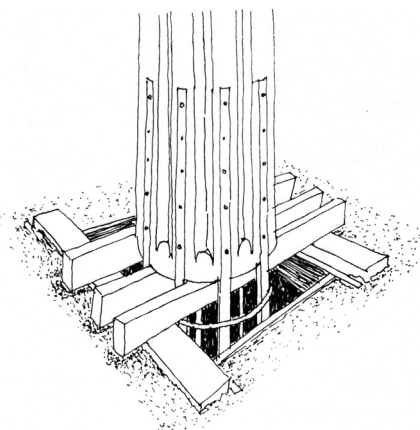
Figure 5: *San Rafael, new anchoring of wooden column. (Roth, 1995)*

In the *San Rafael* church, the whole wooden structure was dismantled and reconstructed in 1972-1979, exchanging many columns and wooden beams. Following Küttingers proposal, the bases of the huge wooden columns were cut off and replaced by a reinforced concrete foundation, connected to the columns by visible, screwed flat steel bars, restoring by this means the lost rigid restraint of the columns (Fig. 5). Additionally, parts of the roof construction were locked with nails or stud-bolts, changing in this way the basic structural system of the building. The restoration was realized in a totally underdeveloped village, with very modest resources and extremely low technical equipment, by a young and enthusiastic architect without knowledge of modern restoration standards, and without any assistance or control by cultural assets institutions. These may be the reasons for some unsatisfying results, like the total repainting of the murals and a certain lack of authenticity of the restored building.

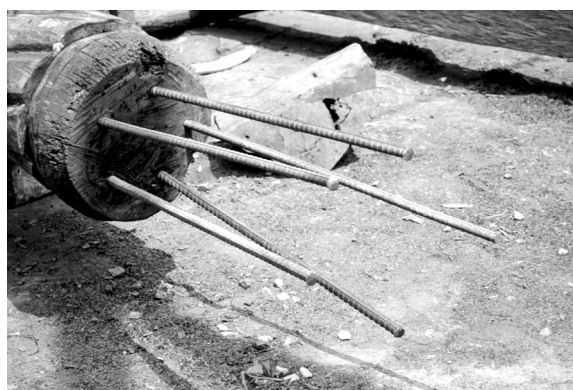
Figure 6: *Santa Ana, new anchoring of wooden column. (Photo Hans Roth)*

These splendid renovations were praised by many people, especially by the local churchgoers, but they also evoked heavy critics from professional architects and art historians. Hans Roth reacted to these critics with the restoration of Martin Schmid's church of *San Javier* (1987-1993). For first time, it was based on a detailed survey, extensive measurements, archeological and historic investigations. The Swiss Jesuit carpenter Joseph Herzog invented a better adapted construction procedure with a respectful treatment of the original building fabric. There was no total dismantling like in the previous sites, but the columns were replaced or adapted under the roof maintained in place. Many old columns and beams were kept in situ, and if necessary adapted to the renewed construction. Instead of the visible flat steel bars, the anchoring of the columns in the reinforced concrete foundations was now made with four to six corrugated 3/4 inch armoring irons, two meters long, of which 80 cm were lubricated and driven into tight pre-drilled holes (Fig. 6). Afterwards, the column with the irons was placed and fixed in final position over the foundation pit, and the concrete was filled in.
