## Second World War Damages of the Architectural Heritage: St. Maria Del Popolo Agli Incurabili Church in Naples

**Abstract** The research concerns the case-study of the church of Santa Maria del Popolo into the historical Incurabili Hospital in Naples, seriously damaged during a bombing raid in 1943. The construction of a reinforced concrete trussed roof and floor above the main nave has caused serious structural problems and the church shows evident signs of deterioration today. The present situation offers the occasion to deep, in an interdisciplinary way, the delicate issue of the recent past strengthening operations realized with reinforced concrete that, associated with highly territorial seismicity, alarm about the condition of many historical buildings. In order to have a clear knowledge of the structural behavior of the church, assessing the actual *in situ* condition, a numerical FE analysis has been performed with the scope of evaluating the state of stress in the structural elements of the walls and of the roof, pointing out the structural deficiencies. The numerical damage assessment has been validated by means of comparisons with crack patterns. Providing a reliable

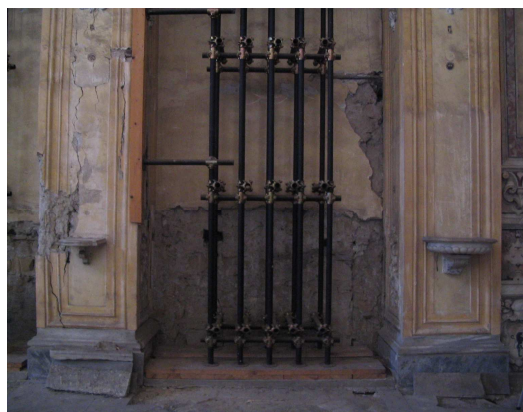
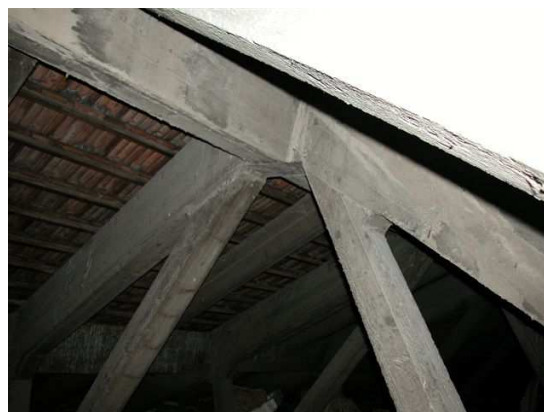
*Figure 2: Naples, church of St. Maria del Popolo: (a) The structural conditions of the south side; (b) A reinforced concrete truss of the roof*

During the years following the strengthening works in 1954, the hospital administration asked for further restoration works in order to reintroduce the practice of worship in the church. These interventions, concerning mainly the restorations of the fresco, were never performed and presumably the church was not re-opened to the public. On November 23th, 1980 the earthquake, cause of considerable damages to the city monumental heritage, has put to a “structural test” the building as it has been modified after Second World War. The vertical trend of the cracking pattern in fact, outlined in the pilasters (Fig. 2a), revealed a lack of resistance to seismic actions of the South wall of the nave, considering also that it is not constrained to any other adjacent building. In 1993 a survey campaign was undertaken to look for the causes of the alarming cracking pattern of the external walls. The survey results let exclude, after a foundations check, any foundational subsidence of the church (ASBAN, 57/985). The compression test on the tuff panels and on the binder left out the hypothesis of materials not enough resistant to compressive stresses, while a disjointedness between pilasters and wall panels was detected on the southern side of the nave as well as wall gaps due to previous interventions and, at least, detachment of whole masonry blocks.

This project was never executed, while tubular-steel were put to sustain three arcades on the southern side of the nave. Today the church is still closed to the public and the presence of the temporary props recalls the necessity of a conclusive solution to the heavy instability of the wall panels. As well, water infiltrations coming from the roof provoked the fall of the concrete cover from the trusses frame and the detachment of the finishing elements. This condition seems to underline the formal dissimulation, carried out in the postwar period, of a “modern” constructive technique that, across the years, revealed itself to be structurally not compatible with the preexistence.
