Experimental Research on Seismic Behavior of Non-Rigid Steel Beam-Column Connections with Concrete Cover

Abstract Four steel beam-column connections were tested under cyclic loads to investigate effects of the concrete cover and the cast-in-situ slabs on the failure modes, stiffness, load-carrying capacity, ductility and energy-dissipation capacity. The test results show that the stiffness and bending strength of the non-rigid steel connections are significantly increased due to the presence of concrete cover and the cast-in-situ slabs can further enhance the connections. Moreover, the connection with slab is prone to debonding failure along beam-slab interface resulting in a remarkable decrease of the stiffness and strength. Practical methods are also presented for analyzing and assessing the steel frames with non-rigid connections considering effects of concrete cover.

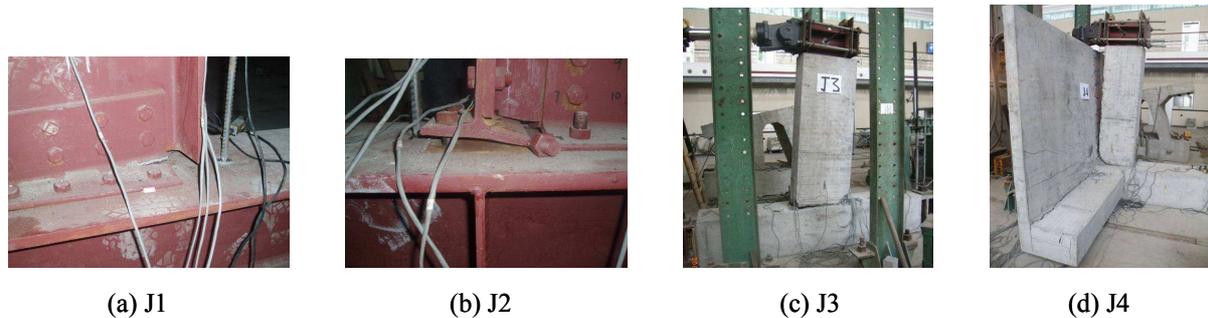
Mechanical Behavior and Failure Mode The column flange and the beam web of Specimen J1 were bolted with double angles and this kind of connection is normally regarded as a pinned joint. When the end of beam was cyclically loaded, the angles bore tension and compression alternatively. When under compression, the angles were pushed and contacted with the column flange. When under tension, the angles were uplifted from the column face. When the displacement of the beam end reached 120mm, the bolts at the first outer row loosed, and the bolts on the column (the bolts under tension) loosed earlier than the bolts on the beams (the bolts under shear). The plastic elongation of the bolts under tension was notable. When the displacement of the beam end reached 160mm, the angle leg adjacent to the fillet fractured. The crack propagated with the increase of the load and displacement. The failure mode of Specimen J1 is shown in Fig. 4(a). The major damage and plastic deformation of the specimen concentrated on the angles and bolts, and no significant damage was found on the beam and the column.

Specimen J2 Specimen J2 was strengthened by adding T-stubs between the column flange and the beam flanges. This kind of connection is normally regarded as a rigid connection. Under the cyclic loading, plastic deformation of the specimen concentrated on the T- stubs connections. When the displacement of the beam end reached 40mm, the bolts on the T-stubs and the angles loosed gradually, and the bolts on the T-stubs under tension elongated plastically. When the displacement of the beam end reached 80mm at the second cycle, one of the bolts on T-stubs fractured by tension and the load resistance of the specimen decreased significantly. The failure mode of Specimen J2 is shown in Fig. 4(b). It can be found that most of the bolts on T-stubs in tension fractured, and the bolts which didn't fail had significant plastic elongations or loosed. The connection and the T-stubs had residual deformation, while the other parts of beam and column remained almost intact after the loading.

Specimen J3 Specimen J3 was same as Specimen J1 and wrapped by concrete cover. When the load reached 52kN, the first bending crack appeared near the root of the beam (close to the column face). When the displacement of the beam end reached 12.5mm, the crack width reached 1mm. When the displacement reached 25mm, several cracks appeared, and the width of the first crack increased to 5mm. When the displacement reached 90mm, the concrete near the root of the beam crushed. The failure mode of Specimen J3 is shown in Fig. 4(c). It can be found that the concrete of the beam nearly detached from that of the column, and the crack width at the connection reached 30 to 50 mm. Significant residual deformation on the beam can also be observed.

Specimen J4 Further to Specimen J3, concrete slab and orthogonal beams were added for Specimen J4. The load was defined as positive load when the top surface of the slab is under tension, and vice versa. The first crack on root of the beam and on the top surface of the slab

appeared when the load reached -15kN and 50kN , respectively. When the beam end displacement reached -15mm , cracks were found at the interface between the beam and the slab. When the displacement reached 45mm , the cracks at the interface progressed through the length of the beam. When the displacement reached -60mm , cracks appeared on the bottom surface of the slab. The concrete at the root of the beam crushed after the displacement reached 100mm . The failure mode of Specimen J4 is shown in Fig. 4(d). It can be found that the beam was almost totally separated from the slab. The beam end was seriously damaged by cracking and crushing. More cracks were found on the bottom surface of the slab than on the top surface, since the slab only bore the negative load after the slab and the beam detached.

Figure 4: Failure modes of the specimens
