## System Based Seismic Strengthening Design Analysis for A Historic Building

**Abstract** In system based seismic strengthening design, the redistribution of inner forces brought by the change of structural members can be considered, which is very important to guarantee the safety of a strengthened structure. Using SAP2000, the seismic behavior of a historic building was analyzed. After that, a system based seismic strengthening plan and a member based seismic strengthening plan were proposed. And the seismic behaviors of the building before and after strengthening were compared. The results show that the seismic behavior of the building can be improved with the system based seismic strengthening and the style and the feature of the building can be protected well.

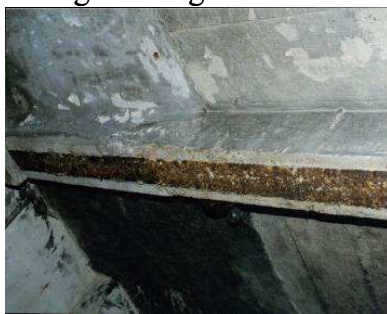
(a) Corrosion of steel in the Building of Bund 18, Shanghai

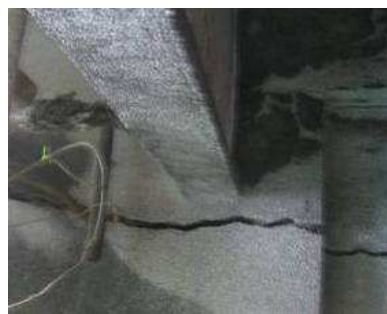
(b) Cracking of structural member in a building in Guangzhou Shamian

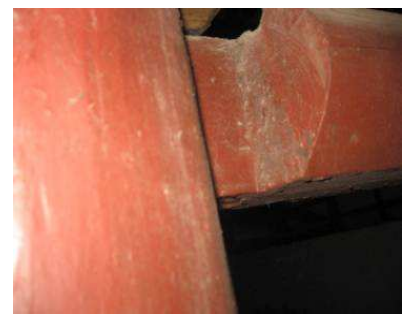
(c) Out of joint in Sichuan Linyun Temple

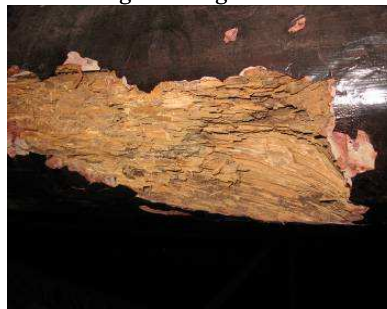
(e) Decayed of wood member in Sichuan Zhaojue Temple

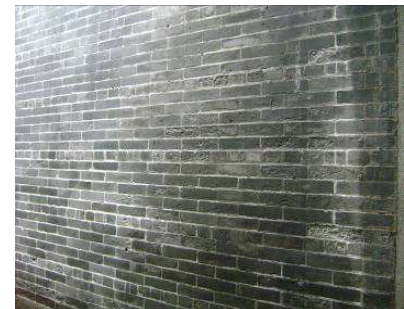
(f) Efflorescence of brick walls in Guangzhou Shoin

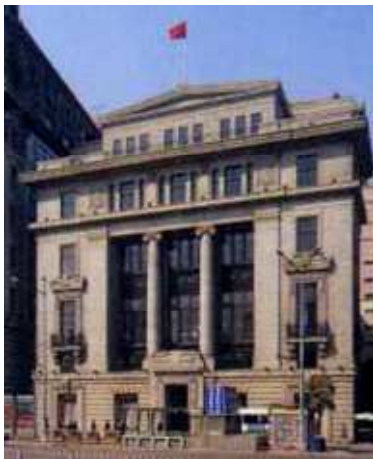
Figure 4: Picture of the Bund 18 building

Bund 18 (Fig. 4), built in 1923, designed for bank office building initially, is one of the excellent historic buildings at the Bund of Shanghai. The building, with area of 10,450m<sup>2</sup> and high of 28.52m, contains one floor of basement and five floors up the ground. Currently the building was proposed to transform into a commercial building. Belonging to the second-class protective category classified by the Shanghai municipal government, the protect details and demands of modification works include the followings (Meng et al. 2007): first, the original appearance, structural system, plane layout (Fig. 5) and special interior decoration can not be changed. Second, decoration and characteristic of the ceiling of the enter hall, grand hall and the lobby need to be protected. Finally, spatial pattern of stair well and special decorations should be protected. Obviously, protection is the first principle in the strengthening of this historic building. It means that new building function should be satisfied without too much direct strengthening.
