The Complexity and the Logic Behind Historical Buildings: the Case-Study of Palazzo del Podestà in Mantova, Italy

Abstract The Palazzo del Podestà, situated in the centre of Mantua, has Medieval origins, but it is the result of many additions and reconstructions and it is now abandoned. In 2005 the Town Council commissioned the Politecnico of Milan a research on the real situation of the palaces, in order to determine the future possible uses of the buildings. The causes of the structural decays were investigated and furtherly studied by means of a comparison between archive records and diagnostic tests.

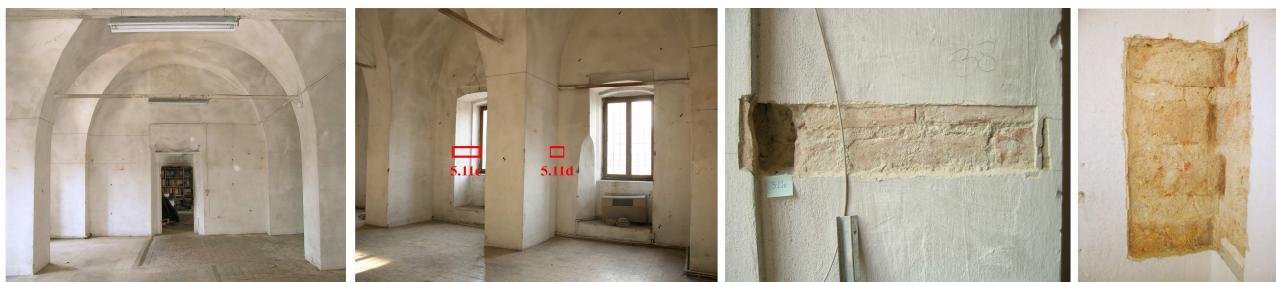
Figure 2: From left to right: pictures of the rectangular room on the third level. Site of the two stratigraphic tests on the wall. Stratigraphic test n° 5.11c: it confirmed that the exterior wall of the building is formed of two well-distinguished brick walls: the hole on the left was completely filled with mortar. The stratigraphic test n°5.11d, made on the edge between the outer wall and one of the four piers: the brick masonry of the pier and the wall are tightly connected

Although some archives are incomplete, it is possible to express a hypothesis about the building. In 1413 a fire destroyed a part of the palace and in 1466 Ludovico II, Marquis of Mantova, gave the architects Luca Fancelli and Giovanni Antonio d'Arezzo the task to definitely arrange the façade looking on to *Piazza delle Erbe* (Carpeggiani and Lorenzoni 1998, Vatovec 1979). They probably had to deal with pre-existing composite structures set against the medieval nucleus of the palace. Probably the architects' restoration consisted in enlarging, raising and rebuilding the façade so to give dignity to the public square. On the lower floors a faced wall was set against the existent brick masonry in order to thicken it: so both structures could better support the load of the added upper storeys and wooden floors. At first this hypothesis was considered only by the historian Giovanni Paccagnini (Paccagnini 1961); now it is confirmed by a test carried out on the internal side of the façade looking on to *Piazza delle Erbe*.

The test suggests the presence of two well distinguished brick masonry walls: nowadays the windows are in the outer faced wall, but the test shows the presence of an inner seat of a window.
