Recent Results on Masonry Infill Walls

Abstract The paper summarizes the main research findings on masonry infill walls which were obtained within the framework of a comprehensive NSF-NEESR-SG project directed by Prof. Benson Shing at UC San Diego (Shing et al. 2009). The main focus of this contribution are experimental and computational observations on 2/3 scale unreinforced masonry panels bounded by a reinforced concrete frame which were subjected to cyclic push-over testing at CU Boulder under constant vertical pre-loading. This study included two-wythe masonry panels of 133in x75.5in size (3.378 x1.897m) with and without openings in form of eccentric windows and doors. The background experiments did include a suite of masonry prism tests on rectilinear and slanted masonry prisms providing important insight into the composite behavior of mortar and brick construction. The paper concludes with remarks on the experimental observations when the panels were integrated into infill walls of two-bay width and three-story height with and without retrofits of reinforced ECC layers (engineered cementitious composites) which were attached to one side for quasistatic testing at CU Boulder,

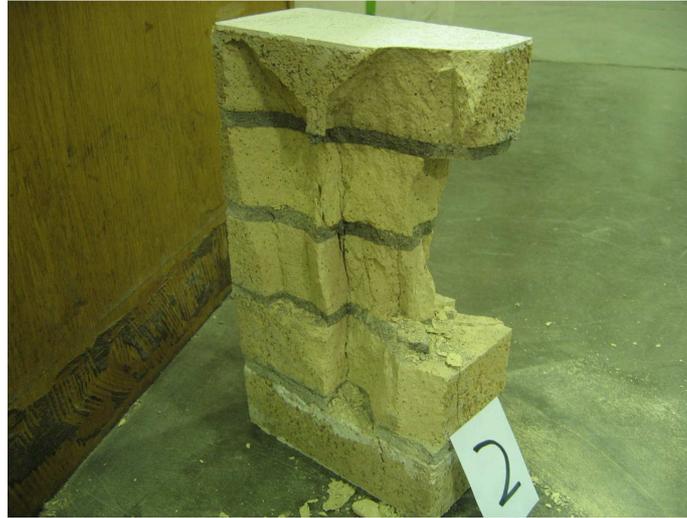
Figure 1: Failure of masonry prism as result of compression test

The masonry prism tests in Figs. 1 and 2 were accompanied by two series material property tests on mortar and brick units. The prisms were made of five brick units and four mortar bed joints using half-length bricks because of the size and capacity limitations of the servo-controlled 110 kip MTS material testing system.

Fig. 1 illustrates the basic prism configuration after failure in the form of axial splitting, both in-plane as well as out-of-plane. Fig. 2 demonstrates the effect of mismatch among the brick and mortar properties which introduces triaxial stresses as long as there is no loss of interface bond. Consequently we observe a more than two-fold increase of compressive strength of the composite masonry prism when compared with the strength of the weak mortar layer in uniaxial compression. In fact, it is elementary mismatch of elastic properties and in particular the inelastic mortar properties which introduces triaxial confinement and hence more than doubling of the mortar capacity, and tensile lateral stresses in the brick units leading to axial cracking and splitting of the entire masonry prism, (see (Hilsdorf 1965), and recently (Blackard et al. 2009)). In short, the axial compression test of the masonry prism is effectively a lateral tension test of the brick units similarly to the Brazilian indirect tension test widely used to evaluate the tensile strength of concrete. Another puzzling observation is the brittle appearance of the post-peak response of the masonry prism when compared with the ductile response behavior of both the mortar as well the brick units when tested under stroke control. Whereas the tensile cracking process of the brittle brick units provides an obvious explanation for the axial splitting mode of prism failure, there is another scenario in the

form of a snap-back instability. This has to do with the early compression softening in the weak mortar layers which introduce stress reversals and energy release in the form of snap-back instabilities (Willam et al. 2010). Henceforth, there are two explanations for the brittle appearance of prism failure in Fig. 2, (a) either due tensile crack initiation in the brittle brick units, or (b) snap-back instabilities due to localized softening of the mortar bed joints in compression.

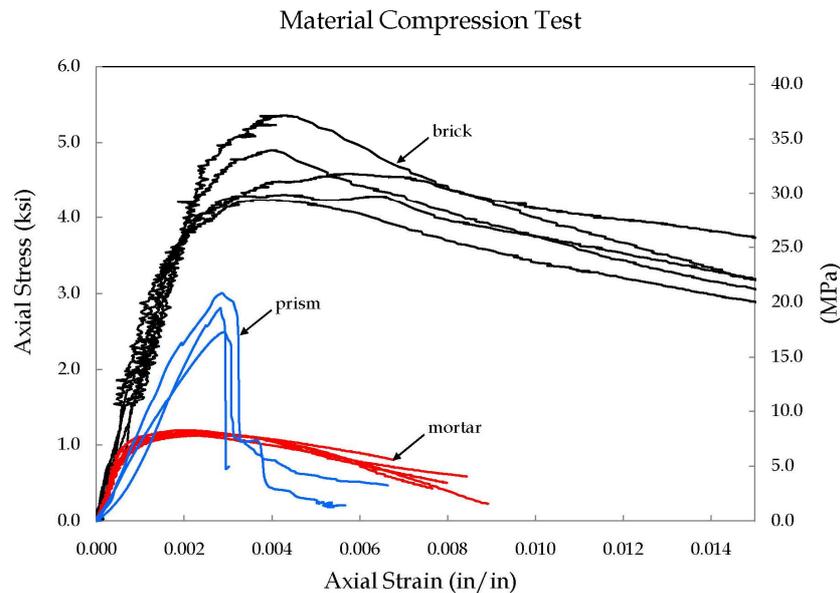
Figure 2: Axial compressive behavior of brick unit, mortar, and masonry prism

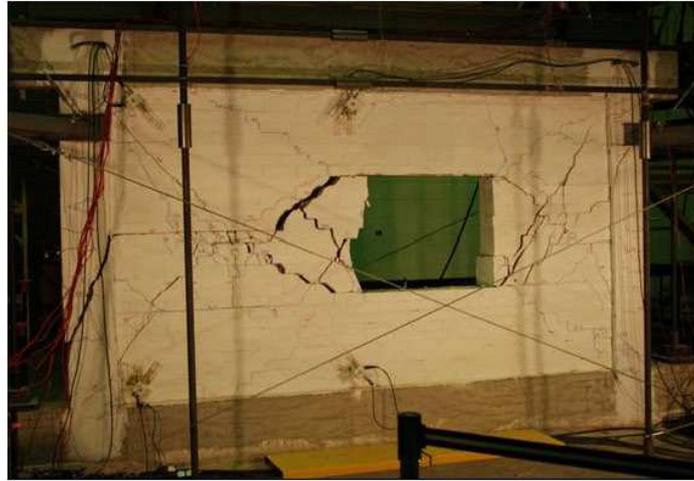
Figure 3: Final crack pattern of infilled frame with eccentric window opening (Blackard et al. 2009)

A representative example of the CU Boulder test series on infill walls with and without opening is illustrated in Fig. 3. It shows the effect of a small eccentric window on the overall behavior of the infill wall. The concomitant Fig. 4 depicts the lateral force-story drift response behavior when the infill wall is subjected to cyclic load reversals by a horizontal 220 kip [979 KN] actuator mounted at the end of the top beam under constant vertical preloading of 2x35 kips [312 KN]. We observe formation of a large inclined crack in the left RC column at the positive load cycle P18 which is associated with a large drop of the shear capacity of the infill wall. In Fig. 4. Moreover we note

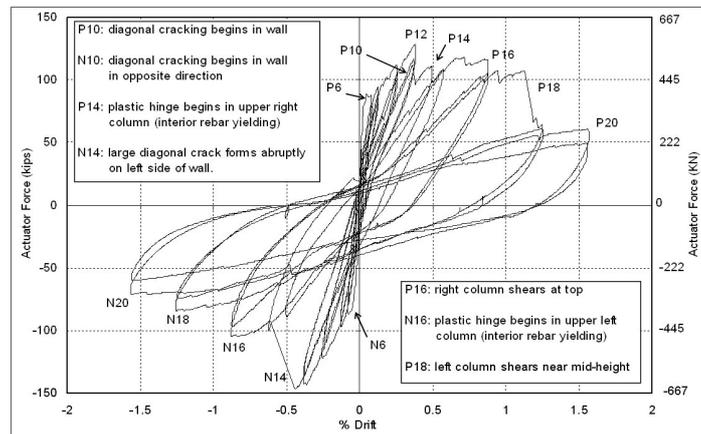
Figure 4: Lateral force vs drift response of infilled frame with eccentric window opening (Blackard et al, 2009)

ovaling of the rectangular window at drift levels of p/m 1.5% while the sustained shear capacity of the infill wall beyond p/m 2% is not shown in the graph for reasons of resolution.

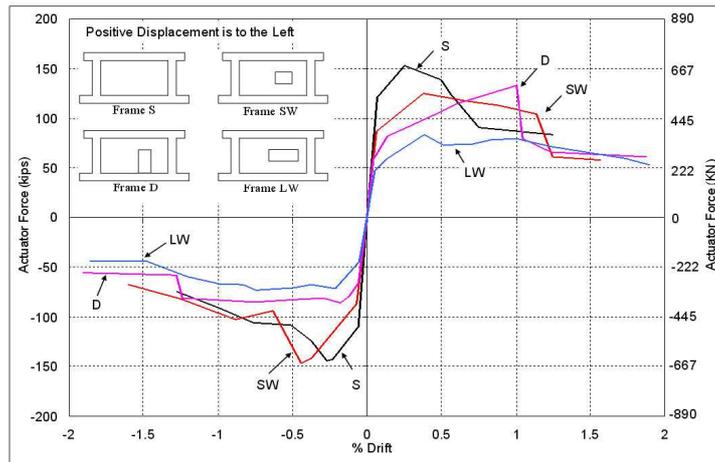
Figure 5: Effect of opening on response envelopes [Blackard et al. 2009]

The test results of the experiments with and without wall openings are summarized in Fig. 5 in the form of envelope curves omitting the details of the cyclic response behavior. The figure illustrates the results of the solid infill wall denoted by S with the envelope characteristics of different openings. Thereby SW stands for a small window, LW for a large window, and D for door all located at the same eccentricity. Note the different wall openings exhibit a moderate decrease of stiffness and strength while the residual shear capacity of more than one third of the maximum shear strength turns out to be quite insensitive with regard to the geometry and size of each opening.
