Experimental and Numerical Analysis of a Two-Span Model Masonry Arch Bridge Subjected to Pier Scour

Abstract A scaled model of a two-span masonry arch bridge has been built in order to investigate the effect of the central pile settlement due to riverbank erosion. The bridge model has been equipped with different Non Destructive Testing (NDT) instruments and subjected to incremental settlement of the pier. The evolution of the pier scour has been investigated experimentally by means of a hydraulic model and reproduced accordingly. The numerical interpretation of damage, carried out by finite element analyses, has been compared with the results of the Acoustic Emissions (AE) monitoring. Several ultrasonic emissions have been detected and main damage source areas have been localized.

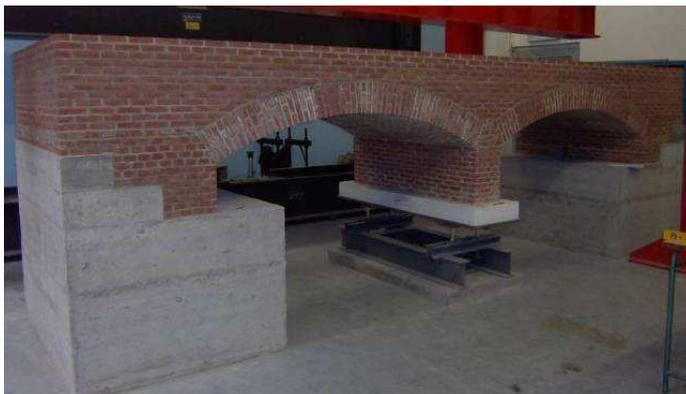
The bridge model shown in Fig.1 (a) is characterised by two masonry arches which are supported by two masonry abutments and a central pier built with the same masonry. The pier was cut at half of the height to allow the insertion of a mechanical device used to apply the differential settlements. The missing weight of the lowest half of the central pier and its foundation was reproduced by means of a load concentrated on the bridge deck above the pier. A more detailed description of the structural elements which compose the bridge model can be found in the literature (Ruocci et. al. 2009).

Figure 1: The masonry arch bridge model (a) and the hydraulic flume test

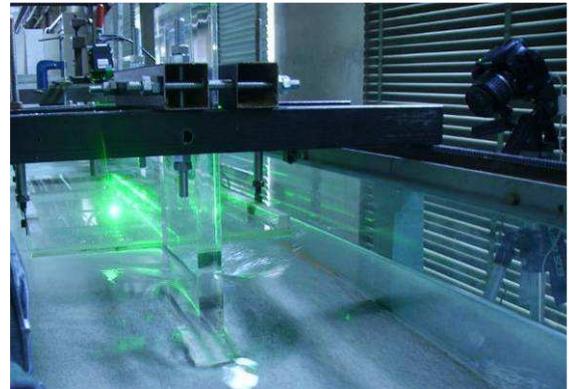
(b)

The simulation of the scour effects on the bridge model has been preceded by some flume tests carried out on a further scaled down model of the pier. The experiment illustrated in Fig. 1(b) allowed to monitor the evolution of the pier scour and to assess the extent of the phenomenon. The snapshots of a laser beam projection on the streambed soil acquired throughout the test and digitally post-processed provided an approximation of the differential settlements of the pier due to the scour erosion. The experimental results were then reproduced in the structural model acting on the four screws of the settlement application system, which allow to apply any kind of displacement and rotation. Four differential settlement steps were applied in order to introduce damage states of increasing extent in the structure. Only the two screws placed at the upstream side of the bridge were turned while the other two were kept fixed. The maximum settlement of each step was measured by displacement transducers placed at the vertexes of the steel plate which supports the pier. The applied four steps were set equal to 0.5, 1.0, 1.0 and 1.5mm, respectively. The polystyrene ring, which surrounds the bottom of the pier and whose density was selected to properly correspond to the foundation soil characteristics, was progressively removed with the settlement steps application in order to simulate the loss of the confinement effect throughout the erosive process.

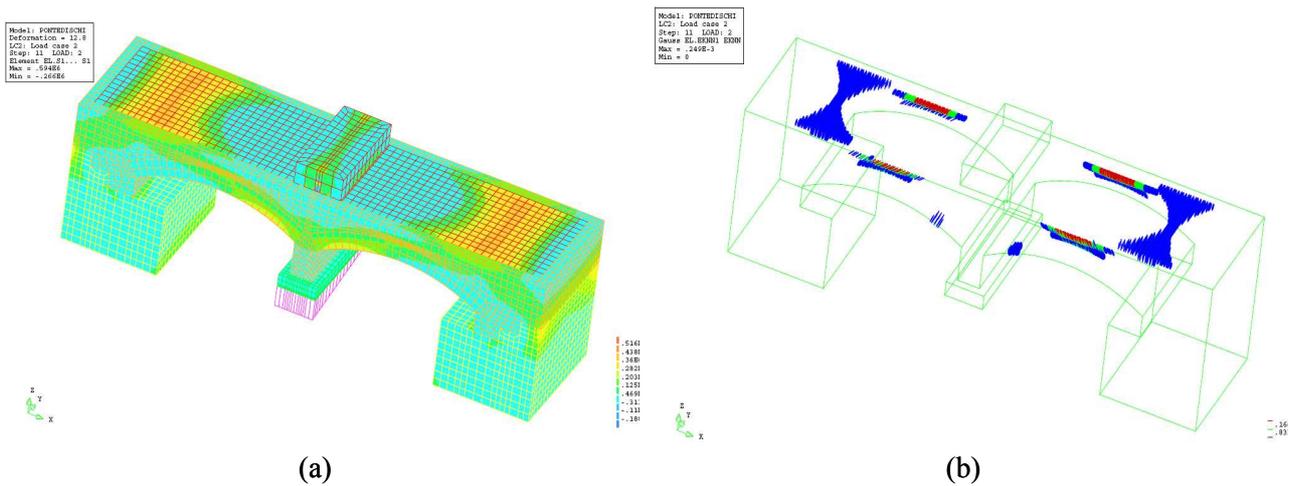
Figure 2: Tensile principal stress contours (a) and smeared crack pattern (b) for the maximum differential settlement (20mm)

the Young’s modulus E , the Poisson ratio ν , the tensile strength f_t , the compressive strength f_c , and the tensile fracture energy G_F . These parameters were used to describe the mechanical nonlinearity introduced in the FE analyses. A smeared cracking model, which incorporates tension cut-off, tension softening and shear retention was selected both for masonry and concrete. This approach allowed predicting the nucleation and propagation of cracks for increasing prescribed displacements. The model mesh was built with about 18000 three-dimensional quadratic brick elements connected by approximately 82000 nodes. The linear differential settlement was imposed to the central pier after the dead load application and progressively incremented till a largest value of 20mm. The contours of the principal tensile stress depicted in Fig. 2(a) show that the highest values interest the arches intrados nearby the central pier, as well as the extrados of the concrete slab on the bridge deck in the sections close to the abutments. Strain gages and fibre optic sensors were deployed in these regions to measure the evolution of the strain with the settlements steps application. Also the pier was monitored in order to detect the decompression it could have experienced because of the change in the boundary conditions. The nonlinear analysis allowed to identify the locations of cracks nucleation and to predict their propagation. From Fig. 2(b) the correspondence between the crack openings and the areas characterised by the highest tractions is clearly recognisable. This result proved the ability of the pier settlements to affect the structural integrity of the construction and consequently the seriousness of the scour effects on masonry arch bridges. The acquired information provided also the term of comparison for the experimental localisation of the AE sources.

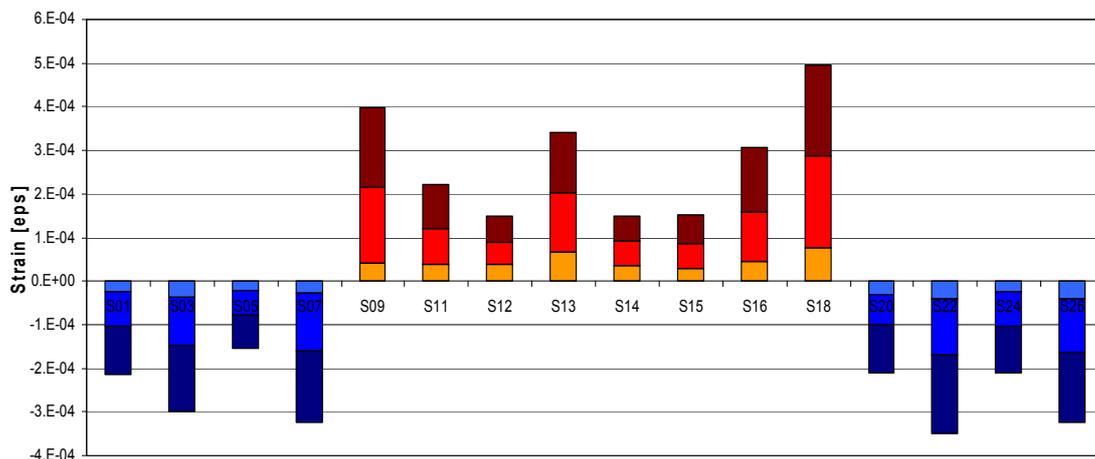
Strain Gages The responses of the arch barrels to the settlements application were measured by means of a set of 16 120Ω resistive strain gages 160mm long and 10mm wide. The length of the strain gages allowed to cross at least five bricks and thus to obtain a representative information of the masonry behaviour. The transducers were divided into two sets and were uniformly distributed on the intrados of the arch barrels at the upstream side of the bridge model. As expected from the numerical analyses, the settlement application led to tensile strains in the central portion of the bridge and compressions in the lateral parts. The distribution of the strains throughout the first three steps resulted unchanged and a progressive increase of the deformations was recorded. In Fig. 3 the maximum strain drifts measured after each settlement step application are shown. The contribution of each successive step is depicted with a colour of the histogram bars varying towards darker tonalities.

Figure 3: Maximum strain drifts measured by the strain gages after each settlement step

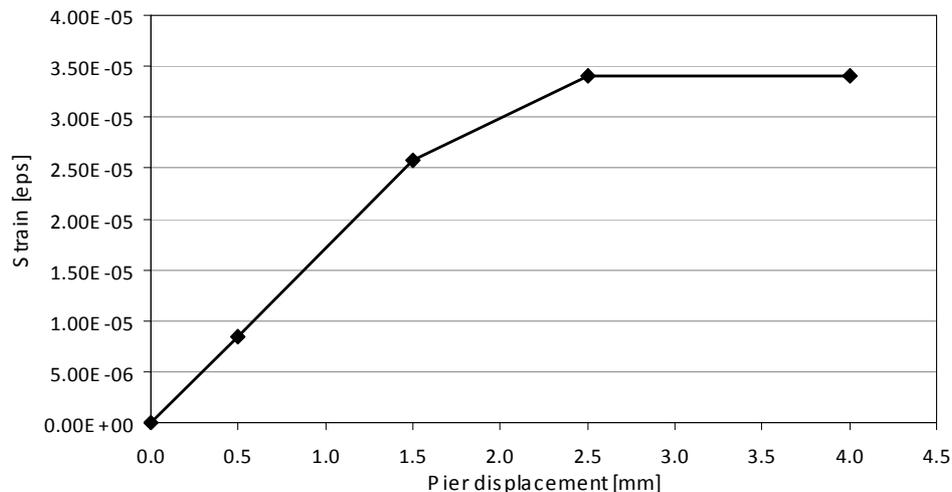
Figure 4: Cumulative measured pier strain related to the settlement steps

Fiber Optic Sensors Fiber Optic technology is widely used to measure different structural quantities. In particular, Fiber Bragg Gratings (FBGs) are simple sensing elements, which can be photo-inscribed into a silica fiber and exploit all the advantages normally attributed to fiber sensors. They are suited to measure strain to a 1 resolution and to operate also in hostile environments. The strain sensors employed in this work are based on the so-called ‘patch sensors’ technology (Ansari and Bassam 2008), where the FBGs are sandwiched between two thin sheets of polyimide, kept together with two-components glue. The sensibility of the FBGs and the strain transmission were ensured by using sheets with thickness around few microns. Twelve patch sensors were glued directly on the structure, in order to measure the strain in correspondence of the masonry joints. The measured reduction in the positive strain moving from the upstream to the downstream side of the bridge agree with the results of the numerical analyses. However, the most encouraging result for a future early warning application on real bridges was provided by the sensor glued along the vertical direction on the bridge pier. This sensor was able to detect the decompression of the pier due to the removal of the base support from the first step application. In Fig. 4 the cumulative strain produced by the progressively induced settlement of the pier support is plotted. It is worthy to stress that the increasing trend of the measured strain observed in the first two steps reduces in the third and finally vanishes in the fourth. This indicates that, while for a total settlement of 1.5 mm still exists contact between the pier and the base support, between 1.5 and 2.5 mm the detachment of the pier from the support occurs.

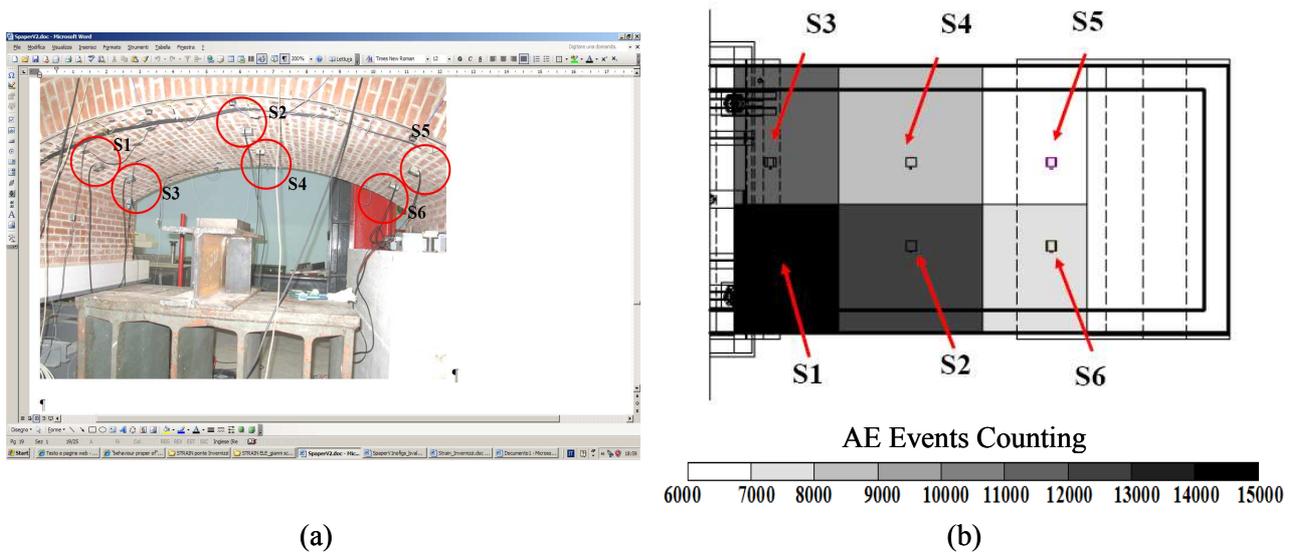
Figure 5: Positioning of the AE transducers (a); Number of AE counts in each competence area (b)

The AE sensors were placed at the intrados of one of the bridge vaults, in order to cover six almost equal competence areas (Fig. 5a). The cumulative AE curves emphasize the different amount of events in the different competence areas. The AE counting is displayed by shaded grey diagrams in Fig. 5b. The regions with the larger amount of AE counts correspond correctly to the most fractured areas visually detected (Invernizzi et al. 2010).
