# Conservation of Heritage Structures in Turkey: Practice and Difficulties

TURER Ahmet<sup>1, a</sup>

<sup>1</sup>Middle East Technical University, Civil Engineering Dept., Ankara, Turkey

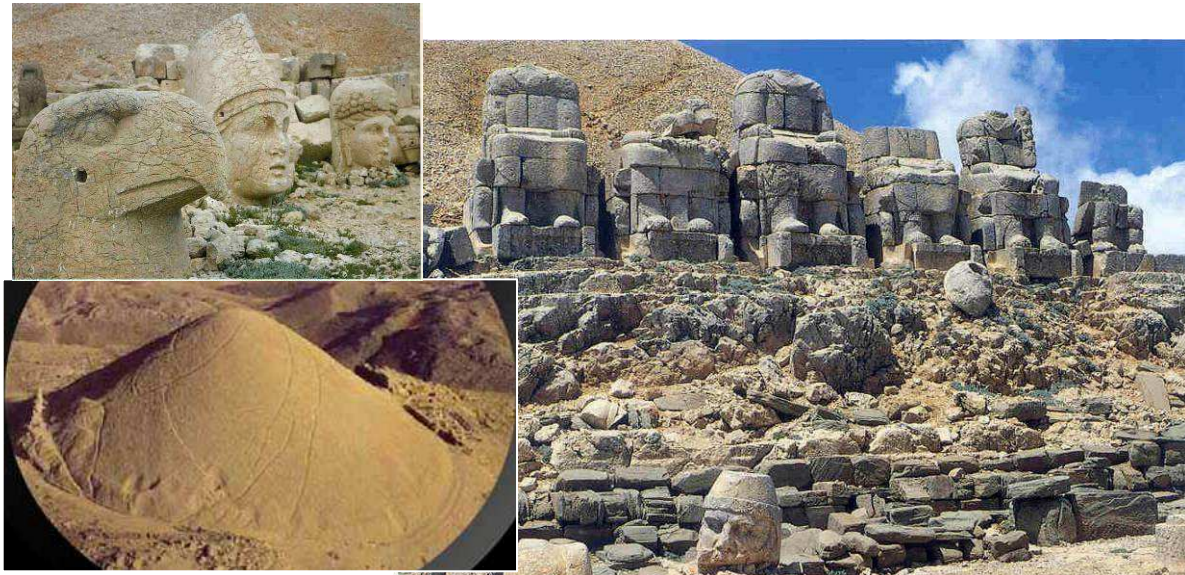
*Figure 3: Nemrud monuments, west and east terraces from left to right*

The monuments are composed of seven layers of large stone blocks which are not interconnected with shear keys, metal locks, or mortar. The 7<sup>th</sup> layer consists of the heads only, which used to be located over a small ditch located over the shoulder level (Fig. 3) but all has been fallen down. The monuments, which are composed of big limestone blocks without mortar or interlocking mechanisms, placed on the East and West terraces show considerable differences in terms of damage level for physical integrity. The east terrace statues are in better structural condition except for the fallen heads while the west terrace statues are almost completely demolished except for the first two layers. The Nemrud monuments were discovered in 1881 by Otto Puchstein and Karl Sester; and various works have been carried out by Osman Hamdi Bey and Osgan Efendi (1882), Karl Humann and Otto Puchstein (1882), Karl F. Dörner (1954-1958; 1984), Theresa Goell (1956-1973), Sencer Şahin (1987-1989), Herman A.G. Brijder and Maurice Crijns (2001-2003). A recent and comprehensive project is being led by Dr. Neriman Sahin Guchan at METU, which involves detailed documentation, evaluation, development of case specific solutions for conservation, strengthening, site planning including the surrounding cities and other structures in the area including bridges, caves, monuments, etc. The Nemrud monuments are especially important and at the core of the current studies.

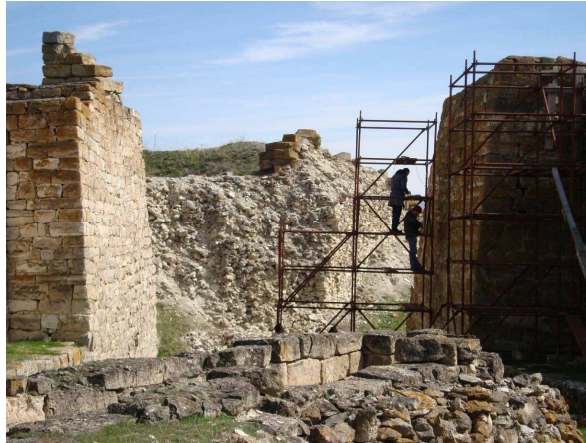
*Figure 9: Gordion Gate bulging and gage installation studies*

masonry. The outer limestone wall shows extensive cracking, spalls, open joints, and bulging. After its excavation in 1950s, the gate has been exposed to environmental conditions. What's more important is that there is soil pressure at the back fill of the wall while about 10m deep wall is not supported on the outer side (Fig. 9). The excavation work and preservation studies are mainly carried out by UPenn (USA - Dr. Frank Matero) teamed up with researchers from METU (Turkey). The bulging wall is now continuously being monitored by three digital LVDTs which are remotely connected to a PC at METU using GSM modem. Furthermore, 3D surface scans of the walls taken last summer will be digitally compared after one year against similar measurements that will be taken in the summer of 2010. Previous injection of lime based mortar at the joints showed limited use and additional measures are being planned such as removal of static pressure behind the wall or anchorage.

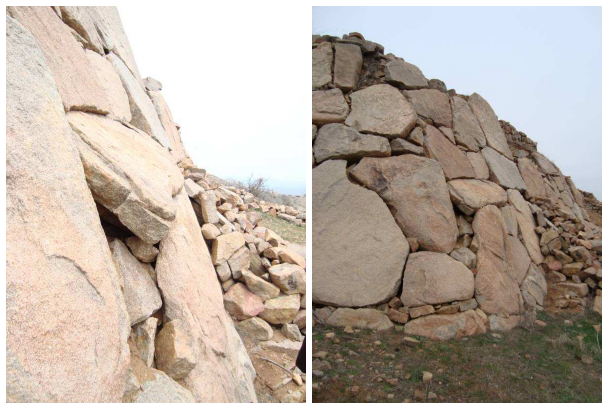
*Figure 10: Cappadocian Gate general view; bulging and partial collapse*

Cappadocian gate is located in Yozgat on Kerkenes dag (Fig. 10). The ancient city is the largest pre-Hellenistic site known on the Anatolian Plateau dates back to 7<sup>th</sup> century BC, covering 2.5 km<sup>2</sup>, enclosed by 7 km of strong defensive wall which can be seen from space. The city was burnt and its inhabitants enslaved by Croesus, the Lydian king of Sardis in 547 BC (Summers 2003). Restoration studies are successfully guided by Dr. Summers since 1993. The excavations studies have been recently interrupted with stability concerns regarding of the Cappadocian Gate and a number of dry masonry walls. Similar to the case of the Gordion gate, the dry masonry walls started bulging as they are exposed to environmental conditions.
