Analysis and Demolition of Some Vaults of the Church of La Peregrina in Sahagún (Spain)

Abstract The Franciscan church of La Peregrina in Sahagún (Spain) was founded in the 13th Century. It has undergone many transformations and additions throughout its history. The most important were carried out in the 17th Century when the church was converted to the Baroque style. The apse vaults were demolished and new timbrel vaults were built hiding the Mudéjar windows. In the nave, the transverse arches that supported the modern roof were also demolished, internal counterforts were built and new barrel timbrel vaults with lunettes, erected. Eventually, an oval dome was built on the transept. Recent restoration work will give the building a new use. The project aims to recover the Mudéjar apse with its windows providing natural light to the presbytery. This involves the demolition of the Baroque vaults above the presbytery (a barrel vault terminated with a semi-dome). The oval dome will lose some buttressing to the side of the apse and an expertise was required to assess the feasibility of the operation. In the present paper the structure of the church will be described and the analysis of

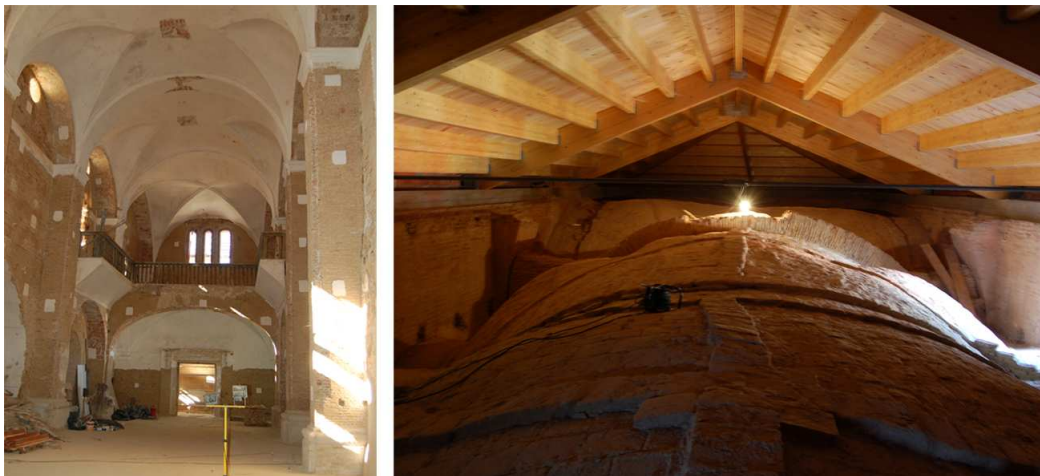
Figure 2: (a) internal view of the nave; (b) extrados of the vaults over the nave

The convent underwent many alterations. The most important intervention took place towards the end of the 17th century. Part of the timber roof had collapsed, and the brick walls were in poor condition. In response to these problems, the transverse arches were demolished and the nave was covered by brick timbrel vaults with lunettes. (This particular type of vault is made of two layers of bricks, set flat with gypsum, and breaking joints, forming one thin shell). The typical thickness is 100

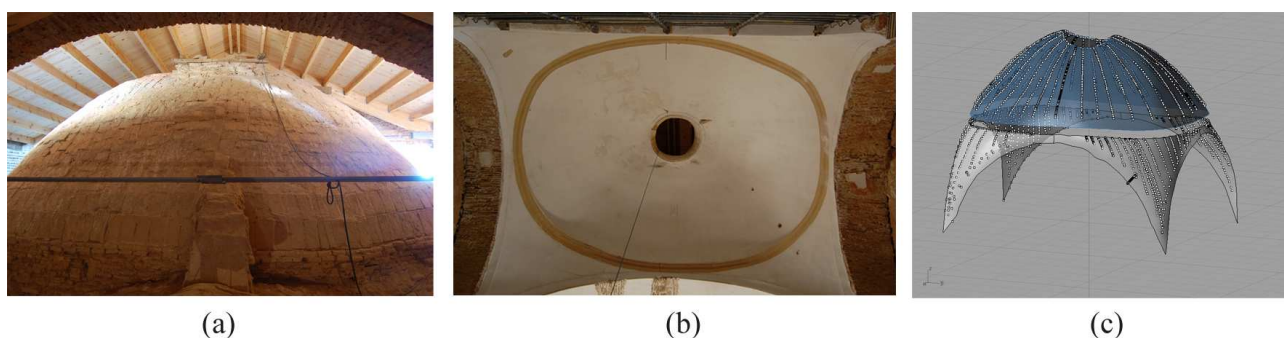
Figure 3: (a) View of the extrados; (b) View from the inside; (c) Geometry of the dome

The structure can be clearly distinguished from the extrados. In particular, much of the fill on the two pendentives adjacent to the nave has worn away, showing the transition between the dome and the pendentive (Fig. 3.a). Thanks to this, a very peculiar characteristic has been observed: the dome and the pendentives are part of the same surface. There is no sign of the usual discontinuity at the impost, it is all one single surface (Fig. 3.c). This observation has been confirmed by the geometrical survey.

From underneath, the observer tends to consider the impost as what it usually is, the result of the intersection of two surfaces with different curvature, the tangents to the intrados of the dome at the impost being usually vertical. This is not the case at La Peregrina, where dome and pendentives have a common inclined tangent at the impost. This fact has a very important structural consequence. The shape of the dome and pendentives is such that a compressive membrane equilibrium solution is possible. Therefore, the fill and the abutment walls that are usually built up to 2/3 of the height of the dome are not necessary. (This recommendation was given by Fray Lorenzo in his 1639 treaty and can be observed in almost all hemispherical domes with uniform thickness.) Thus, demonstrating great skill, the master builder of La Peregrina devised a shape that, capable to adapt to a rectangular layout, didn't require the fill and low buttressing walls that would have made the work more expensive and complex. Besides, since the system dome-pendentives forms a unique vault the principal arches receive substantially less weight.

The extrados of the dome presents many irregularities. These are due to building without centering and not paying much attention to the continuous variation of the curvature. This becomes evident near the oculus, which forms a warped curve in space (Fig. 3.c). This could perhaps be considered as ‘untidy’ construction, but the truth is that these irregularities can't be appreciated from the nave (Fig. 3.b), and the builder probably opted to save the excess cost that an accurate definition of the surface would have introduced. Besides, the survey shows that the rectangle of the base is in fact a quadrilateral; the sides that correspond to the nave are almost parallel, but the sides corresponding to the transept are not. This is frequently the case in historic construction, where different conditionings motivated by diverse aspects related in general to the history of the building, don't allow the design

The tangent at the level of the impost, as can be appreciated from Fig. 3. (c), is not vertical. Therefore, the stress resultants can be decomposed in two components: one vertical and the other horizontal. The average vertical component V_a can be obtained dividing the total weight of the dome by the length of the oval on the base, approx. 22 m. Then, $V_a = 80/22 = 3,65$ kN/m or 36,5 ton/m. Near the pendentives, the forces are transferred without difficulty because, as said before, there is no discontinuity of the curvature. In the area near the arches, however, some horizontal thrust is generated. This thrust must be counteracted in order to preserve equilibrium in the dome. Currently, the principal arches and the vaults are counteracting this thrust.

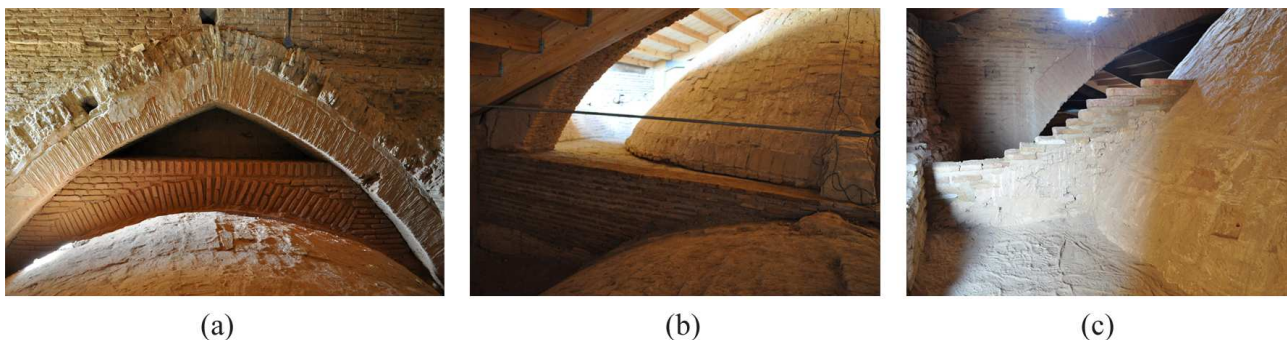
Figure 5: Preparation of the dome for the demolition. (a) over-arch; (b) wall over the chancel arch and new fill; (c) reparation of the existing abutment walls

Two more little abutment walls were added between the extrados of the dome and the wall over the chancel arch. Thanks to being closer to the keystone of the arch, these walls will transfer more of the weight of the shell on to the pendentives. The chancel arch was strengthened by building an over-arch with a thickness of 1 foot (250 mm) and the same width as the chancel arch (500 mm), aligned with the adjacent wall. The haunches of this over-arch were filled with good-quality brick masonry of the same thickness (Fig. 5.a); eventually, over the horizontal extrados a horizontal lintel arch with a thickness of $\frac{1}{2}$ foot was built. The purpose of this masonry is that the system can act as a flat arch if necessary, transmitting thrusts to the springings, if necessary. A brick wall was also built over the chancel arch, running horizontal from the keystone to the lateral walls. The wall has the height of the top of the impost of the dome (Fig. 5.b). The space between the extrados of the pendentives and the wall was filled. The fill was constructed alternating layers of soil and weak lime mortar, tamped down to obtain a suitable consistency. The works concluded with the cleaning and repointing of the buttressing walls of the dome (Fig. 5.c).

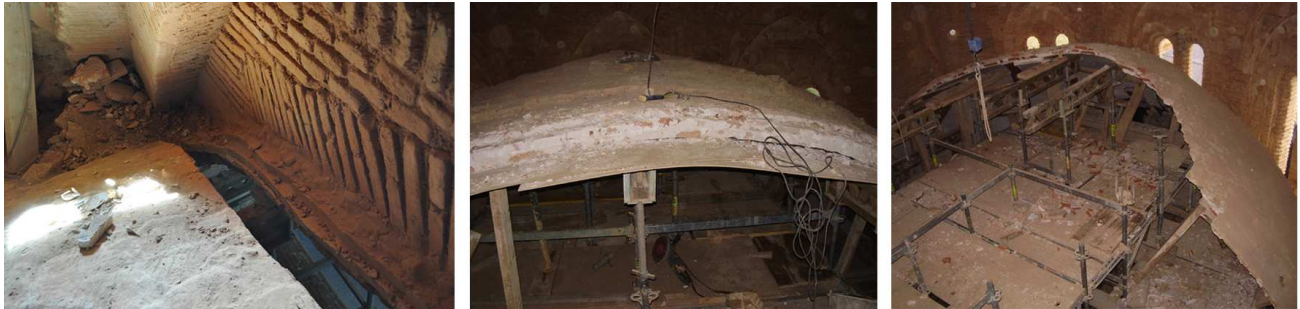
Figure 6: Sequence of the demolition of the vault.

In order to carry out the demolition of the vault, the first task was to separate it from the oval dome and check there were no movements in the dome. First, a cut through the dome next to the chancel arch was done using a circular saw. The cut run from springing to springing. After observing the state of this cut, a second cut was done parallel to the first one, with a separation of approx. 100 mm. The stretch of vault between the cuts was then demolished (Fig. 6). After the demolition of the narrow stretch, no progress was made on the demolition for a week in order to monitor for any possible movements. No movements were appreciated, and the rest of the vault was demolished.

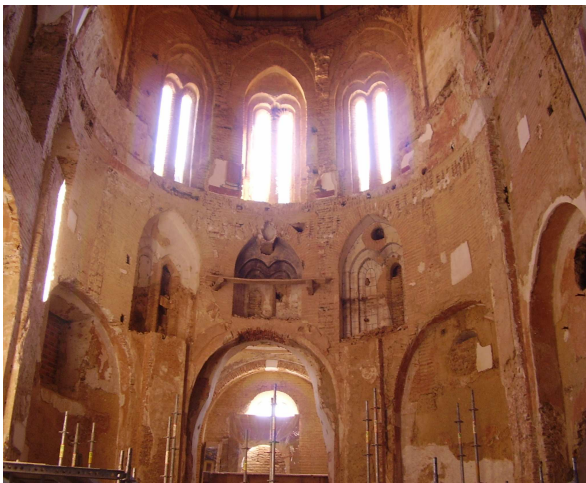
Figure 7: The freed apse
