## **Stability Analysis on the Roof Trusses of the Broumov Group of Churches to Underline Statical Sense of Dientzenhofers**

**Abstract** The Broumov group of churches represents an integral part of Bohemian baroque architecture. The famous Dientzenhofer family of architects, that helped define the Bohemian baroque style in the early 18<sup>th</sup> century, designed the Broumov group for the governing Benedictine abbey of St. Wenceslaw in Broumov. This report summarizes a structural investigation, using FIN10 finite element software, into the stability and efficiency of the roof trusses design. The structures age and current state were taken into account in calculating both the applied loads and structural capacity by increasing loads and reducing material strength. A damage analysis, including identification of fungi species, was performed, documented and implemented in a three-dimensional model for comparison with undamaged results. Magnitude and distribution of axial and bending forces were determined using both two dimensional and three-dimensional models for several load cases. Using the comparison of 1<sup>st</sup> order and 2<sup>nd</sup> order structural analysis results

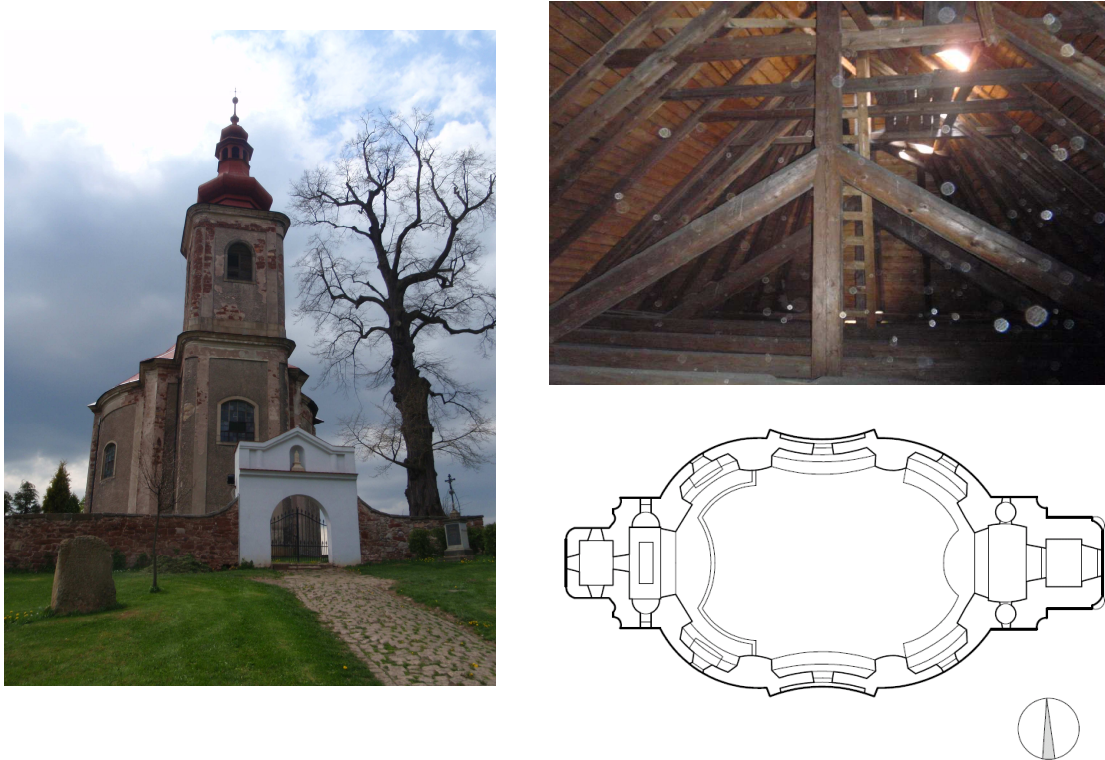
*Figure 1: The church of St. Anne - view, roof truss and floor plan*

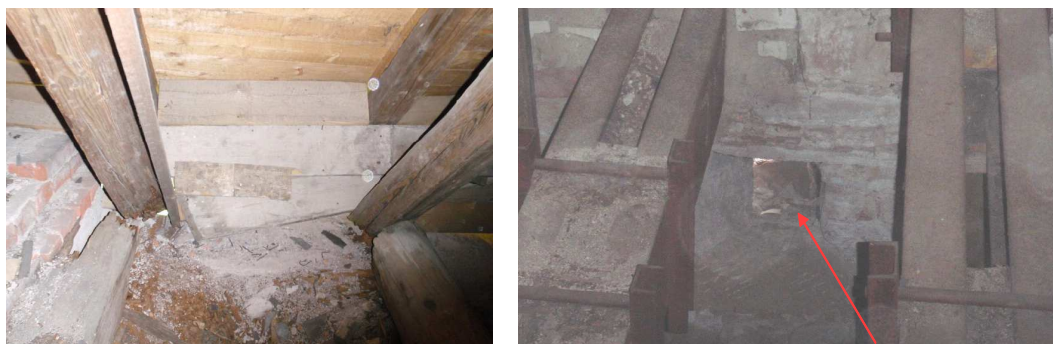
*Figure 2: Deterioration of the roof and small square hole for drying the roof*

An initial survey done of the roof identified damaged areas, type of fungus and the truss geometries next used in the FEM models. Consistent neglect since the Second World War has left these churches damaged, frequently with moisture and fungus problems. Recently a temporary roof was installed and the fungus eradicated but more funding is needed to properly restore this structures (Fajman et al. 2008, Fajman 2009, Kuklik 2008).

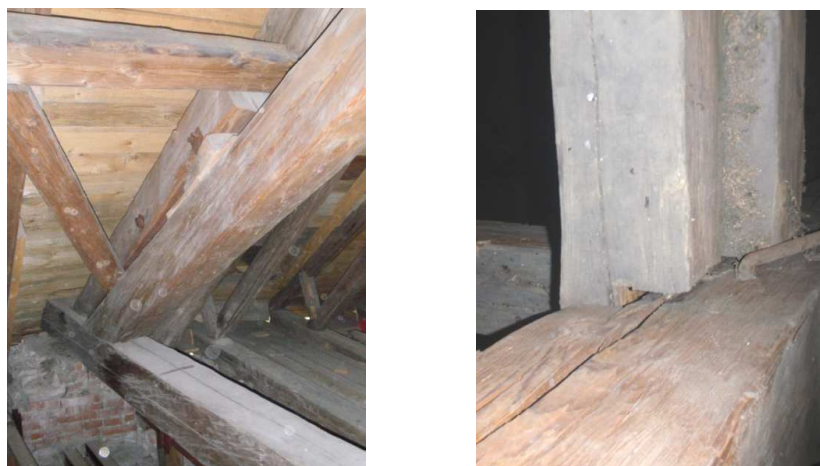
Figure 5: Typical "end of member" and mid-span connections
