The Seismic Assessment of the Curia in the Roman Forum through Simplified Models

Abstract The knowledge of historical buildings represents the necessary condition for obtaining a reliable evaluation (even if simplified) of their structural safety, especially in relation to the seismic assessment. In the case of archeological finds, the knowledge of the building modifications, due to anthropic or natural events, assumes a particular importance. The Curia, placed in the archaeological site of the Roman Forum in Rome, represents, under this point of view, an emblematic case. The several transformations suffered by the building during the centuries determine the need of a seismic evaluation able to take into account the different structural conformations and the different boundary conditions.

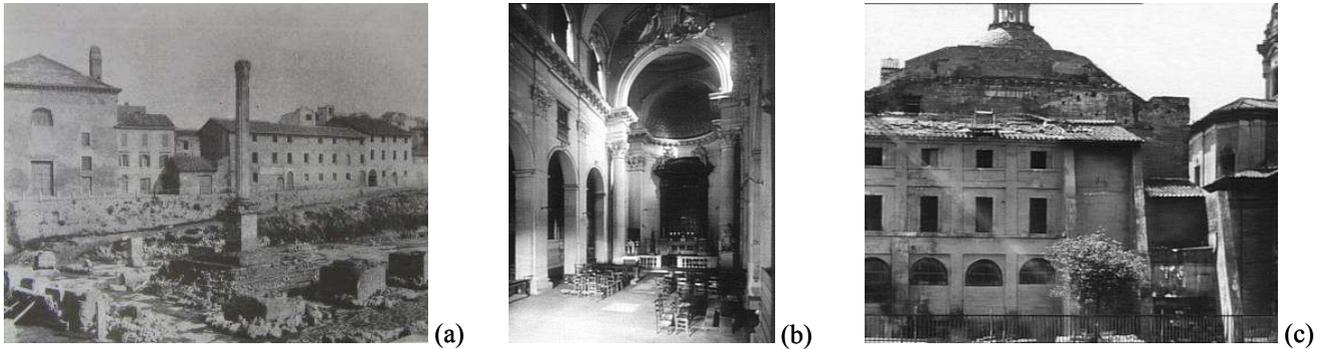
Figure 1: St. Adriano Church: (a) Roman Forum at the end of XIX century; (b) internal view of the Church; (c) external view of the Convent (Photographic Archive ICCD)

The Curia, or Senate Building, placed in the archaeological site of the Roman Forum in Rome, was built in its actual form by Diocletian in the III century AD. From the VII century, the building was transformed in a church and was consecrated to St. Adrian (Fig. 1a, b). In XIII century it suffered significant restoration interventions: the original floor of the ancient Roman Senate was lifted up of 3

m (in relation to the raising of the external countryside level due to the collapse and the burying of adjacent buildings) and two aisles (with ancient columns) were built. After a period in which the building was not used, in XVI century, the Curia was another time restored and a Convent was annexed to the church (Fig. 1c).

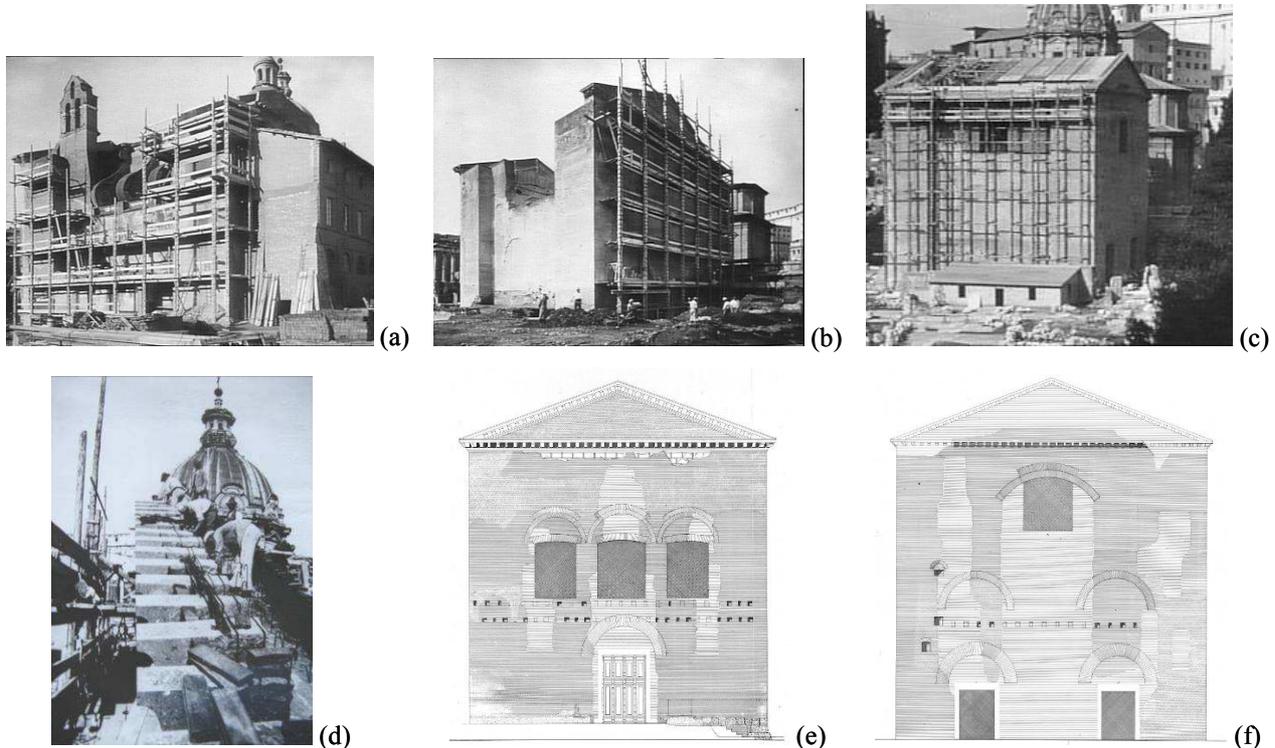
Figure 2: Curia: (a), (b), (c), (d) historical images taken during the 1903's restoration works (Photographic Archive ICCD); (e), (f) individuation of rebuilt masonry parts in 1930, respectively the top and back facade (Morselli C. e Tortorici E., 1989).

The church was used until the '30s when, during an excavation in the Roman Forum, it was decided to bring the building back to its original appearance by depriving it of all later additions at the time Diocletian (Fig. 2). The drastic nature of the intervention, that has destroyed all the account of an era, is clearly evident in the historical images following reported (Fig. 2). In figure 2e and 2f, in particular, the ancient masonry walls are identifiable by the rebuilt or consolidated parts. The two facade gables have been almost completely rebuilt, as well as the roof covering system, the back facade and part of the two side-walls.

The roof covering is not visible inside, since a wooden false ceiling is present. From an image taken during the 1930's restoration interventions, it is possible to notice that the roof covering system (Fig. 2c, d) is constituted by reinforced concrete trusses. In particular the position of the first truss, in correspondence of the masonry gable, puts in evidence how the secondary warping of the roof is not directly connected to the façade gable. The reinforced concrete tie-beam, built on the top of the façade, connects the stone elements positioned on the crowning of the façade gable (Fig. 2d).

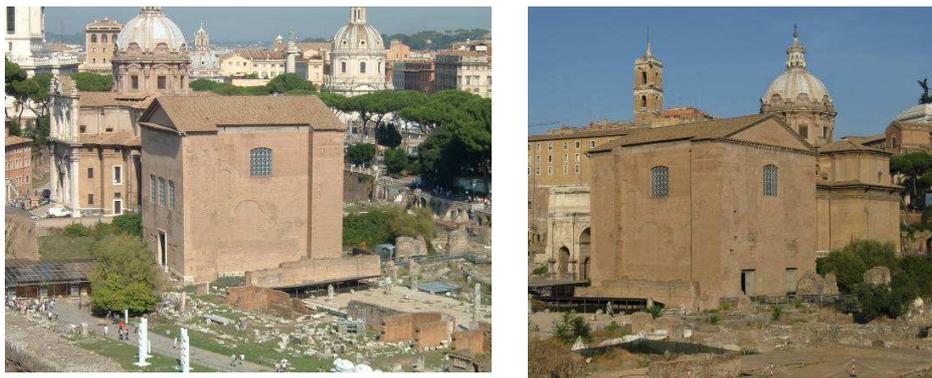
Figure 3: External view of the Curia in its actual conformation

In its actual conformation, the fabric has a rectangular shape with maximum dimensions equal to 25 meters wide and 28 meters in length with a height of the façade equal to 24 meters. In the corner of the buildings four big masonry pillars are present (Fig. 3).

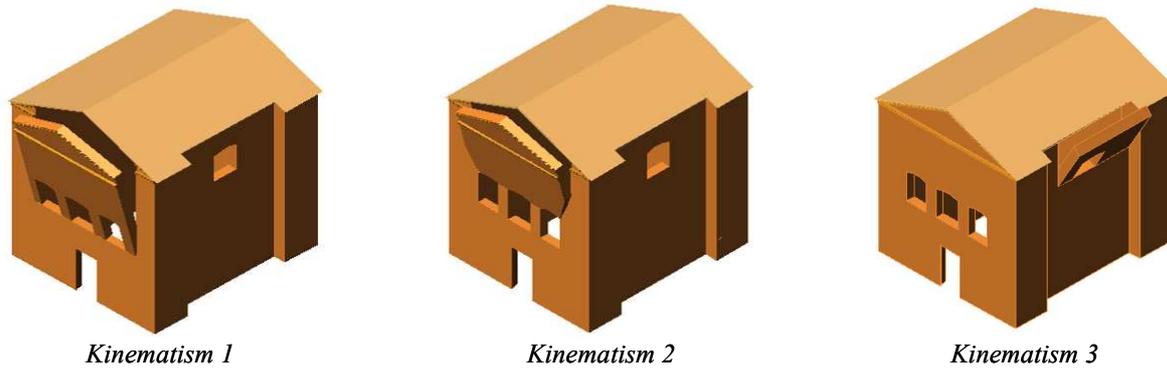
The kinematisms 1 and 2 have been chosen because the facade openings cause an important reduction of the masonry section; a cylindrical hinge can be localized in this point determining the consequent overturning of the upper masonry part. Moreover, the definition of the kinematism has been studied on the basis of the surveyed damage pattern.

The kinematism 3, as mentioned before, has been individuated in relation to the transformations of the building. Analyzing the historical images, it is possible, in fact, to observe how the modifications of the Curia in church have determined the demolition of the top parts of side walls, rebuilt during the 1930's restoration works (Fig. 2 a, b, c). For this reason this masonry portion can be assumed limited connected to the original one and therefore very vulnerable regarding to an overturning collapse mechanisms.

Figure 4: Collapse mechanisms analyzed for the seismic behaviour study

The *Guidelines*, in fact, propose simplified models to evaluate the global seismic vulnerability of some types of monumental buildings, underlining, nevertheless, the importance to analyze the presence of those constructive details able to favour the activation of eventual local damage mechanisms. The knowledge level obtained for the Curia has allowed, in particular, to individuate, among the several potential damage mechanisms, the more vulnerable one. The kinematisms have been chosen taking into account the actual conformation of the building, the damage pattern (surveyed during a visual inspections) and the historical phases of the building, with particular care to the masonry parts rebuilt during the 1930's restoration interventions. These parts, in fact, have yet not suffered severe intensity earthquakes, and therefore the test of a significant seismic event cannot be assumed. The analyzed collapse mechanisms are reported in Fig. 4.

The position of the cylindrical hinge has been moved from the external surface of the wall to the internal part (20 cm) for the collapse mechanisms 1 and 2, while in the kinematism 3 the hinge has not been rearward. For the original masonry the partial collapse of the external brick masonry curtain appears possible: this damage mechanism is, in the past, attested by the several structural integrations. In the rebuilt parts, instead, we have assumed that the transversal connection has been conveniently carried out, and therefore the exfoliation of the external brick curtain is not possible.

Kinematism	a_0^* (m/s ²)	Demand DLS (m/s ²)	Verification DLS	Demand LLS (m/s ²)	Verification LLS
1	0.38	0.78	No	0.86	No
2	0.61	1.00	No	1.22	No
3	1.04	1.12	No	1.37	No

Kinematism	$d_u^*(m)$	Demand Δ_d (m)	Verification
1	0.13	0.11	Yes
2	0.13	0.10	Yes
3	0.17	0.10	Yes
