## Preliminary Studies for the Recovering of the Armstrong, Mitchell & Co. Hydraulic Crane of the Arsenal of Venice

**Abstract** In this paper, the preliminary study of intervention on puddle iron and cast iron Hydraulic crane, situated in the “Arsenale” of Venice is described. The crane was built by Armstrong, Mitchell & Co. in 1885. It is one of the most important and the last remaining example of XIX century innovation of English engineering, after the disposal of other Armstrong Company cranes. Thanks to the interest of the Superintendency of Venice and The Venice in Peril Fund UNESCO Committee, the crane is now undergoing restoration works. To design and execute the restoring interventions of the crane, a preliminary study was necessary. The first fundamental step consisted on performing a detailed historical research, focused in particular of the past interventions and on identifying the most important causes of damage.

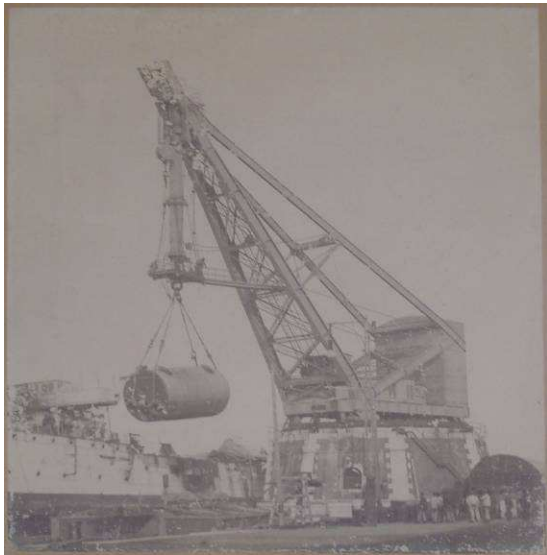
*Figure 1: Armstrong, Mitchell & Co. Hydraulic crane in Venice (Bovolenta 2005)*

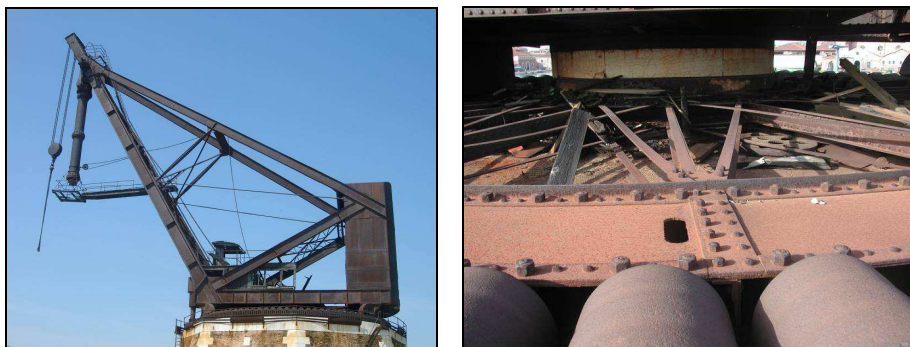
The mobile elevation structure includes training fifth wheel, turntable, sliding blocks, arm of the muzzle and balance weight. The training fifth wheel (Fig. 2) is built in cast iron and iron. It is composed by rolling ring and crown gear in cast iron, 96 rollers in cast iron, iron sheet ring with structure to caisson, iron structure composed by rods with a sunburst pattern.

The turntable (Fig. 2) is utterly built in puddle iron, it leans against and it slides on the rollers below by means of 4 cast iron sliding block. An horizontal frame with rectangular contour constitutes the structure of the platform. The arm of the muzzle is constituted by a reticular spatial structure composed by an inferior strut and a main one, a tight main rod, an intermediate compressed rod and a support tie rod. The balance weight is included in this static system.

*Figure 2: mobile elevation structure, training fifth wheel and turntable*

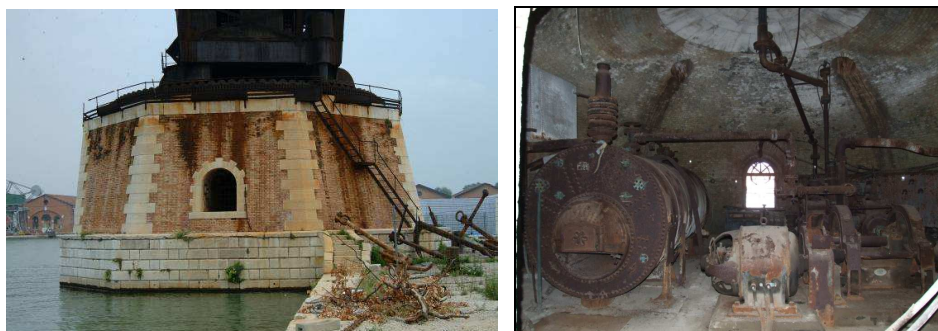
Superficial elements caused by scouring of the products of metallic structures oxidation was observed. The saline efflorescence is mainly in the lower parts and never on the corrosion drifts or the black crusts. The main cause is chemical agents due to the marine environment and presence of humidity. Inside the basement, the condensate humidity, the steams produced during the working and the external percolations have made easier the deposits of the corrosion products on the whole surface of the vault (Fig. 5).

Figure 5: Actual degradation of the basement – outside and inside

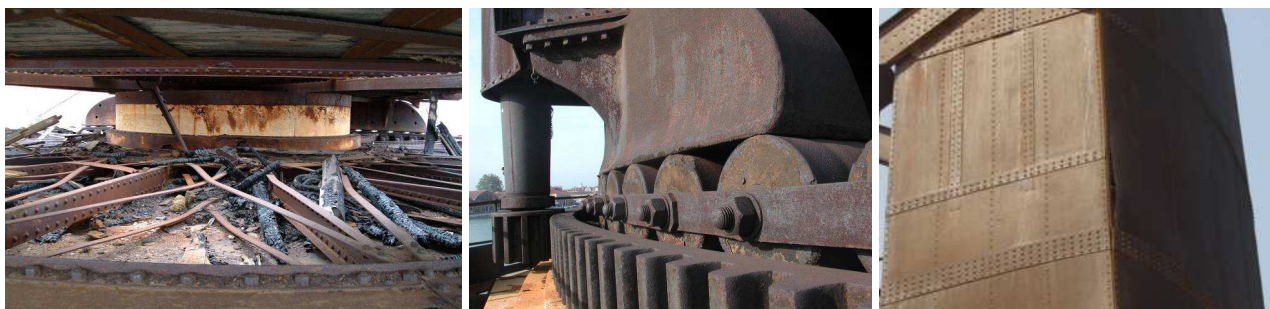
In the crane there are diffusion and localized corrosion. The rollers localized corrosion is characterized by a particular exfoliation of the superficial veins due to the wear and to backwater. The rolling plane (Fig. 6) of the rollers is irregular because of differences in the load, the rods with a sunburst pattern are deformed and irregular. There is also a stratified drift of different materials that makes easier corrosion on the less ventilated areas.

The cast iron sliding blocks (Fig. 6) are interested by a strong localized corrosion, emphasized by a corrosion fatigue stress, mainly on the two sliding blocks behind, under the balance weight (400 t). On the back sliding blocks there are stiffening in sheet steel. The curtaining (Fig. 6) seem present only on the sheets steel of the balance weight, limited thanks to accurate steel structural work and for the low pith of the rivets. The diffuse corrosion in all the metallic parts didn't have probably damaged the structural integrity of the crane thanks to the quality and the dimensions of the elements.

*Figure 6: Actual degradation of rolling plane, sliding blocks and curtaining*

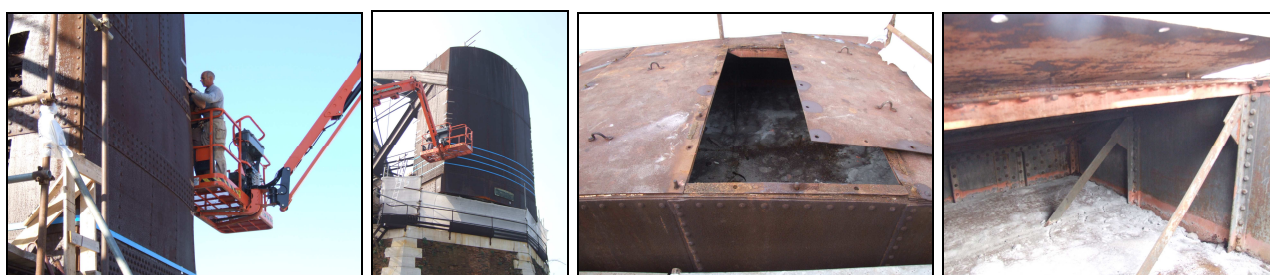
*Figure 7: Intervention to provide safety conditions*

At this moment the first phase only (Fig. 7) was concluded. It was oriented towards reconfiguration a new equilibrium of the structure in the actual load patten (dead load, roll and purchase). For this study we made particular attention at the condition of the sliding blocks under the balance weight, that are interested by a strong localized corrosion.

Operations that have been made for the recovery of the crane are reinforcement ring of the balance weight and the partial emptying of the balance structure maintains the equilibrium of the structure.

The wind pressure had been taking to account. The balance weight, which was approximately of 400 tons, has been reduced of 100 tons in order to maintain the balancing.
