Strengthening Design of a Business Architecture Built During the Period of the Republic of China in Nanjing

Abstract Based on strengthening project of a business architecture built during the period of the Republic of China in Nanjing, some key problems in strengthening design of reinforced concrete frame structures built during the period of the Republic of China are roundly discussed, including methods of testing and appraisal, computing and analyzing, foundation reinforcement, brick wall reinforcement, concrete members reinforcement and seismic reinforcement, etc. Some effective methods are introduced to solve the problems, which can be referenced for similar design.

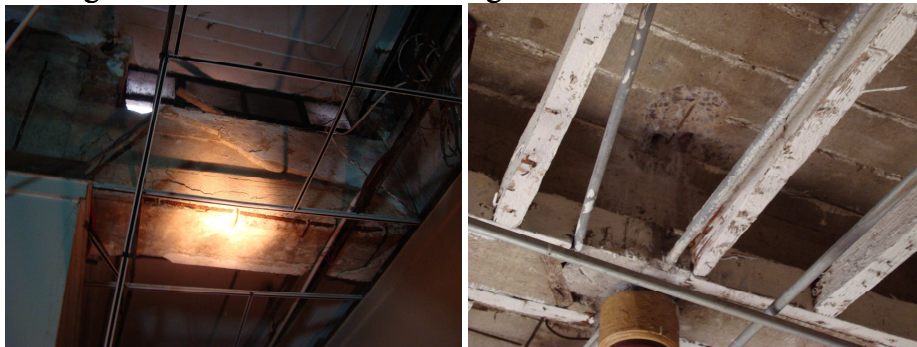
Test Contents Because the lack of original design information, the first step is on-site measurement, including the structural arrangement, structure type, member section size, supporting and connecting conformation, structural materials, etc. Then, the present situation of the building is surveyed, including the load of structure, the environment investigation of the building; the structure defects of various members (concrete beams, slabs, columns, brick walls) are detailedly carried out. The test results showed that the overall appearance of concrete members was relatively undamaged, but there were some honeycomb pitting surfaces on local columns. There was some phenomenon of reinforcement revealing on some columns. There was similar phenomenon on some concrete beams and slabs. The damages of structure are shown in Fig. 3.

Figure 3: the phenomenon of reinforcement revealing in concrete members

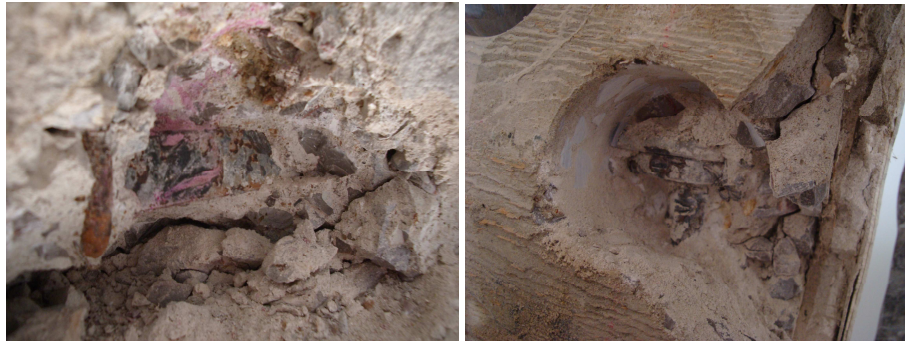
columns, beams, slabs respectively, the carbonation depth is about 60mm for these kind of members, which has exceeded the thickness of concrete cover. This is the main reason that causes the corrosion of steel bars inside the concrete members. The corrosion damages of structure are shown in Fig. 4.

Figure 4: the corrosion of steel bars inside the concrete members

In order to calculate the main structure, the strength of materials and the reinforcement condition in the members should be understood. Using the method of drilling core, the concrete compressive strength is tested and the result is about 8.3MPa. With the method of sampling on the site, the yield strength of longitudinal reinforcement is tested as about 272MPa, the yield strength of hoop reinforcement is tested as about 254MPa, the yield strength of slab reinforcement is tested as about 228MPa. Using the rebound method, the compressive strength of the wall brick is about 10MPa. With the penetration method, the compressive strength of the wall mortar is about 0.7MPa. The thickness of concrete cover and the carbonation depth of the main members were test, the results showed that, the thickness of concrete cover is about 20 ~ 50mm, 20~30mm and about 15mm for
