## **The Conservation of Earthen Architectural Heritage in Seismic Areas**

**Abstract** The acceleration of climate change and the increasing frequency of natural disasters mean that there is an urgent need to adapt conservation strategies for architectural heritage to the world's new demands and situations. This is particularly relevant for the most vulnerable constructions, such as earthen structures.

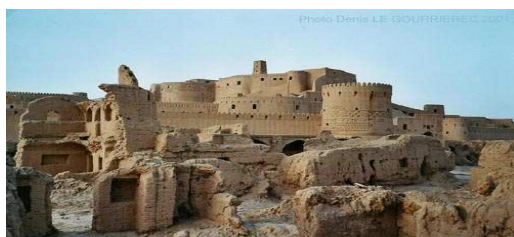
*Figure 10: Arg-e-Bam 2000. Reconstruction  
From 1970 to the 2003 earthquake*

The interventions to earthen archaeological heritage were based on the reconstruction of the earthen buildings that had been destroyed by earthquakes in the previous centuries. Nevertheless, less than half a century after they were intervened, subsequent earthquakes destroyed most of these sites, such as Acllawasi in Pachacamac, Peru and the Arg-e-Bam Citadel in Iran (Figs. 8-11).

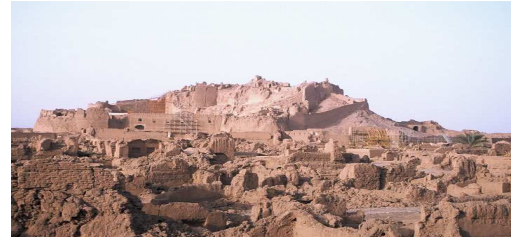
*Figure 11: Arg-e-Bam 2004 Re-destruction  
After the 2003 earthquake.*

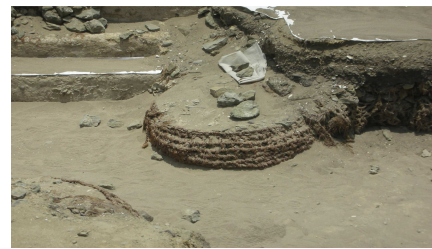
Figure 13: Bag or Shicra with stones, Caral

They then discovered that by "bagging" the stones with the adequate material, they could prevent the stones from pushing each other and create a layered and stable core that didn't produce any stress on the façade walls.

These bags, made with vegetable fibers from the highlands, contributed to the creation of a seismic-resistant technique that increased the buildings' strength during an important lapse, longer than their own life average, although time eventually decomposed the bags' organic material. How could this technique be maintained in a permanent way? They were precursors of the modern day gabions.
