The Intervention of Earthen Heritage in Seismic Areas and the Conservation Charters

NEUMANN Julio Vargas^{1,a}, BIONDETY Marcial^{1,b} and IWAKI Carlos^{1,c}

¹Pontifical Catholic University of Peru, Lima, Peru

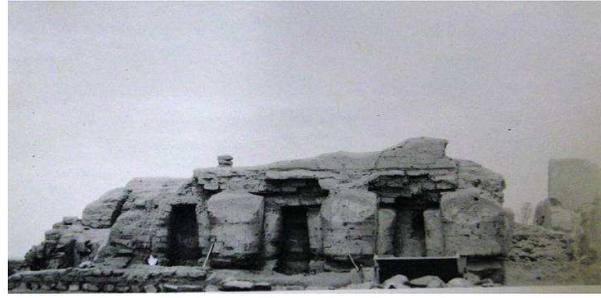
*Figure 1: Pachacamac, Peru. Moon Temple. Detail view of the three niches, 1941
(Credits: Archive from the archeologist Julio C.Tello. National University of San Marcos)*

Fig. 1 is an important photograph of Acllawasi, part of the Pachacamac complex, which is located close to Lima. The image is a good example of the destructive effect that earthquakes have had on earthen architectural heritage throughout the centuries. The photograph shows what was left standing of Acllawasi (built around the XII Century) in 1941 and the destructive impact of earthquakes on this great Inca maiden temple, built on earth, with stones foundations, steps and water wells.

The temple of Acllwasi was completely rebuilt by Julio C. Tello between 1941 and 1945. It was dramatically destroyed by the earthquakes of 1966, 1979, 1974 and 2007, and is currently closed to visitors for safety reasons.

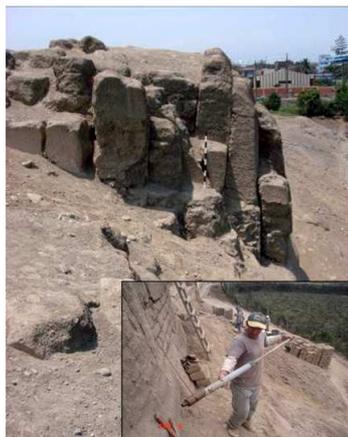
Figure 3: Weakened containment wall, injected with mud grouts to increase its strength to side filling tension (Credits: Mirna Soto, 2008)

Fig. 3 shows one of the cases in which a containment mud wall has lost stability and strength after its vertical layers fell apart, worn out by the pass time. It is well known that a wall formed by three unjoined layers is much weaker than a solid wall.

The mud injection increases the wall's strength without having to use any kind of reinforcement. These friendly solutions were applied by the archeologist in charge of the restoration works, Pedro Espinosa, from the INC (National Institute of Culture), 2009, with the structural guidance of Julio Vargas N.

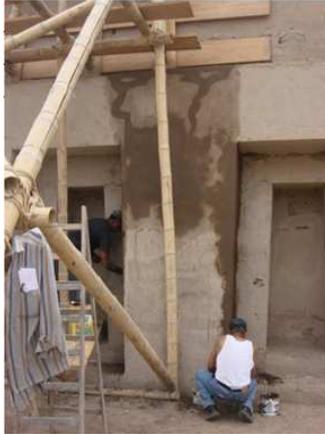
Figure 4: Crack repair by liquid mud injection in Acllawasi. Heritage friendly solutions. Credits: Sofia Rodriguez Larraín, 2008

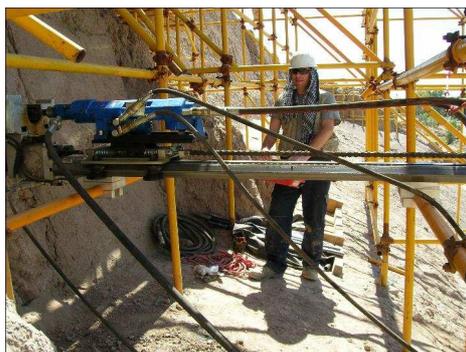
*Figure 6: Scaffolding, drilling and placement of glass fiber rods. Bam Citadel, Iran
(Credits: Engineer. Valter Santoro, 2008)*
