Seismic and Wind Performance of Five-Storied Pagoda of Timber Heritage Structure

Abstract In Japan, there exist a total of 22 five-storied timber pagodas constructed before the middle of 19 centuries. All of those pagodas are registered as the important cultural heritages by Japanese Government, while some of them are listed in World Cultural Heritages such as Horyu-ji Temple's Pagoda that was built in the end of 7th century. As those timber pagodas in seismic areas have survived against earthquakes during their long histories, their earthquake resistant capacity has been studied for a century. However, the actual dynamic behaviors of timber pagodas subjected to large earthquakes should be recorded to understand the seismic performance. Furthermore, an interesting structural issue has recently risen of wind resistant capacity of traditional five-storied timber pagodas, as such tall timber structures may be severely affected by strong wind. In order to record the actual dynamic behaviors during not only earthquakes but also typhoons, we have been conducting earthquake and wind monitoring at Hokekyou-ji Temple in Ichikawa City, next to Tokyo, which has survived for 4 centuries again

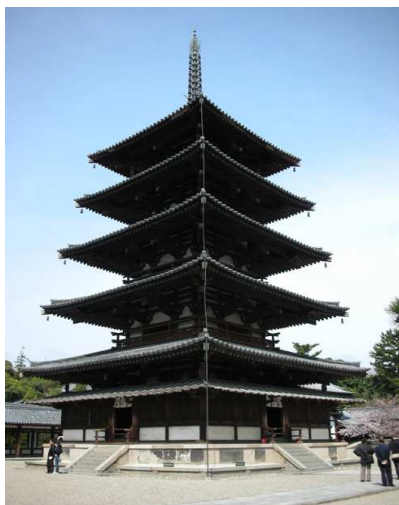
Photo 1: The oldest timber building of existing five-storied pagoda in Horyu-ji Temple, World Heritage

successfully improved by Japanese master carpenters. One of the most advantageous techniques of restoration of timber structures is disassembling and reassembling of the members. The five-storied pagoda in Horyu-ij Temple has a history of structural restoration. During its long history, the pagoda was disassembled (partially or totally) and reassembled several times with replacing the deteriorated elements by new materials. However, owing both to the excellent properties of the original materials, in particular, Japanese Hinoki tree, and to the good conditions at the site, approximately 80% of the timbers materials are surviving from the original construction. Another important factor was the form of the building. The ancient construction of timber pagodas had deep overhanging eaves covered with thick and heavy roof tiles, shown in Photo 1, as buildings in Japan was affected by heavy rainfalls. However, such heavy roofs sometimes caused serious structural problem, large creep deformation of eaves due to the gravity. In order to solve this problem, the light materials of bark or bronze plate were usually used after the medieval period as the roofing materials for new construction of pagodas. This alteration of roofing materials also might contribute to improvement of seismic performance, but might not contributed to wind performance. During the history of the improvement of timber structures in Japan, a penetrating beam might be the most significant element among the various techniques. After penetrating beams were introduced in Japan for strengthening technique of timber frame structures in 13th century, the timber structures had been constructed or restored by employing penetrating beams which must have contributed the improvement of seismic safety. This alteration means that the piling up construction technique in the ancient period changed to the frame structure during the medieval period.

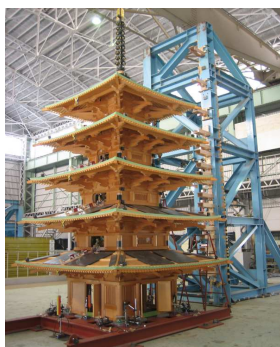
Photo 2: 1/5 Scaled model structure of timber five-storied pagoda in Horyu-ji Temple for shaking table test

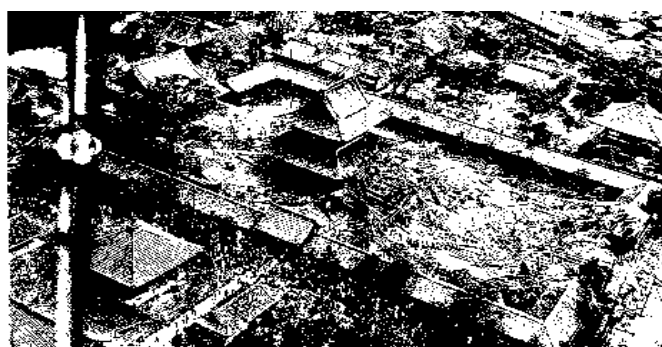
Photo 3: Collapse of the five-storied pagoda in Shitenno-ji Temple, Osaka by Muroto Typhoon of 1934 (after the Asahi Shinbun)

On the other hand, in general, such high-rise and light structures of timber are affected by wind. In fact, the five-storied timber pagoda in Shitenno-ji Temple, Osaka, totally collapsed by the Muroto Typhoon in 1934 (See Photo.3), one of the strongest typhoon that has hit Japan so far. This disaster indicated that a five-storied timber pagoda was not safe against strong wind. In consideration of this experience, timber pagodas were strengthened against wind loads, when new timber pagodas were structurally designed in the last decade. However, it should be emphasized that the other historical five-storied and the three-storied timber pagodas existing in Kaisai district (Osaka, Kyoto, Nara) where they were severely affected by that strongest typhoon survived. This experience also suggested, on the contrary, that timber five-storied pagodas might withstand considerable strong wind. However, only a few studies were conducted on wind resistance of Japanese multi-storied timber pagodas. For examples, the wind tunnel tests using small models were performed to study wind resistance (Ohkuma, T. et al. 2004) or to structurally design a new timber five-storied pagoda. Some analytical studies were also conducted to study wind performance of traditional five-storied timber pagodas (Katagiri, J. et al. 2005). In order to discuss the potentiality of wind resistance, it should be essential to record the actual behaviors of a five-storied timber pagoda that survived for many centuries against severe typhoon. In the present research, not only the earthquake monitoring but also the wind monitoring have been successfully conducted at the historical five-storied timber pagoda that has withstood large earthquakes and strong typhoons for four centuries.
