Blasting Near Old Foundations and Strengthening of Foundation Walls for the Headquarters of the Ministry for Foreign Affairs of Finland

Abstract Designed by architect C. L. Engel (1778 – 1840), the Naval Barracks facility was originally built in the 1820's for the Russian Navy and also served as a shipyard. The building of national heritage is a prime example of neo-classical architecture in Helsinki. Strengthening and underpinning work for this structure was realised from 1985 to 1988. It was a part of the larger renovation project, where the building was made suitable for the Ministry for Foreign Affairs of Finland. The purpose of underpinning was to realise a new basement in its eastern part as well as to lower the basement floor level in other sectors. The ground engineering duties covered geotechnical and structural designs of temporary and permanent structures from the basement up to the ground floor.

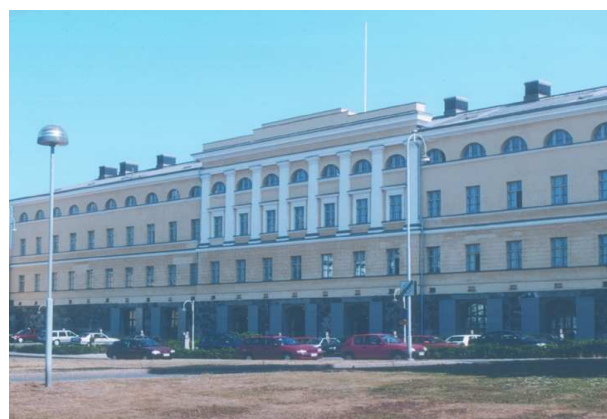
Photograph 1: Ministry for Foreign Affairs Finland, north elevation (seaside)

From the 18th century, the area of the Naval Barracks was a Swedish military base. As Finland became an autonomous Grand Duchy of Russia at the beginning of the 19th century, Helsinki was proclaimed capital in 1812. The town was then completely rebuilt and the area of the Naval Barracks assigned for the construction of Russian military buildings. In March 1816, German-born architect C. L. Engel was appointed architect in charge of the city's building committee. After three months of planning, his layout was approved by the Tsar. At the outset, building conditions were difficult because of the winter weather as well as the proximity of the sea. Outer dimensions of the sailor barracks were to be 93 m x 13.4 m x 16 m in height, with 3 floors above basement level (Photograph 1). Later, two wings were added, and the building complex was mostly complete by 1838. Two artillery warehouses from the time of the Swedish rule remained bordering the court at the eastern and western sides (Sinisalo 1980, Kråkström 1988). When Finland gained its independence in 1917, the area was taken over by the Finnish Navy for use as a military harbour. In 1972 the state council decided to place the Ministry for Foreign Affairs in the Naval Barracks, using all the existing structures and eventually demanding the creation of additional basement space (Favorin and Ristolainen 1993). (Photograph 1).

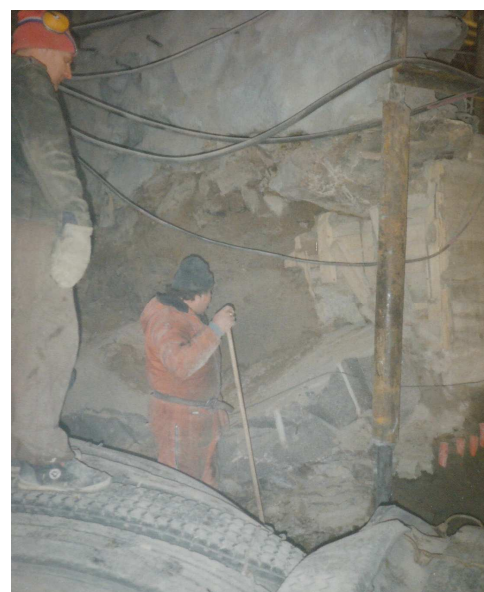
Photograph 2: Middle wall, Drilled steel piles, Smooth blasted face

Rock blasting with explosives proceeded around these trusses with a minimum safe distance from piles to smooth blasted face of 0.5 m. For work closer to the steel piles and underneath the brick columns / brick wall, only old hand methods such as loosening rock by using wedge and hammer in close spaced holes were normally accepted. In some cases the loosening of rock could be done by hydraulic wedge machine (Photograph 2). Formwork and reinforcement were realised inside the temporary steel structures and subsequently the new column extensions poured. In one sector of the middle wall, to establish a new floor level, foundations on moraine had to be realised. As mentioned previously, the loads were taken temporarily on steel piles. In this case the sides of the brick columns were prestressed by tension bars to prevent structural collapse during underpinning work. The steel piles were drilled with Odex equipment, with a casting tube of 139.7 x 5 and a core diameter of 80. Empty space between the tube and core was grouted using a cement mix $w/c=0.45$ and additives.

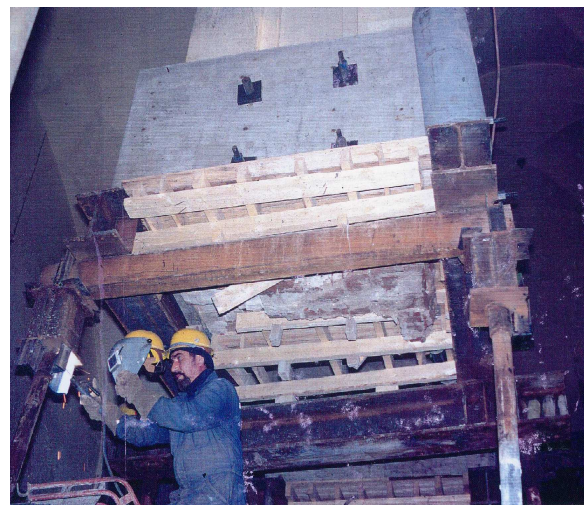
Photograph 3: Eastern stair column, Old brick column, Pretensioned concrete plates, Temporary steel supports
