Archeological Excavations: the "Trauma" and Other Consequences on Structural Conservation of Buildings and Sites

The archeological excavation 1991 -2000 of the Hospital-Order Castel in Old Akko, Israel

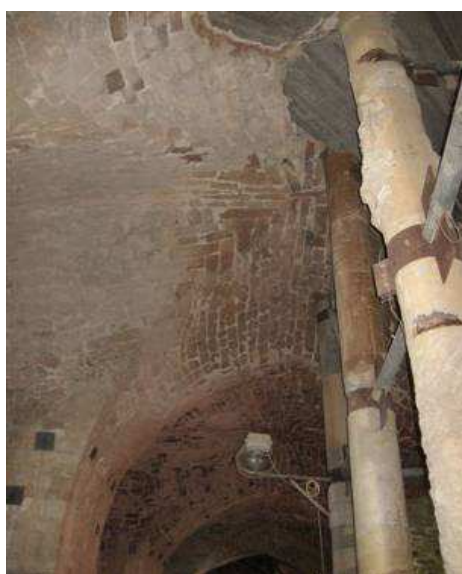
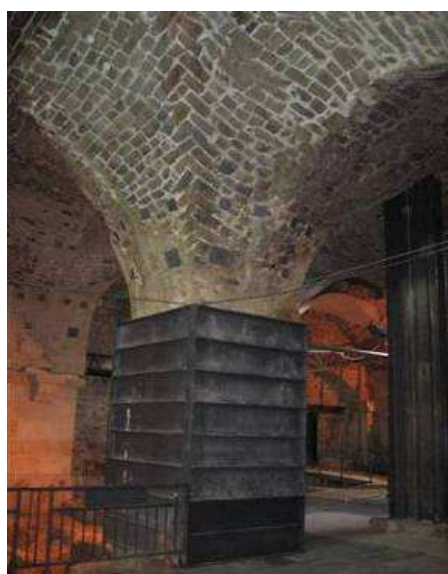
What then are the results? The excavated ruined structure receives in a relatively short time, quick structural and physical changes which alter without reversibility the building – cracks open that can not be closed anymore, the "still good mortar" deteriorates, temporary reinforcements create a local static equilibrium that is irreversible and we lose important materials including layers of stone in pillars, columns and vaults. (Figs. 5, 6)

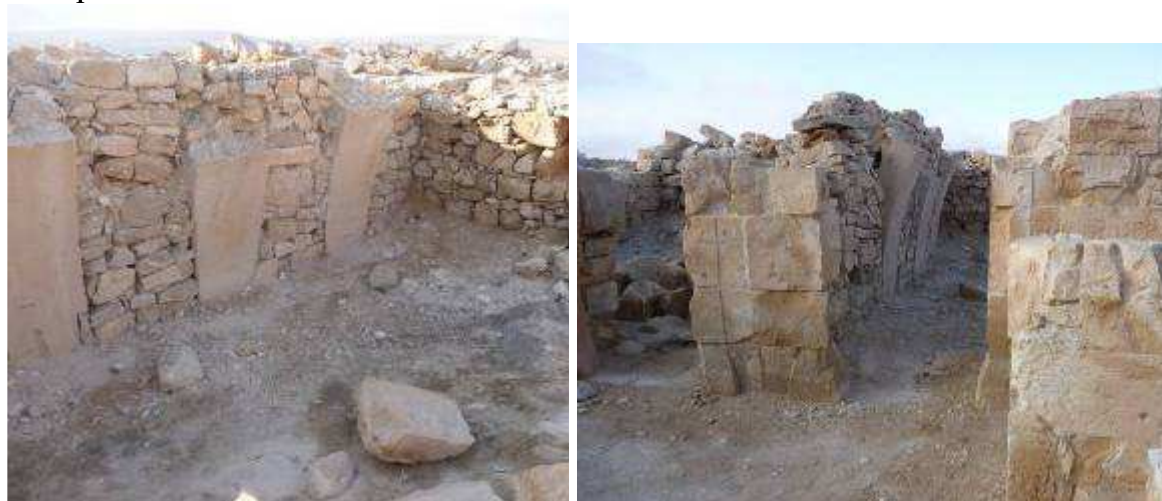
Figure 7

What would cause the builder to build such a phenomenon? From the detailing survey, we found that most of the arches have a width of 40cm-60 cm, cut stone, inserted in the wall, and with or without a similar arch in the rear part of the wall in the other room (Fig. 7). From a structural point of view, we can suggest some observations and explanations as follows:

First, about $1/5$ to $1/3$ of the horizontal reaction of the arch with the wall is parallel to the wall, decreasing the horizontal stress by the same 20%-30% and in practice – decreasing the wall thickness-weight needs for contrasting the horizontal stresses.
