## **Retrofitting and Moving Protection for Historical Buildings in Jinan City**

**Abstract:** Retrofitting and moving protection for historical buildings have vital historical and cultural value for they concern both the development of human society material civilization and the continuation of human cultural heritage. Jinan City is ranked among the second group historic and cultural cities of China, where has many valuable historical buildings. The urban construction advances by leaps and bounds in Jinan City since the nineties, which brings tremendous challenge for the protection of historical buildings. The state of the art of protection and retrofitting for the historical buildings in Jinan City is summarized. Three protection schemes, namely in situ retrofitting and minimum distance moving protection as well as long distance moving protection, are adopted in Jinan City. Six finished protective projects are discussed from a structure viewpoint. Retrofitting and monolithic moving techniques are presented for different historical buildings according to the style and features as well as requirements, and also the pivotal techniques for improving aseismic performance are suggeste

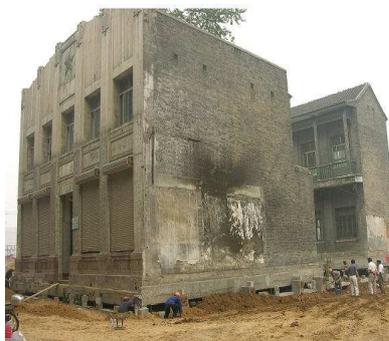
Figure 5: The old drugstore moving spot Figure 6: The old drugstore moving sketch map

**The Old Drugstore** The building named “Hongjitang Drugstore” was built in 1920, which was a two-storey brickly timberwork structure with two towers in north and south as shown in Fig. 5. It was protected by monolithic moving for the near road widen in 2008. Namely, the two towers were moved about 11.6 meters toward the north together, then were moved about 16 meters toward the east together, and then were rotated 3.8 angles together as shown in Fig. 6. After being moved to the new position, the building was lifted 0.4 meter upward(Xia and Jia et al. 2008).

For the limitation of integrity and earthquake resistance, there was high requirement in integrity of the underpinning structure and in stability during the moving construction process, and also the building need be strengthened for improving earthquake resistance. The double girders underpinning was adopted instead of direct underpinning under walls for the limitation of the building. For integrity

of the underpinning structure and the loading transmission of the superstructure, short beams were built to connect double sides underpinning girders every 1.5 meters, and also many horizontal diagonal stays were constructed. Considering the features of small weight and bad integrity as well as bad earthquake resistance, the sliding monolithic moving technique was adopted in the project which had the characteristics of stable moving and low libration as well as good adaptive ability for uneven tracks. The tractive system was made up of many synchronous hydraulic jacks controlled by PLC to ensure the smoothness and synchronization during the moving process. The dielectric plates were used as running gear. After moved to the new position, the laminated rubber bearings were installed between top underpinning girders and basement walls or columns, which formed a vibration-isolation layer with the sliding rubber bearings to improve aseismic performance of the building. It showed that the smoothness of the moving could be effectively assured using the sliding moving technique for historical buildings with bad integrity. Combined with the moving, laminated rubber bearings could be installed to enhance vibration-isolation performance without changing architecture shape.

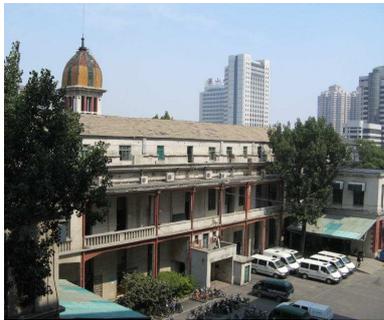
Figure 7: The old post office      Figure 8: The cinema north solid drawing

**The Old Post Office** The building built in 1919 was also a two-storey building structure of brick and concrete. A new annex floor was added by the construction unit as shown in Fig. 7. It showed that some external decorative coating of the walls scaled off, and bricks weathered. The safety and aseismic performance of the building as well as the bearing capacity of members were checked in 2007. Plenty of protective remedy measures were adopted for some related members. Most walls were strengthened on both sides with steel meshed cement mortar according to the testing strength of blue brick and lime mortar. As to walls less than 1.5 meters in width were strengthened on each corner with angle steel edge-plated along their height. The diagonal cracks in walls were treated with chemical grouting. The parapets on the original roof were rebuilt because most were destroyed greatly, and some RC structure columns were added. The longitudinal rebars were anchored into slabs through the method of steel bar implanted by chemical adhesive.

Part RC columns had been strengthened by using section increment. But the incremental sections were detached from the original sections, the reinforcement corroded and protruded, and also the concrete cover shelled. Some measures were taken to solve this problem, namely eliminating vital part concrete, removing reinforcement rust, smoothing with cement mortar, strengthening by angle steel edge-plated.

There were many cracks along rebar under the beams for reinforcement corrosion. Another measures were taken to solve the problem, namely eliminating crack surrounding concrete, removing rebar rust, renovating to original section, strengthening with two-layer SBC-300 carbon fiber cloth.

The building was the highest and biggest RC structure at that time in Jinan, which had a high research value in history and culture as well as science. Therefore, the incremental floor was demolished to renew its historic style and features with authenticity and integrity after discussions. It was indicated that the consequent service life of the post was 30 years after the retrofitting.

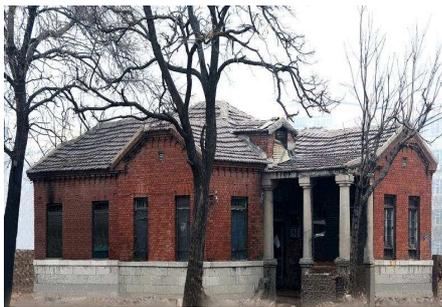
Figure 9: The old villa appearance

**The Old Villa** The building with a complicated sculpe in roof was one of the most famous residential building in China with a history of about 80 years, which had many features such as harmony of proportion and appropriate of scale in architecture as well as reasonable in function as shown in Fig. 9. It was a local two-storey brick and timberwork structure with a lime clay strip foundation under the wall. Its length was about 15 meters in north-south, and its width was about 9 meters in east-west. The total height was about 6.5 meters. The integrity of the superstructure was poor by reason of longer service. The strength of the mortar was almost zero. For protecting the historical building as well as planning the shanty town in Jinan, it was moved to a new place with a distance about 30 kilometers by the research institute of engineering assessment and repair of shandong jianzhu university in March 1st, 2009. The Fig. 10 showed the long distance moving spot. For there were many overbridges along the path, the complicated roof was removed specially for safety. It was the longest moving for buildings in China.

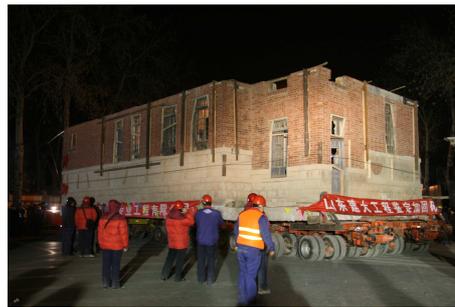
Figure 10: The moving spot

The moving construction was made up of several processes. Namely, construct wall joists of RC under the indoor ground, then underpin the building up 0.8 meter, then place the trailer in position, then promote the underpan and transfer loading to the trailer, then start up the trailer and move the building to new position, then land the underpan and transfer loading to the supporting wall and new foundation, then joint the superstructure and substructure, then renew the building. Finally, the old villa was located in Shandong Jianzhu University as shown in Fig. 12. This not only protected the

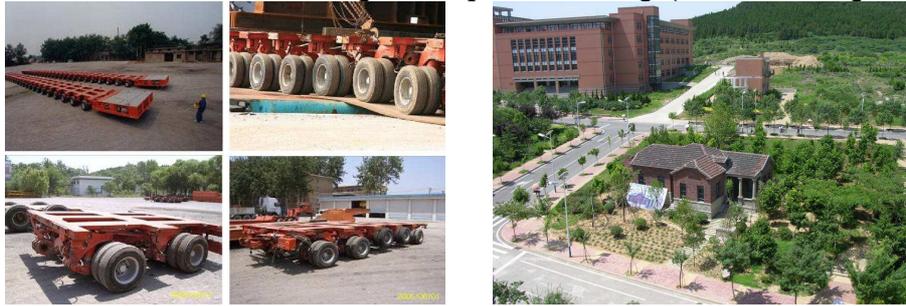
Figure 11: The flat trailer      Figure 12: The old villa after moving

The building was drawn by a large-scale hydraulic flat trailer made in France, which had many merits such as wire control operation, whole hydraulic upward-downward, self-propelled, controlled full-hydraulic steering, flexibly assemble. Twenty group carts arranged in two-line with a total 128 wheels were applied in the moving. The large-scale hydraulic flat trailer was composed of heavy-duty part and traction part, which had power equipment by itself. The flat trailer was shown in Fig. 11.
