SEISMIC VULNERABILITY ASSESSMENT AND REHABILITATION DESIGN OF THENAGHAREH-KHANEH EDIFICE

Peyman Homami¹, Mahmood Golabchi², Mohammad Javad Jabbarzadeh³

ABSTRACT

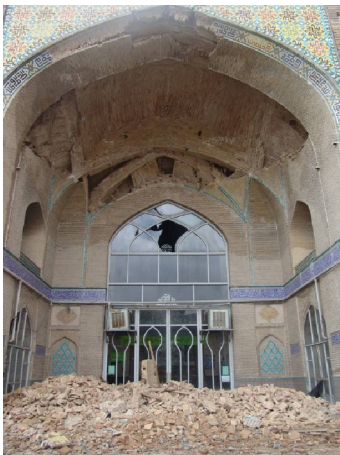
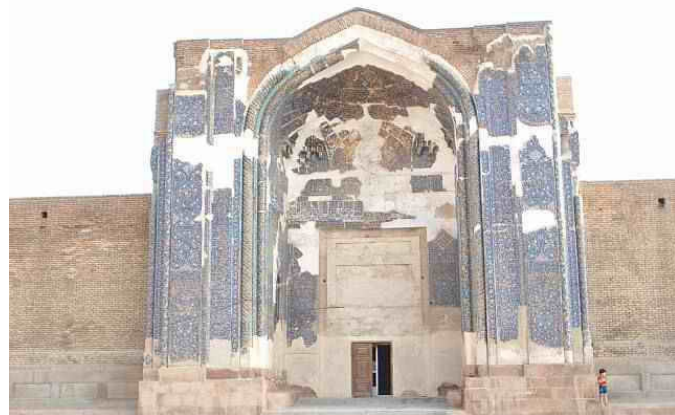
Fig. 2 Sample responses of masonry edifices to earthquakes

(a) Soltaniyeh Mosque of Brojerd damaged by the Silakhur earthquake (2006)

(b) Kaboud Mosque of Tabriz Damaged by the Tabriz earthquake (1721)

Samples of these destructions are illustrated in Fig. 2. In the earthquake of Silakhur (2006), the Soltaniyeh Mosque endured structural and non-structural destruction. The minarets and the thick walls witnessed cracks at the joints of the arches and the anterior corners. Alongside the destruction of the main sections of the structure, masonry covering collapse is also observed. The destruction of this covering has no structural effect on the behavior of the building, but has an intense dangerous impact on the lives of the commuters.

In structures that have undergone a more intensive vulnerability, destructions have been vastly displayed and noted in the base and center of thick walls at the location of the joint of the main arch of the structure. This feature is observed in the edifice of the Kabud Mosque of Tabriz, which tolerated intense vulnerability in the earthquake of 1721 AH (Fig. 2b). Parts that have been repaired are shown in contrast in white. In addition to the thick walls, cracks in the crown of the arch have also been noticed. Similarly, major sections of the walls above the arches which were similar to parapets have collapsed.

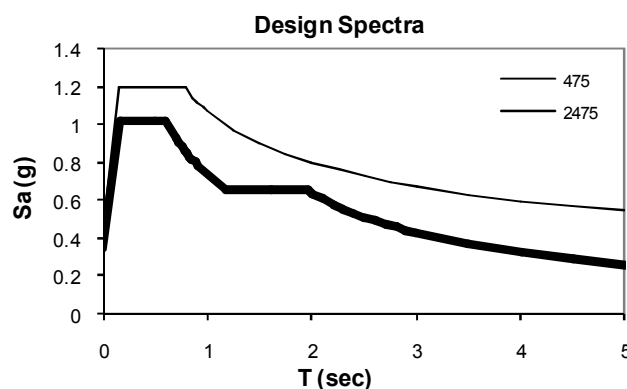
Fig. 3 The Design acceleration spectrum for two level of hazards in the site

Site soil properties and seismic geo-technique information were gathered, hazard analysis was performed, site design spectrums were developed and consistent artificial accelerations according to the site condition were generated. Site design spectrums have been illustrated in Fig. 3. Studies for 2 levels of probable hazards of 10% in 50 years (hazard level 1) and 2% in 50 years (hazard level 2) took place and two spectrum were extracted. The maximum spectral acceleration of hazard levels 1 and 2 that came to hand were equivalent to 1g and 1.2 g respectively.

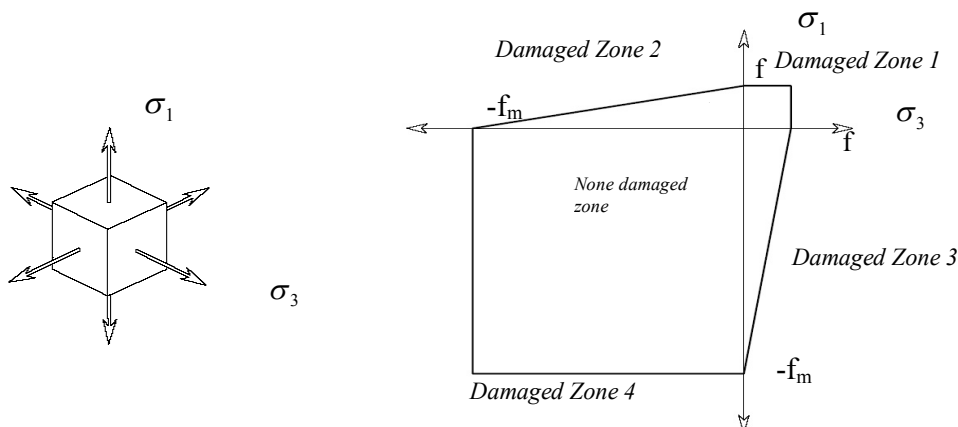
Fig. 7 Idealized model for cracking in masonry

In order to specify the threshold limit of damage, a suitable model for the masonry material should be taken into consideration. The model surmised in this article is similar to Mohr-Coulomb Model. This model has four limits, outside of which is the damaged zone and the inside of which the considered elastic behavior zone. These four limits are considered and are according to Fig. (9). To control the structure after the performance of each analysis for a combination of loads with a specific S_a , the principal stresses are extracted and combined in pairs such as (σ_1, σ_2) , (σ_1, σ_3) and (σ_3, σ_2) according to the mentioned pattern. In this order by overlapping their results, vulnerable points, in relative to cracks and erosion has been drawn graphically.

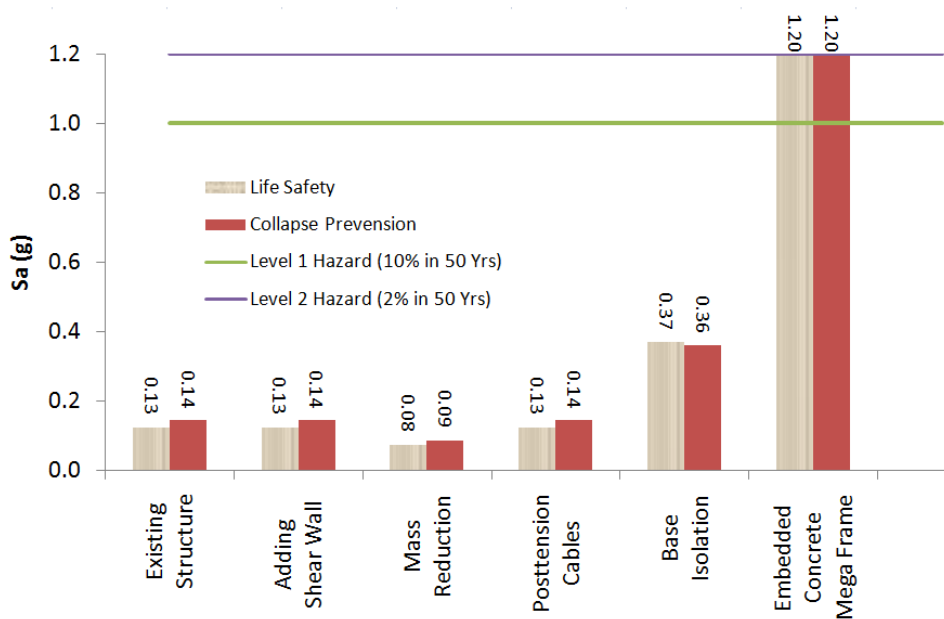
Fig. 9 Acceleration capacity of the investigated methods

For this analytical modeling has been utilized; and according to the method used for the existing structure, the maximum spectral acceleration capable of being tolerated in the three levels of performance, was extracted. In Fig. 9 acceptable accelerations for the immediate occupancy of the life safety level of the building for the structure in its current condition; and various rehabilitation methods on the bases of the studies performed were rendered. Horizontal lines express the spectral requirement in hazard levels 1 and 2. The amount of this difference shows that the only rehabilitation method is the concrete mega-frame that can secure the seismic requirements of structures against danger levels 1 and 2.
