EXPERIMENTAL EVALUATION OF SEISMIC BEHAVIOUR OF QUINCHA WALLS FROM THE HISTORICAL CENTRE OF LIMA – PERU

This paper presents the results of an experimental program consisting of cyclic horizontal shear test of twelve full scale walls that reproduce the original typologies of quincha system from the historical centre of Lima. From these tests, numerical values of mechanical properties were obtained for properly modelling the seismic response of these ancient construction system and in this way confirming the good behaviour of this type of construction.

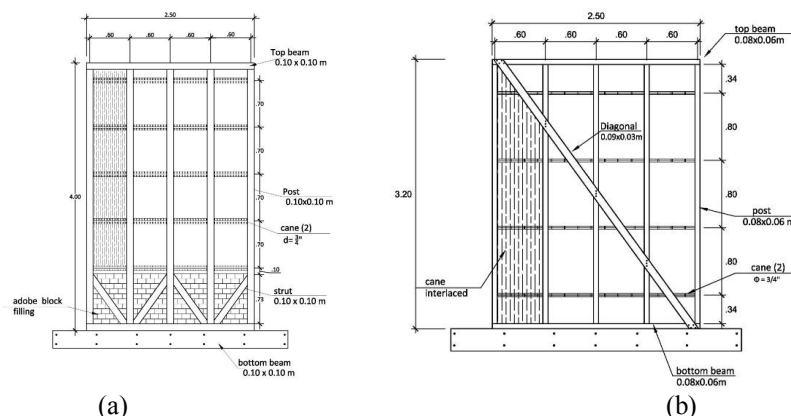
Fig. 1 Quincha wall specimens: (a) with “citaras”; (b) with diagonal.
(Credits: Alexis Rossi, Lourdes Mogollón, 2011)

Twelve quincha walls were constructed reproducing two typologies: 1) 6 with “citara” and 2) 6 with diagonal. The first type corresponds to the second floor of the Hotel Comercio and the second type corresponds to third floor.

The walls with “citara” are 4.00 m high and the walls with diagonal are 3.20 high. All specimens are 2.50 m long (see Fig. 1).

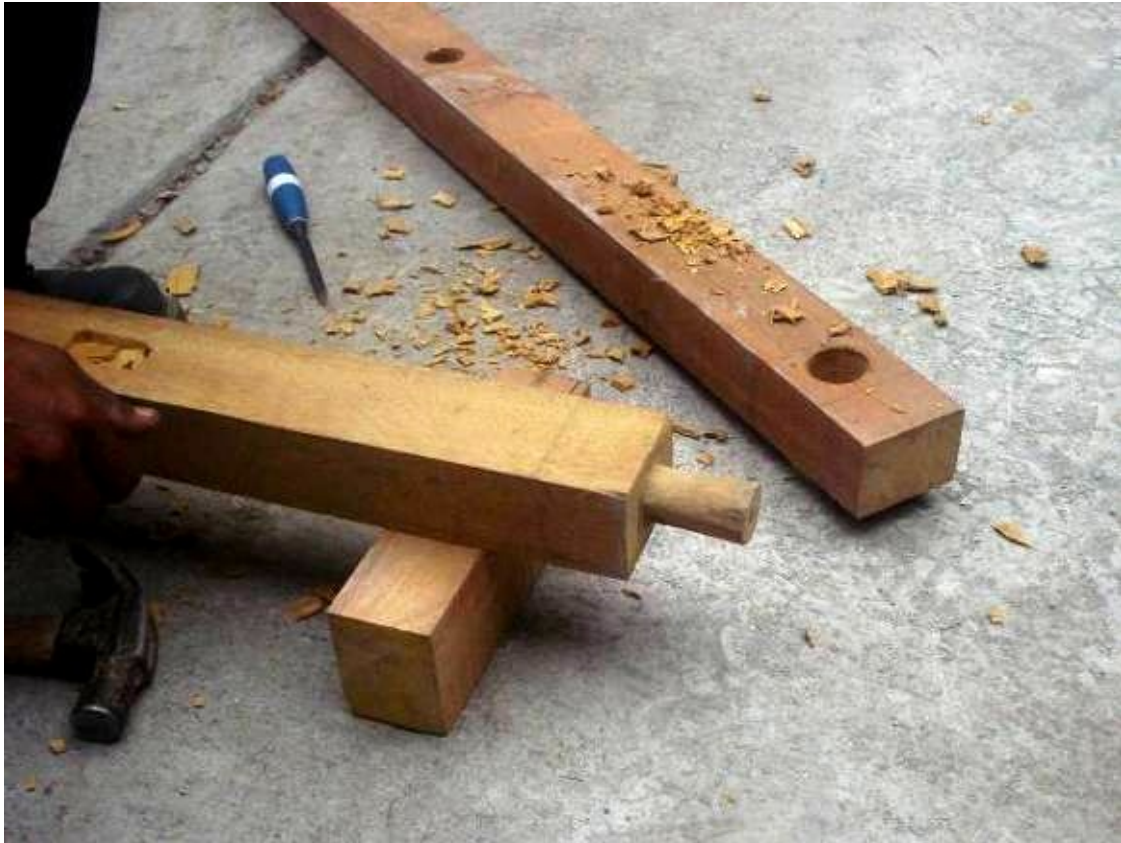
Fig. 2 Typical mortise and tenon joint. (Credits: Erika Vicente, 2011)

In all cases, the junctions between the posts and the beams are the tenon and mortise type (see Fig. 2), while the bracing conformed by the diagonals and struts are nailed. As the original walls, the specimens were fulfilled by cane and mud. Furthermore, mud layer covers the entire wall.

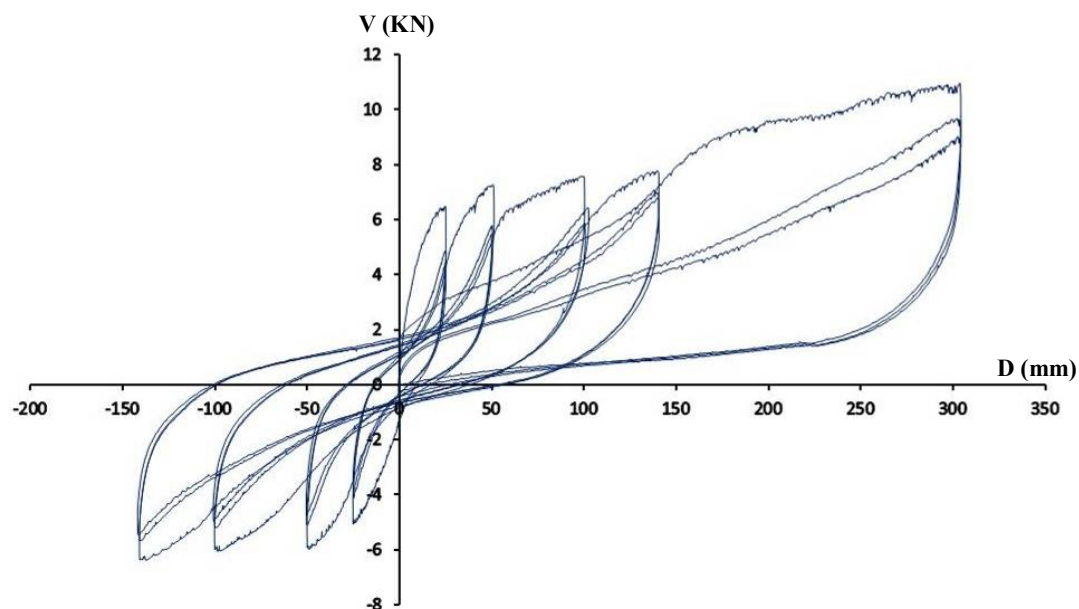
Fig. 3 Curva Fuerza – Desplazamiento del muro con citara MA2. (Créditos: Erika Vicente, 2011)

The six specimens with “citara” were tested under lateral cyclic test. The specimen MB1 was tested in four phases and the rest walls were tested in five phases, to the fifth phase the load application system was changed to develop a displacement of +300 mm. A typical hysteretical curve is showed in the Fig. 3. Despite the large displacement applied to the walls, the horizontal load did not fall; instead, it continues to increase. It does not reach the maximum capacity of shear strength. Even in the fifth phase, is not observed significant deterioration failures in the connections and the timber elements. Only the mud, that covers the entire wall was cracked. The maximum shear load was 10.5 KN, which is related to a distributed force of 4.2 KN/m for +300 mm of displacement, and a drift of 0.075.

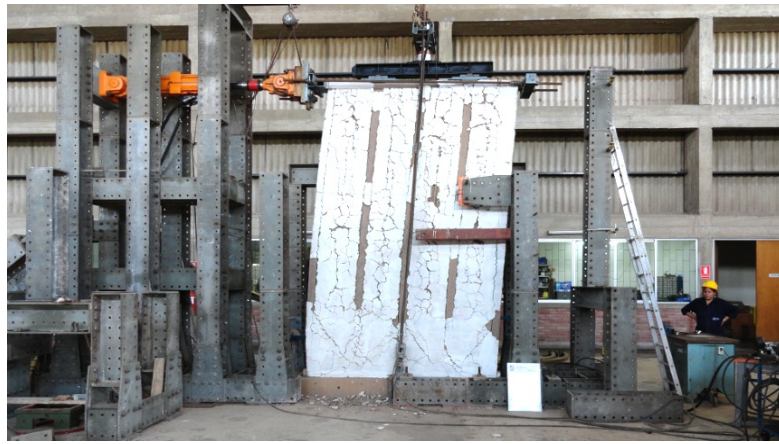
Fig. 4 Fifth phase of MA5 ($d = 300$ mm) (Credits: Diego Regalado, 2011)

The six specimens with diagonal MB1, MB2, MB3, MB4, M5 and MB6 the behavior was similar. In the first phase of ± 25 mm and the second phase of ± 50 mm, an elastic no lineal behavior with low load loss is showed in the second and third cycle of each phase (See Fig. 4).

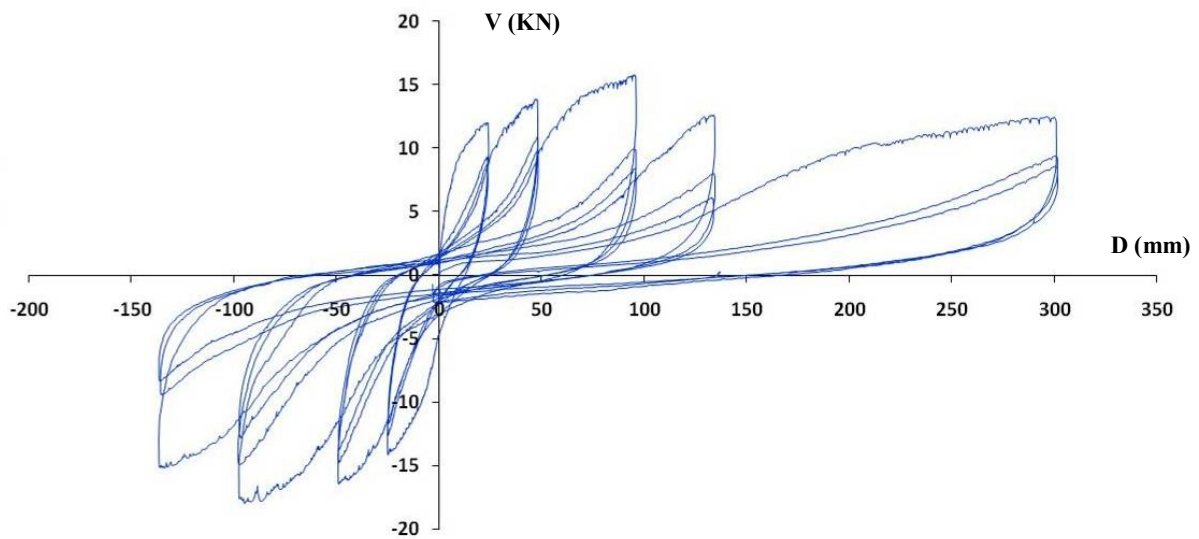
Fig. 5 Load – displacement curve. MB5. (Credits: Oswaldo Saénz, Alexis Rossi, 2011)

From the third phase of ± 100 mm (drift = 0.0312) was evident that the diagonal was unpinning. In the four phase (± 125 mm, drift = 0.039) the diagonal was completely detached and the wall began to work without the diagonal influence. At that time, the shear load was resisted by the rest of the structural system, ie, posts, beams, joints and the fulfilled of cane and mud, forming a second line of strength. Any element specimen observed failures in the elements or connections, except for the diagonal unpinning in the third phase. As expected, the mud was cracked since the first phase. The maximum shear load was 13.5kN averages corresponding to the distributed load of 5.4 kN/m to a displacement of +60 mm and a drift of 0.093.

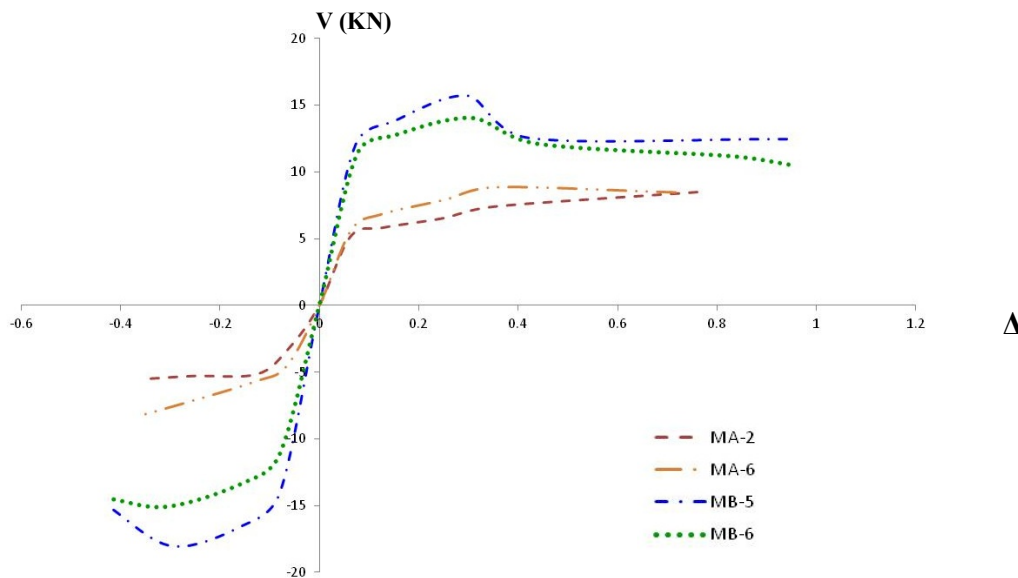
Fig. 7 Envelope curves comparison. MA and MB. (Credits: Erika Vicente, 2011)

To compare the behavior of two types of quincha walls, with different heights, the horizontal force versus horizontal drift was plotted. The horizontal drift was calculated as the horizontal displacement divided by the height.

The quincha walls with diagonal had similar behavior, independently of whether or not they had vertical load. There was a notorious the resistance increase due the presence of the diagonal which provides stiffness to the system. Then there was a marked decrease of the resistance since the diagonal was detached. However, the performance does not correspond to a fragile failure; the wall does not collapse because the rest of the system continues operational.

In the case of the quincha walls with citara, the behavior is quite different, the horizontal load keeps growing, with the increasing the horizontal displacement.
