ON-SITE TESTING AND EVALUATION OF A RELOCATED AND RECONSTRUCTED HISTORICAL TIMBER BUILDING

ABSTRACT

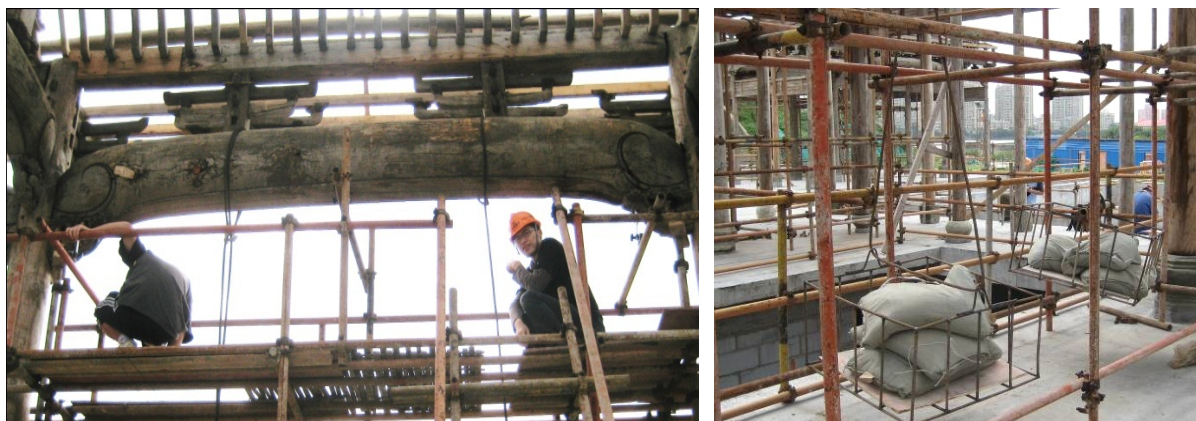
Fig. 2 Steel lifting cage and cable connection position of beams under static loading

The static loading was applied in steps: for each step of loading, a certain amount of packed cement (the weight is known as 50 kg per pack) was put into steel lifting cages. The lifting cages were connected to the tested beam via steel cables that were wrapped around the beam at prescribed positions, as shown in Fig. 2. Beams 1 and 3 were of relatively large span (4630 mm) and therefore two lifting cages were used and connected at the third points of the beam, respectively; whereas beam 2 was of a smaller span (2680) and only one lifting cage was used and hanged at the midspan node of the beam. For all the three beams, a total cement weight of 150 kg per lifting cage (the weight of the lifting cage itself is ignored) was applied in three steps.

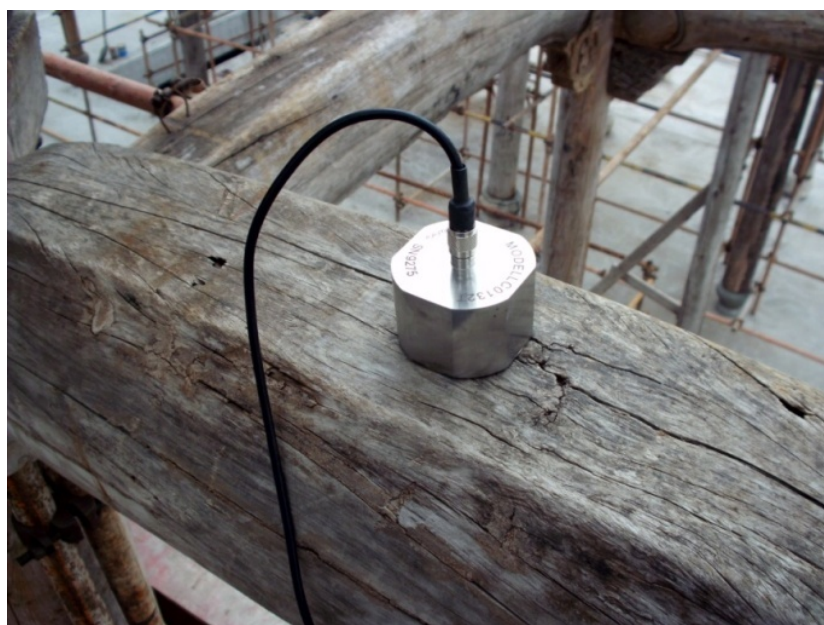
Fig. 3 Lance piezoelectric type accelerometers for measurement of acceleration

The structural acceleration responses were recorded by use of Lance (LC0132T) piezoelectric type accelerometers and processed by a SVSA signal acquisition instrument, which can convert the piezoelectric data for structural analysis purpose. The accelerometers were placed on the top surface of prescribed beam members and were oriented to measure the accelerations in the three directions as mentioned earlier [5], as shown in Fig. 3.

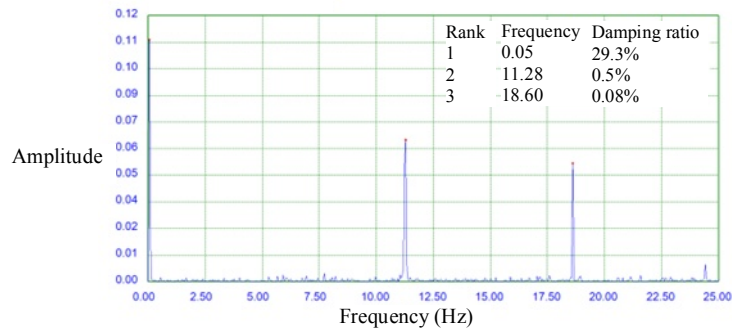
b) Distribution of acceleration in frequency domain based on results of measuring point 1

Fig. 5 Evaluation of natural frequency and damping ratio based on results of point 1

The dynamic test results mainly consisted of the acceleration readings measured along the y and x axes in the plan and the z axis of the frame. The original data of measuring point 1 is shown in Fig. 5 for demonstration purpose. These original data were then used for evaluation of the natural frequencies and damping ratios of the frame in the three directions. The evaluation diagram of damping ratio based on the acceleration results of measuring point 1 is also shown in Fig. 5. More detailed results of all four measuring points are listed in Tabs. 4 and 5, respectively.
