# **SUSTAINABLE REHABILITATION, PRESERVATION AND PROTECTION OF ACCESS ARCH STONE BRIDGE AT THE ENTRANCE TO THE MEDIEVAL OLD TOWN KORČULA**

*Amir Čaušević<sup>1</sup>, Lana Kudumović<sup>2</sup>, Neriman Rustempašić<sup>3</sup>, Nadira Kuljuh<sup>4</sup>*

## **ABSTRACT**

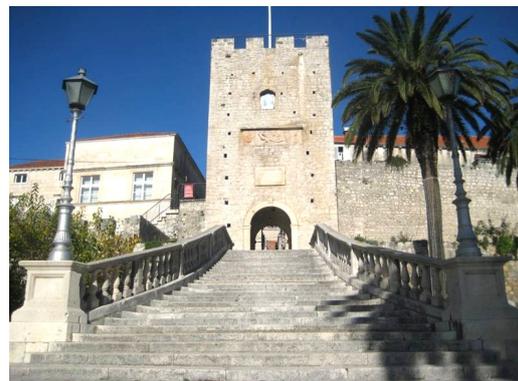
**Fig. 2** Main entrance to Old City of Korčula, Arch Bridge emphasized

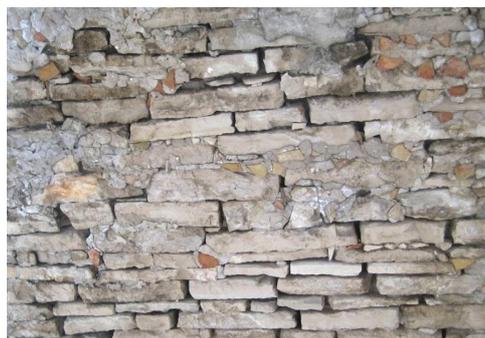
**Fig. 3** Degradation process on intrados

General impression of the existing condition of the Arch Bridge and surrounding objects is some instability and neglected appearance. Obvious lack of care is visible as large cracks, rock dislocation and crumbling, wild vegetation, inaccessibility and practically no maintenance. Exposed to the natural elements, bridge shows signs of structural wear and tear and weakening.

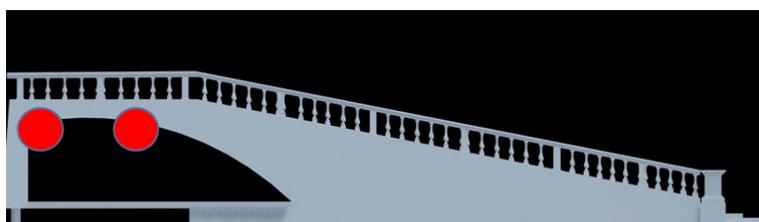
**Fig. 4** Critical points

When carrying out detailed survey of the stone bridge, we have noticed the types of damage as follows:

- construction of the vault with visible cracks and falling off the rock
- damage to the joint between the ceiling and walls
- the construction of the bridge on one of its circuits represented visible cracks
- railing of the bridge is moving in two places
- repeatedly movement of the stone railings resulted in damages and cracks
- stair steps are worn and extremely slippery
- visible cracks of floor stone cladding
