ENABLING A FUTURE FOR CULTURAL HERITAGE BUILDINGS

Lazarus Deborah¹

Keywords: Re-use, Adaptation, Significance, Design life

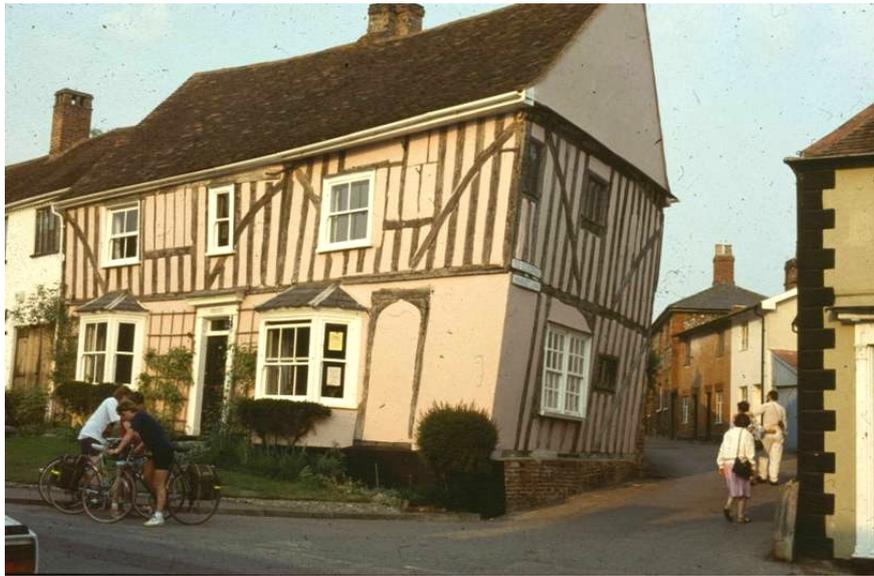
Cracking and signs of movement may appear alarming (see Figure 1) but further investigation may confirm that these are historic and that movement has ceased.

Fig. 1 Historic distortion in timber framed house, ©Peter Ross

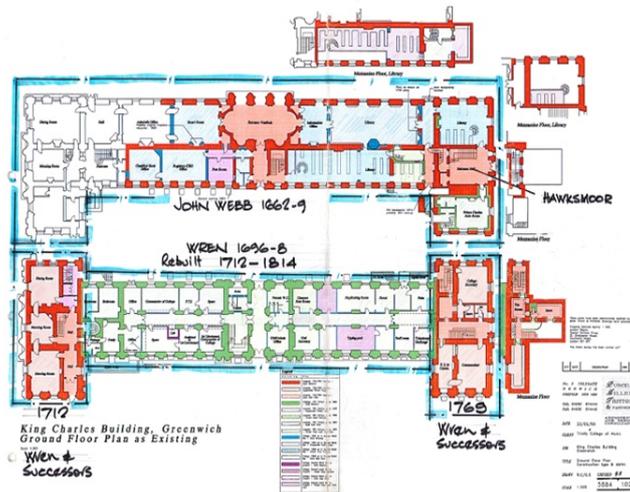
Fig. 3 Development of King Charles Court at Greenwich

It was originally built as a Royal Palace for Charles II but never occupied and instead used as a Royal Hospital for naval seaman until 1869. For the next 125 years it was part of the Royal Naval College. During this period changes took place, including extensive alterations to the floors, addition of new wings and substantial rebuilding of the Western Range (originally completed by Wren in 1698), as shown in Figure 3 below.
