# SYSTEMIC IMPROVEMENT OF OVERALL SEISMIC RESPONSE

Subassemblies and building models at reduced scale are tested on shaking table facilities. This experimental program is part of the project NIKER and constitutes the Work Package 7 (WP7): “Systemic improvement of overall seismic response”. The purpose of this WP is to define global intervention strategies through shaking table tests on both substructures and entire structures before and after intervention in order to check the performance of single elements and to characterize the seismic behaviour of whole buildings. The obtained results will also allow data for FE and analytical modelling to be obtained for both single elements and whole structures. The design and the testing protocol of both subassemblies and building models were based on the results obtained from the experimental campaigns carried out on individual vertical members (quasi-static tests), on horizontal elements (e.g. floors and roofs) and on connections between bearing elements, all these performed within the same project. The experiments summarized in this paper proved the efficiency of the investigated intervention techniques and provided fundamental data to c

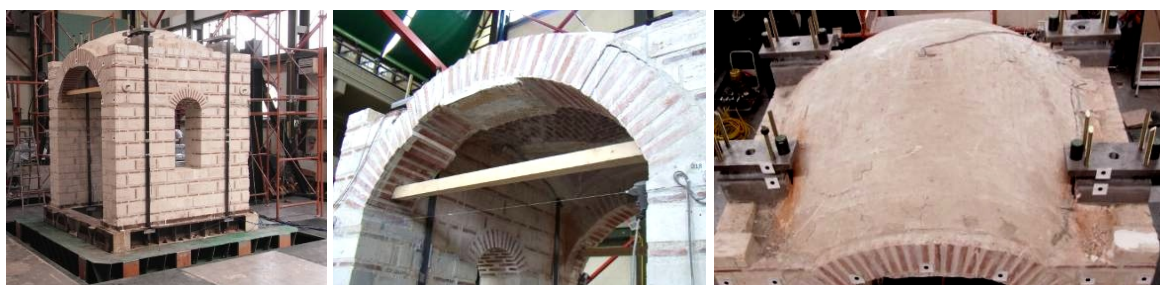
**Fig. 5** (a) The strengthened cross vault; (b) Damages in the arch; (c) Damages in the vault [input motion: 450% Irpinia earthquake]

The subassembly was subjected to a series of input motions along two axes. For that purpose, the Calitri record (Irpinia earthquake, 1980,  $M_s = 6.9$ ) was used. The maximum input acceleration of the adequately scaled motions was gradually increasing. After the occurrence of severe damages, the subassembly was strengthened: All cracks were grouted, the three-leaf masonry piers were grouted, timber struts/steel ties were placed at the base of the two arches, whereas vertical prestressing was applied to the piers, using CFRP plates. The prestress force has increased the compressive stress in the piers by 0,20 MPa. Fig. 5 shows the strengthened subassembly on the shaking table, as well as the damages observed after the completion of the test. It is important to note that the damages recorded after strengthening were of the same nature as those observed in the as-built case, namely: Cracks in the vault and in the arches (due to the out-of-plane movement of the supporting piers), as well as horizontal cracks in the piers (at the top and the bottom of the openings, again due to their out-of-plane

bending). This is a positive result, in the sense that the applied techniques do not alter the structural behaviour of the structure. On the other hand, the strengthened subassembly was able to sustain three times higher maximum acceleration than the unstrengthened one, and significantly larger deformations (40,6 mm at the top of the piers vs. 11,4 mm for the unstrengthened specimen) for the same level of damages.

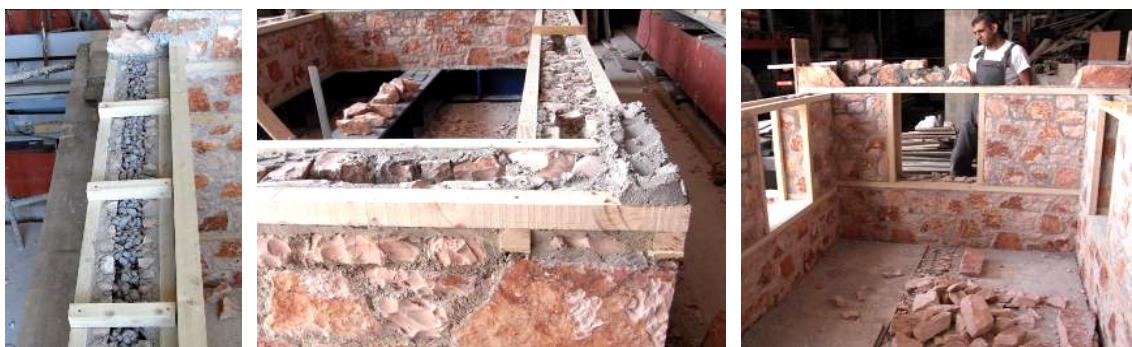
Fig. 7 (a) In-thickness layout of longitudinal and transverse timber elements, (b) Connection of timber elements in the corners of the building, (c) Timber ties and timber frames of openings

Some construction details of the system of timber reinforced masonry adopted for one of the models tested at NTUA are shown in Fig. 7. The aim of this test was to obtain quantitative data about the positive effect of timber laces on the seismic behaviour of historic structures. For this purpose, the model was subjected to three series of seismic tests along two axes, namely: (a) In the as-built state, in order to compare its behaviour with that of the plain masonry model, (b) After the application of grouting, in order to check whether grouting alone (in presence of timber ties) is able to improve the seismic response of the building and (c) after the enhancement of the diaphragm action of the roof alone (as tests on the plain masonry model have proven that the diaphragm action of the roof is decisive for the seismic response).
