THE EFFECT OF HYDRAULIC LIME POZZOLANIC GROUTS ON THE MECHANICAL PROPERTIES OF THREE-LEAF STONE MASONRY IN COMPRESSION

Adami Ch.-E.¹, Vintzileou E²., Mouzakis Ch³., Badogiannis E⁴., Kalagri A.⁵

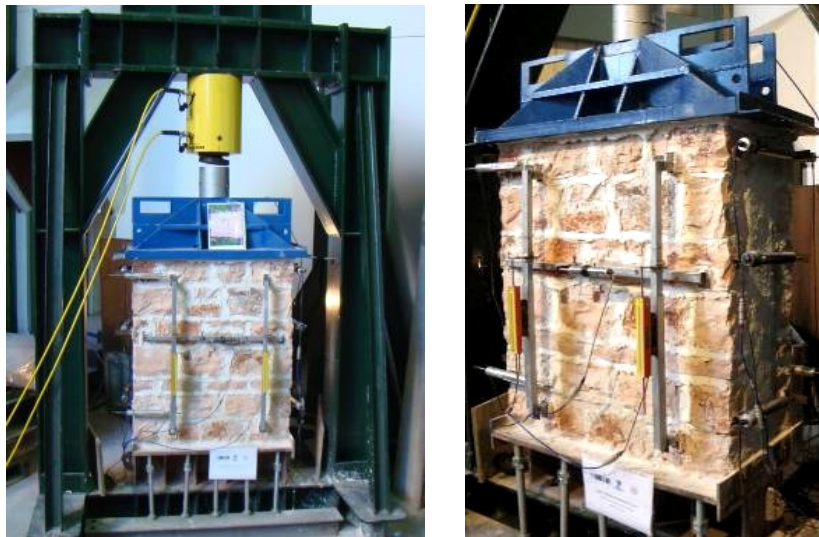
Figure 1 shows the test setup for the wall specimens subjected to compression. Load controlled tests were carried out. The load was applied through a hydraulic jack (maximum capacity: 6000 KN).

Fig. 1 Test setup and instrumentation of wallettes subjected to compression.

The hydraulic jack was fixed on a steel frame. The compression load was applied through a steel beam, in order to obtain uniform distribution over the entire length of the wallette. Deformations on the wallets were measured by means of LVDTs. In detail, four LVDTs (two for each facade) were used to measure vertical deformations; six LVDTs (three for each facade) were placed to measure horizontal deformations and vertical crack openings, while six LVDTs (three per side) were recording the transverse deformations of the wallets (i.e. separation between the external and internal leaves). Each specimen was loaded to its maximum capacity, without being disintegrated though. Then, it was unloaded and removed from the steel frame. Subsequently, the wallettes were strengthened with one of the two abovementioned hydraulic lime-based grouts. Approximately two to three months after the application of grouts, the wallettes were retested to failure.

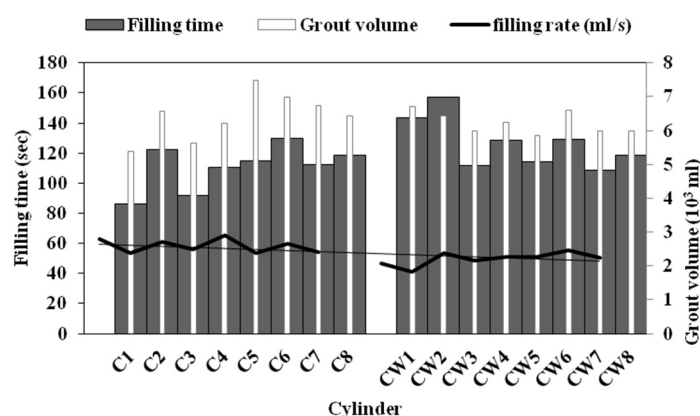
In Figure 2, the filling time (s), the consumed grout volume (lt) and the filling rate (ml/s) are correlated. By comparing the two grout mixes, one may notice that the average values of the consumed grout volume are almost equal, as well as the voids content. However, the average filling rate is lower for the grout mix GW10s, in which μ -silica/W substitutes NHL 5 by 10 %. This observation is in accordance with the higher injectability characteristics (penetrability and fluidity) exhibited by grout mix Gs, as compared to those of GW10s (see [3]).

Fig. 2 Filling time, consumed grout volume and filling rate of cylinders, injected with the two grout mixes

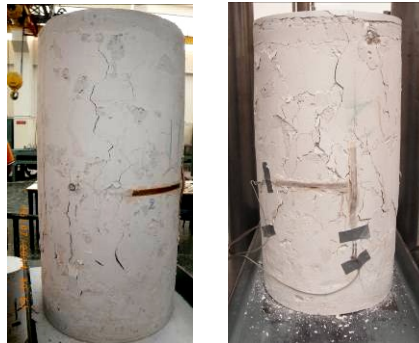
Independently of the grout mix, the failure mode of cylinders was characterized by the formation of almost vertical cracks (see Fig. 3).

Fig. 3 Failure mode of grouted infill material in compression.

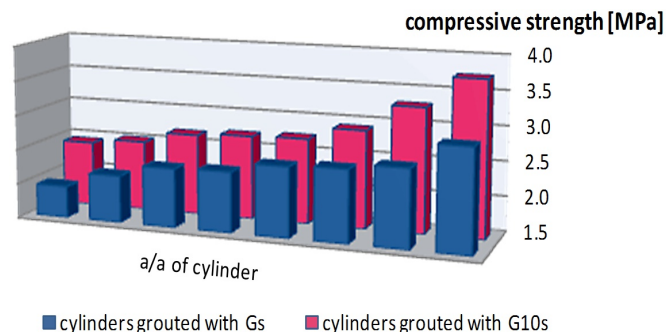
Fig. 4 Compressive strength of grouted cylinders at the age of 180 days.

Table 6 summarizes the results for the compressive strength, $f_{inf,s}$ (MPa) and modulus of elasticity, $E_{inf,s}$ (GPa) for the grouted cylinders, at the age of 180 days. One may notice that the comparison of the two alternative grout mixes shows a rather limited effect of the grout composition on the mechanical properties of the grouted filling material (see Tab. 6 and Fig. 4). In fact, the compressive strength of the grouted cylinders varies between 2.18 and 2.97 MPa for the specimens C1-C8, grouted with pure NHL 5. For the specimens GW1-GW8, which were grouted, with 10% μ -silica/W mix the compressive strength varies between 2.44 and 3.73 MPa. The mean compressive strength obtained by

specimens grouted with grouts Gs and GW10s is equal to 2.44 MPa and 2.88 MPa, respectively. These values are in agreement with those reported in literature for cylinders grouted with hydraulic-lime based grouts [6, 7]. As far as the moduli of elasticity are concerned, the reported data vary

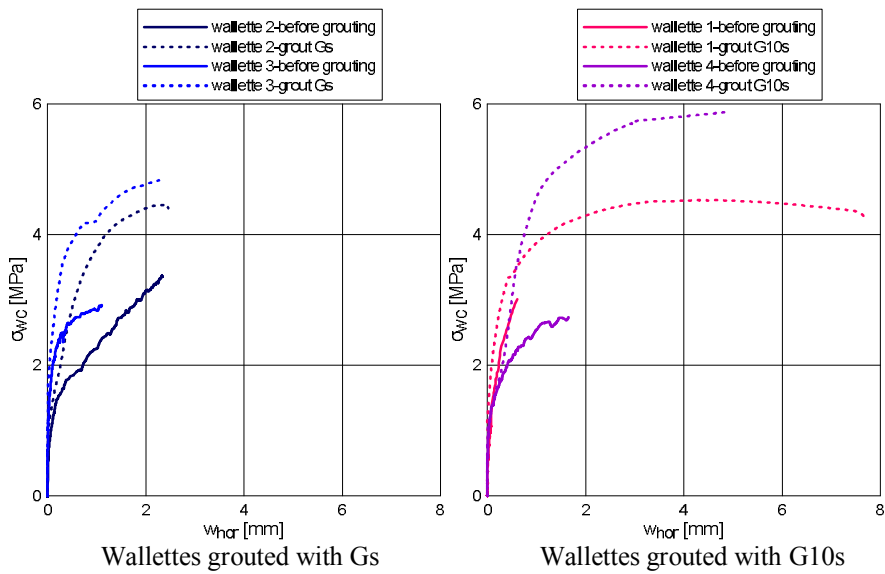
Prior to the application of grouts, the comparison of curves ‘vertical stress vs. horizontal deformation’ (Fig. 7, solid lines) and ‘vertical stress vs. transverse deformation’ (Fig. 8, solid lines) at mid-height of specimens, shows that the horizontal deformation (i.e. the total opening of the vertical cracks on the faces of the wallettes) was at maximum equal to ~ 2.0 mm. On the contrary, transverse deformations (i.e. opening of cracks between external leaves and filling material) reached values between 2.0 and 5.5 mm. It is, therefore, confirmed that the primary cause of failure of this type of masonry is the separation among the three-leaves and the resulting out-of-plane deformation of the external strong leaves, as discussed in detail in [8, 9].

Fig. 7 Wallettes 1 to 4 before and after grouting. Stress vs. horizontal deformation at mid-height [mm]

As shown in figs. 6 to 8, as well as in Tab. 7, grouting resulted to a significant enhancement of the compressive strength of masonry (by 32% to 66%). This is attributed [8, 9] to the enhanced mechanical properties of the filling material, as well as to the improved bond between exterior leaves and filling material. In connection to the latter, is observed that wallettes 1 and 4 (grouted with a lime-pozzolan mix) exhibited higher strength enhancement. This is attributed to the better bond properties achieved the interfaces of this type of mixes and in-situ materials [10, 11].

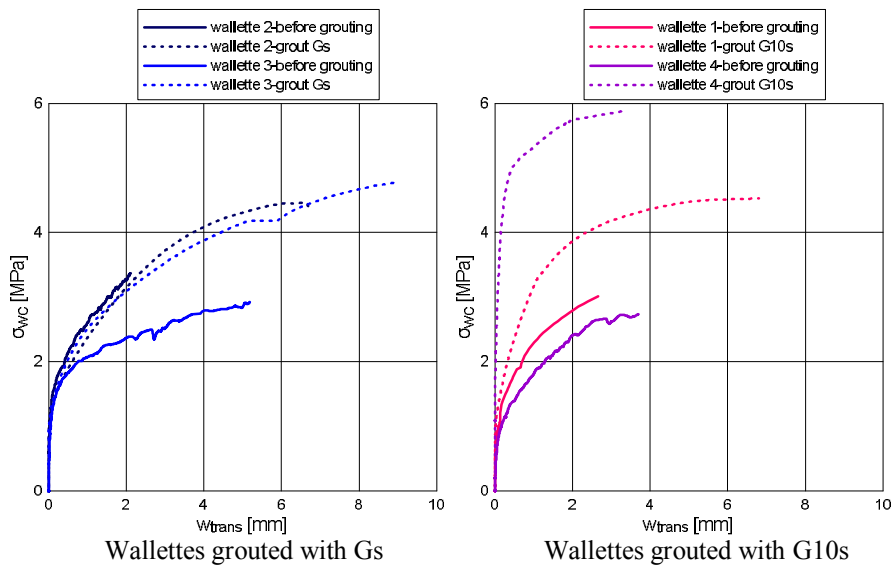
Fig. 8 Wallettes 1 to 4 before and after grouting. Stress vs. transverse deformation at mid-height [mm]

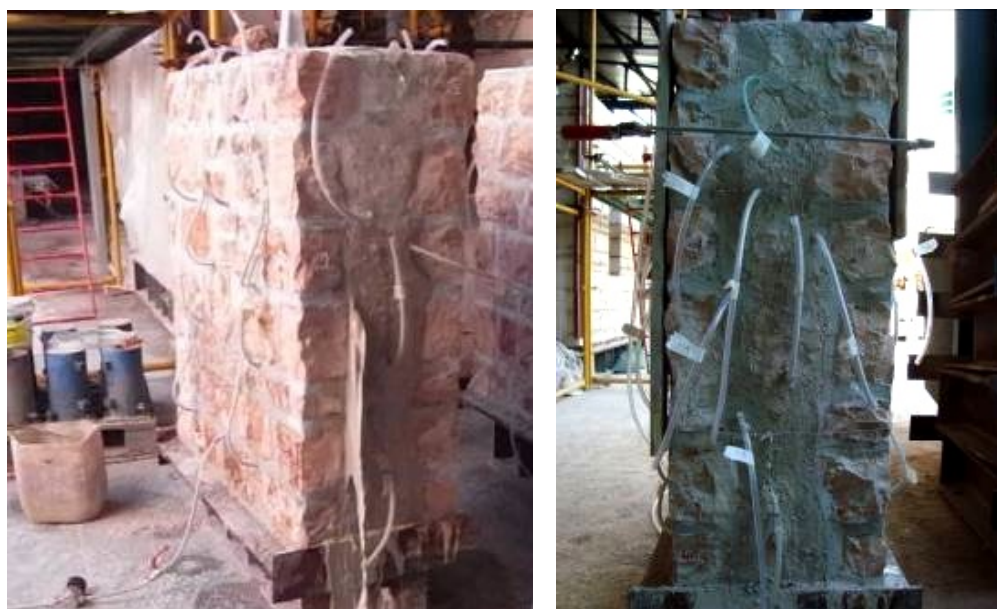
It should be noted that walette 4 exhibited an increase in its compressive strength equal to 115%. This is attributed to the different failure mode exhibited by this walette, as mentioned in section 3.2.1. Actually, the failure mode of walette 4 was governed by the formation of vertical cracks on its faces (Fig. 5b – blue lines). This is also evident in Figures 7b and 8b: The total opening of vertical cracks on the faces of walette 4 are approximately equal to 5.00 mm, whereas the total opening of vertical cracks within the thickness of the walette is significantly smaller (~3.30 mm). It should be noted that this walette was cracked during the grouting and pronounced separation between the leaves was observed (Fig. 9). This “accident” may have had a beneficial effect on the final (after grouting) behaviour of masonry, as the interface between filling material and exterior leaves was easily filled with grout and, thus, better bonding was achieved.

**Fig. 9** Walette 4. Application of grouts
