THE POSSIBLE UTILITY OF POLYMERS IN THE RESTORATION AND PRESERVATION OF EGYPT'S SPHINX

*Wafeek Samuel Wahby*¹

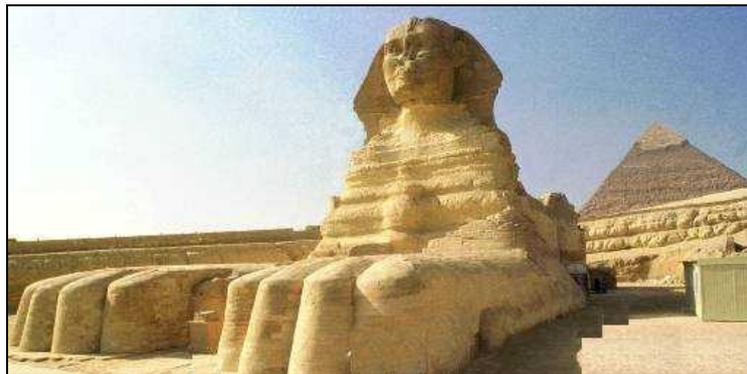
Fig. 1 Sphinx

Shaped as a lion's body and topped with the head of a man, the Sphinx's awesome frame measures 242 feet long, 66 feet high, and 18 feet average width. Its face is 20 feet wide, 22 feet high and its eyes are over 4 feet high. [8] It reclines with its head upright and its front legs extended and parallel, while its back legs folded underneath its body and its gaze contemplates the rising sun in the East.
