## USING MUD INJECTION AND AN EXTERNAL ROPE MESH TO REINFORCE HISTORICAL EARTHEN BUILDINGS LOCATED IN SEISMIC AREAS

**Abstract.** This paper presents preliminary test results from an ongoing research project conducted at the Catholic University of Peru (PUCP), whose aim is to develop reliable techniques for the repair and retrofit of historical earthen constructions damaged by earthquakes. Initial test results showed that liquid mud injections were effective in restoring most of the strength of small adobe walls which had been previously cracked under to diagonal compression, and of full-scale adobe walls subjected to lateral cyclic loads. This repair procedure, however, was not adequate in recovering the original structural properties of a full-scale adobe model tested under simulated seismic loads on the PUCP's shaking table. Mud injection, therefore, must be complemented with other techniques which use minimal and reversible reinforcements made of materials compatible with adobe.

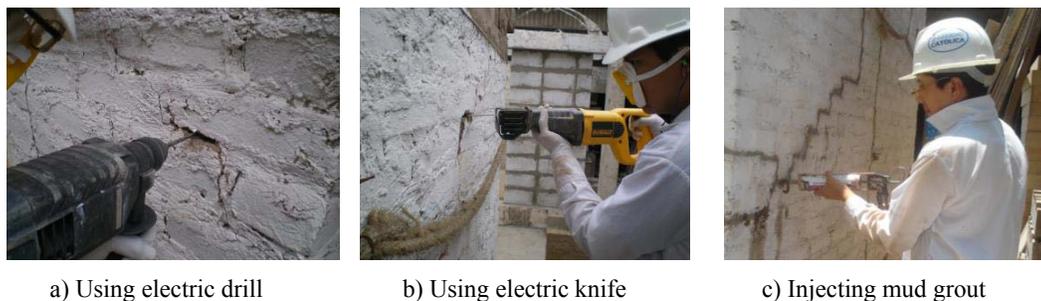
Figure 5. Opening seismic cracks and injecting mud grout.

The damaged model was retrofitted (repaired and strengthened) in the laboratory yard. Repair with grout injection required that the cracks be opened to allow for full penetration of the grout (which may be in conflict with the conservation principle of minimum intervention). In the cases of historical monuments, it is advisable to proceed step by step with the sequence of crack opening and grout injection. In this case, because of time constraints, it was decided to open all the cracks in the adobe walls simultaneously. All cracks wider than 1 mm were opened to about 8 mm wide using a drill and an electric knife, as shown in Figures 5 a) and b). Then, all the cracks were sealed with a layer of silicon on both wall faces, leaving small openings separated approximately 100 mm from each other. Afterwards, liquid mud grout was injected on the openings. The grout consisted of a mixture of one part of soil sieved through #10 mesh (2 mm opening), 50% in volume of finely cut dried grass (10 mm average length), and 35% in weight of water. This mixture was injected inside the cracks until they were completely full with, as shown in Figure 5 c).

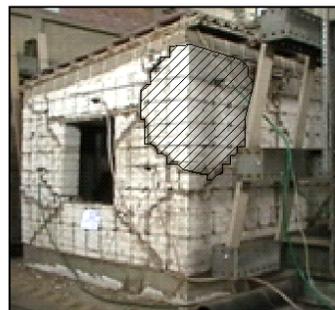
a) Damaged full scale model

b) Simplified model

Figure 11. Simplified model for adobe block interaction.

During most strong shaking table tests performed on adobe structures at the PUCP, it was observed that the adobe walls break in large pieces, which then detach and collapse by overturning. In this project, a portion of the back wall (shown hatched in Figure 11 a) was detached from the rest of the structure during the strong shaking tests performed with the retrofitted adobe model.

A simplified structural model was generated by considering that the main structure and the detached wall portion are rigid blocks, as shown in Figure 11 b). Block A represents the main structure (assumed undamaged) and block B is the detached portion of wall. The nylon ropes prevent the overturning of block B. This situation can be represented schematically by a simple dynamic model in which the two blocks are connected by a set of N horizontal elastic ropes.
