## CONSTRUCTION SYSTEMS AND PROBLEMS OF PROTECTION OF BASTIONED FORTIFICATIONS IN ANATOLIAN/THRACE REGION

Dr. Soner YELER<sup>1</sup>, Prof. Dr. Nadide SEÇKİN<sup>2</sup>

**Keywords:** Military architecture, Bastioned fortification, Cultural heritage

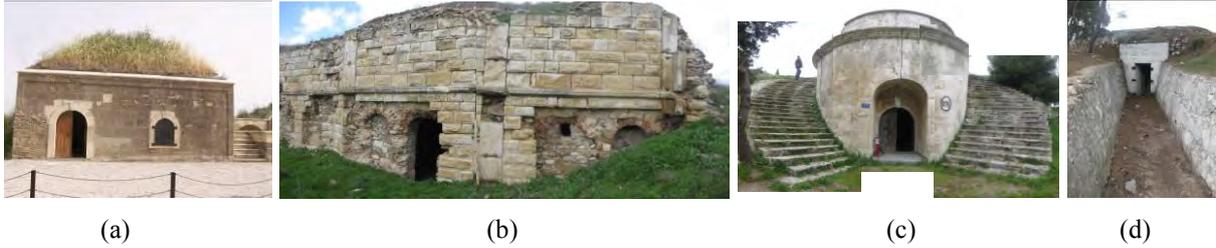
Figure 7: (a) ashlar facade wall of powder magazine of Rumeli Mecidiye Bastions, 2013 (b) spilled stone cladding of quarters of Big Tasocagi Bastion, 2013 (c) ashlar facade wall and stone stairs of powder magazine of Anatolia Mecidiye Bastions, 2013 (d) reinforced concrete facade wall of blockhouse of Anatolia Mesudiye Bastion, 2013.

The foundation walls of single or two floored construction units of the bastions were predominantly rubble stone walls (see Figure 6). The height of foundation walls could not be determined since an excavation could not be performed. Rough sculpture stone and alternating and random fabric systems were used in addition to rubble stone in the inner and outer walls which were placed on foundation walls. On the rubble stone wall, brick horizontal beams were used in the form of maximum 3 vertical rows (Figure 6). Outer wall thickness ranged from 1.00 to 2.10 m, whereas the thickness of walls used in between-space passages ranged from 0.45 to 1.85 m.. The surface of inner walls was made of horasan (mortar made of brick dust and lime) and was covered with limewash. The facade coating of outer walls was made of ashlar. In the reinforced concrete system, outer wall thickness ranged between 0.50 and 1.00 m. The surface of inner walls was generally covered with limewash (Figure 7).

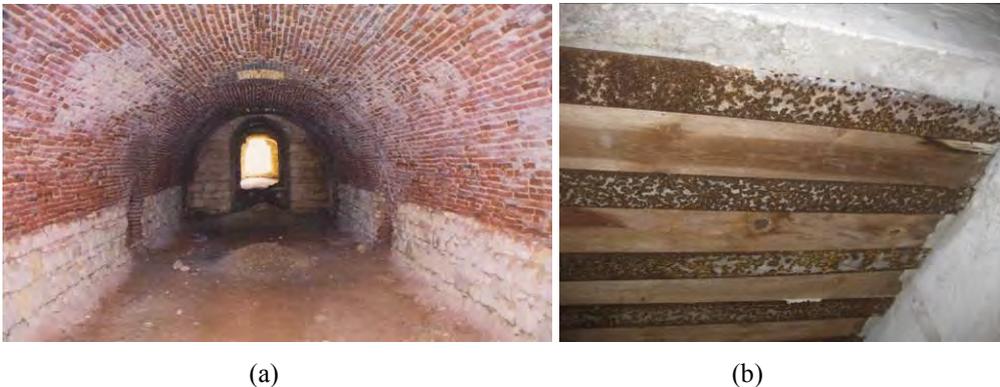
Figure 8: (a) brick vault on masonry foundation walls of garrison and quarter of Kırklareli Seyfioglu Bastion, 2004, (b) reinforced concrete slab supported by steel profiles of Canakkale Anatolia Mesudiye Blockhouse, 2013

Top covering systems of bastions were brick vault and can be classified according to places as drop vault, semicircular vault or quarter vault. Vault thickness changed between 0.50-1.20 m, and the thickness of soil on vaults ranged between 0.50-6.50 m. according to construction units and the location of measurement. The soil layer is a mixture of soil-clay-horasan<sup>5</sup>. Bastions that were built with the reinforced concrete and mixed systems had a top covering of flat slab (Figure 8).

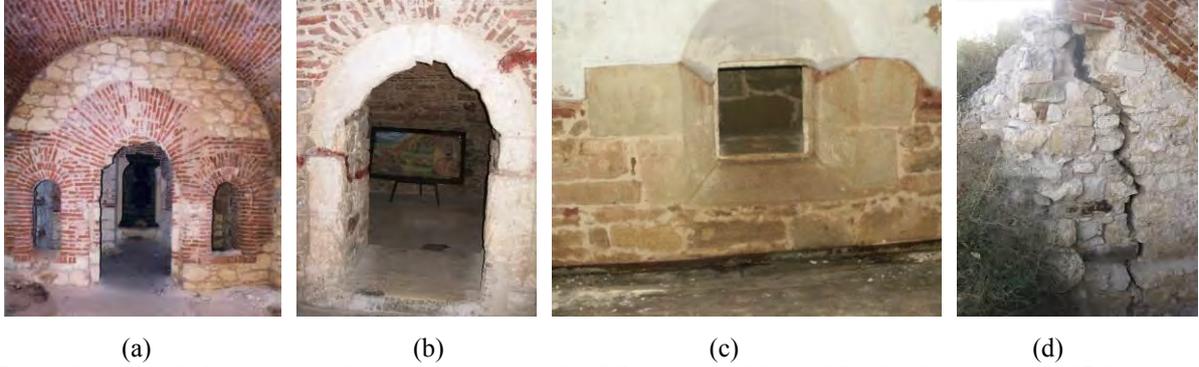
Figure 9: (a) brick door and windows arches and vault of Garrison building of Seyfioglu bastion, 2005 (b) coarse sandstone passageway wall of garrison and quarter building of Dortkaya bastion, 2013 (c) ashlar window of ordnance depot of Namazgâh Bastion, 2013, (d) segregated, rubble stone retaining of walls powder magazine of Aynalibag Bastions, 2011.

Brick and coarse sandstone was used in arches of door passage and window opening areas that are on the rubble stone walls of inner spaces. The door and window opening on facade were also placed with a specific arrangement and the arches were made with the same material. Doors and windows in restored bastions were made of timber woodwork (Figure 9).

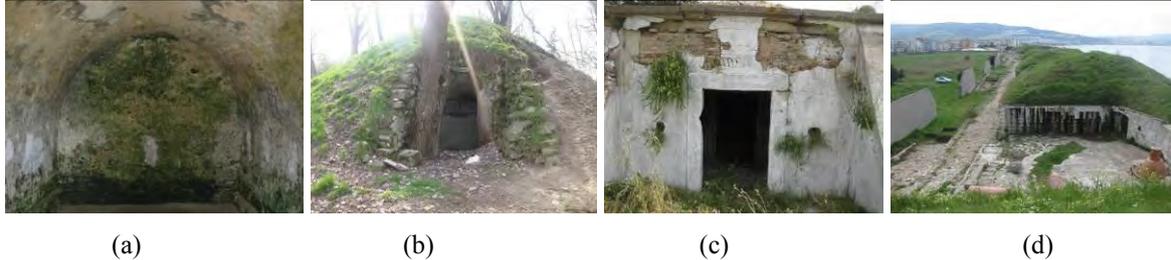
Figure 12: (a) Interior walls covered with moss of powder magazine of Kumkale Bastion, 2013, b) Vegetation problems in entrance of powder magazine of Bosna Bastion, 2013, (c) Vegetation problems on the exterior walls and plasters of powder magazine of Bolayir Merkez Bastion, 2013.

Neglect is the most important cause of deterioration in bastions that are completely abandoned or are unused even though they were assigned to an institution. In addition, natural factors such as wind, rain, and temperature differences between day and night accelerate deterioration; therefore, moist, loss of equipment and collapsing occurred on the vault covering and inner walls. Efflorescence on coated surfaces and corrosion of metal construction components occurred due to moist. Abrasion, disengagement, and spillage were observed on façade surfaces; whereas color changes and pollution were observed on stone coverings. In addition to moist, drops with dense salt which were cast from the sea by the wind and dust were more effective in deteriorating Canakkale bastions compared to other bastions. Furthermore, seeds blown about by the wind led plant and tree roots to develop within the surrounding of bastions and these roots shut some of the space entrances as well as deteriorating materials and fracturing walls (Figure 12).

stairs, the original plan and facade organization of the bastions have changed. Also, there were newly coated and painted surfaces on building facades (Figure 12). “Treasure hunters”, who constitute another threat to bastions, caused partial collapse in the constructions since they make excavations and demolitions.
