STRUCTURAL INTERVENTIONS ON THE MODERN HERITAGE BUILDINGS: CASE STUDY OF THE HISTORICAL MUSEUM IN SARAJEVO

This paper will bring forward approach to understand structural interventions on the buildings of Modern heritage respecting its values as the memory of 20th century, describing case study of the Museum of the Revolution in Sarajevo, built in the early sixties, in contrast solid and transparent volume of its refined reductionist geometry in a chapter of Bosnian architecture in the sixties of 20th century, which realizes a specific contribution to the history of international modernism. Although the best way to preserve valuable historical buildings is to raise awareness of the value of the object, in order to gain the necessary knowledge on ways of maintaining the building, it is also important that the building is used in a way that respects the historic value of the building. Well prepared Management plan, with long-term goals will define and propose developments of particular building in order to achieve sustainability and involvement of different counterparts.

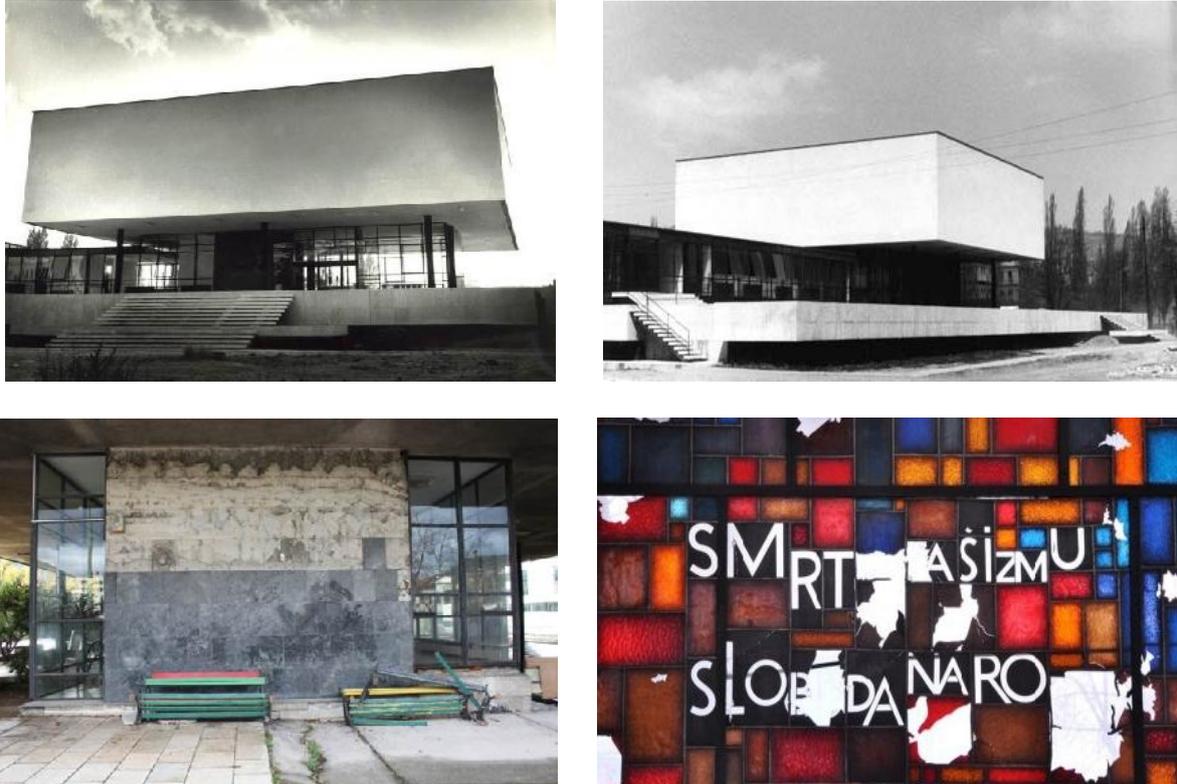
Figure 1: Historical Museum in Sarajevo

Museum of the Revolution, as a monument sample of the public type, has been designed as a simple sheath in the game of empty, light ground floor and full cube over which has been violently degraded due to war-time as well as lack of maintenance.

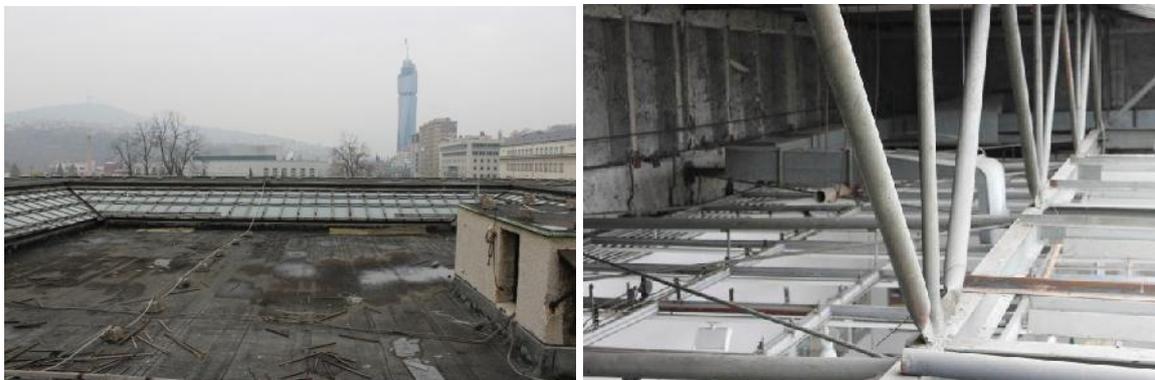
Figure 5: Detail of the existing roof structure

Assessment and classification of damages of the existing structure as a result of investigation detected further damages: rough holes, misaligned holes/open holes, nicks and gouges, cracks, bending/buckling/sweep. Trusses are comprised of both tension and compression members. Distortion in tension members is not as critical as distortion in compression members.

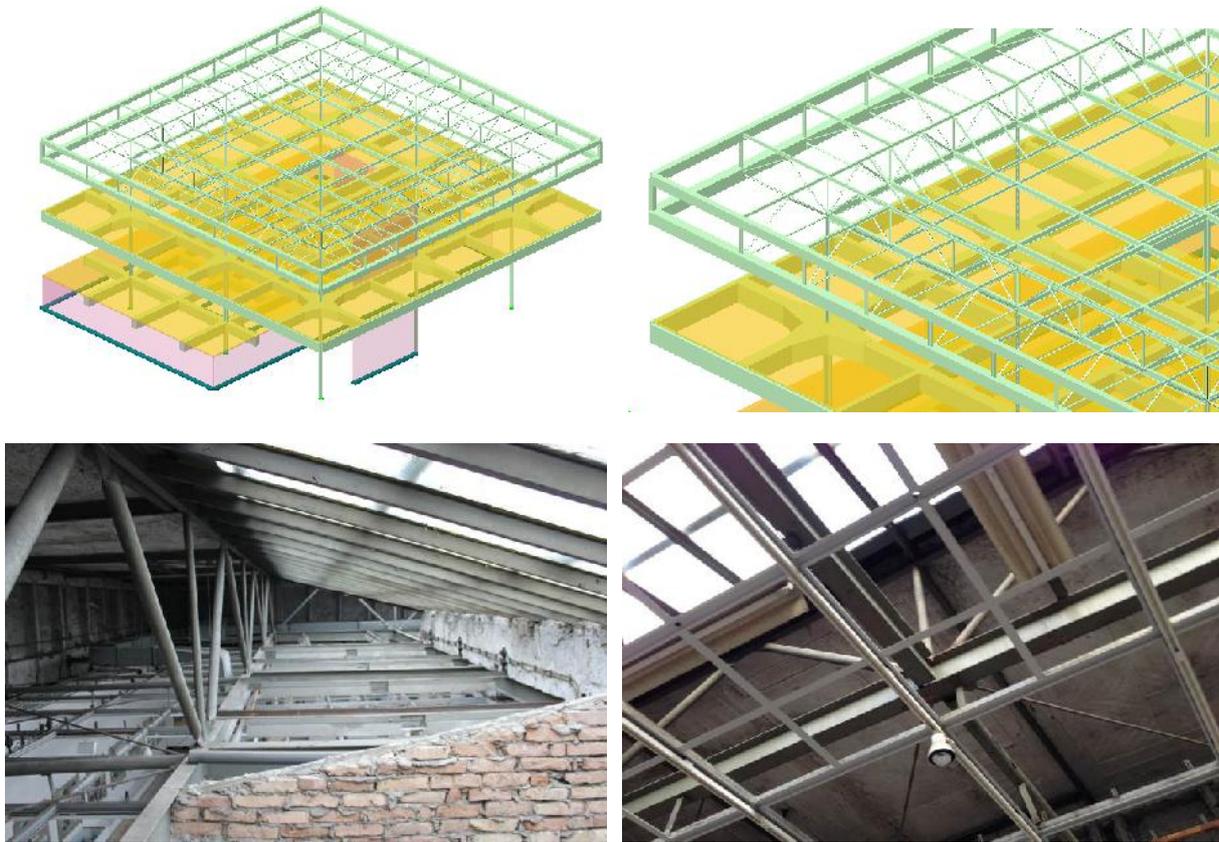
Figure 7: Tower 7 - 3D model of the steel structure and existing condition of the roof structure

According to the current stage of the building entirely new roof structure has been proposed for the building. The plan predicts construction of horizontal reinforced concrete beams that will be embedded in the existing reinforced concrete beam. The project envisions the creation of an entirely new roof structure consisting of primary, secondary and tertiary girder.

The differences of the results obtained by the finite element method (provided by software Tower 7) and those obtained by gradual calculation range within the limits of 10-14%. Differences arise due to the automatic introduction of own weight of structural elements, as well as due to application of loads for maximum impacts on the main structural system. Steel structures are designed in a way that elements dissipate seismic energy, by bending, and by the occurrence of non-linear distortion. In the case when we have approximate systems, nonlinear deformations are allowed at the ends of the rods or the diagonal pair. Buckling and yielding is not permitted in plastic hinge zones. Choosing dimensions of nodes is done so that the node is able to provide transfer limit bending moments and shear forces corresponding from one element to another, without the appearance of large nonlinear deformation in the node zone. Designers, guided by building legislation, design standards and the construction zone, need to decide on the acceptable risk level and then, bearing in mind the costs involved, selecting a method of achieving either full hazard avoidance or an acceptable level of hazard.

It is necessary to change flat dilapidated roof completely, and to apply contemporary details, to remove the old improvised details or missing one, to make water protection such as bitumen stripe, which are almost completely melted by the heat – to change gutters, which will adequately drain the water from the roof to worn skylights replaced with new ones, with windows for collecting solar energy - the part of the building used solar panels and energy collected will be used to run the air conditioning.

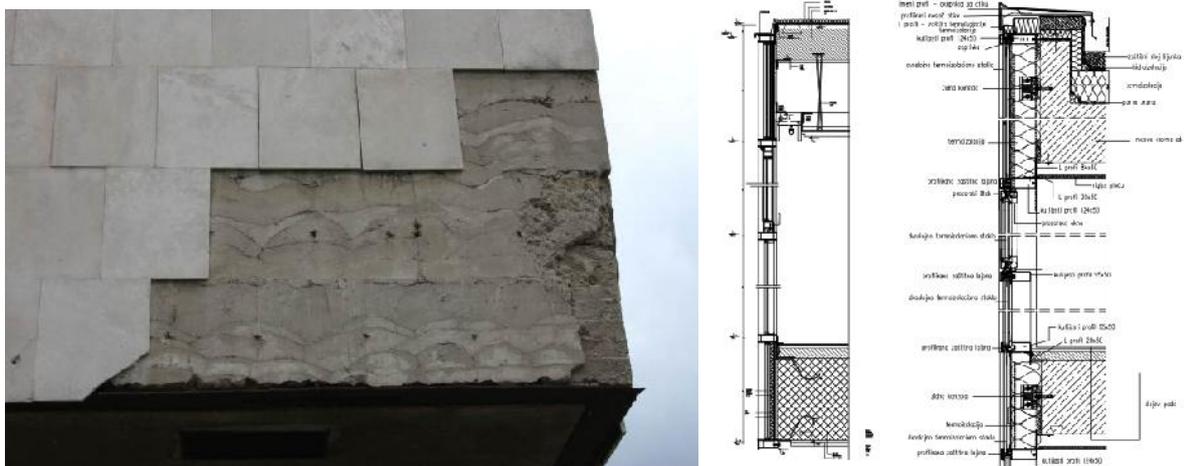
Figure 8: The current state of the facade and the proposed details of the new facade

The existing façade which is mostly glazed glass currently does not meet requirements of the architectural physics, since the heat energy losses are enormous. Due to the emergence of huge heat losses, at the façade is currently visible attempt of alternative solution that will contribute to lower heat losses, but in the same time it was not done in an appropriate way, and also does not meet the basic laws of architectural physics.
