## PRELIMINARY RESEARCHES ON LIME-BASED INJECTION GROUTS FOR CONSERVATION OF EARTHEN ARCHITECTURAL HERITAGE AND RUINS

**Abstract.** *The most common defects of earthen architectural heritage and ruins are cracking and detachment. The technical criteria for appropriate grouts are mechanically and chemically compatible with original earthen substrate. Various formulations of earthen materials mixed with air limes, natural hydraulic limes and micro lime have been preliminarily tested. The compatibility of injection grouts are evaluated according to injectability, shrinkage, adhesion to earthen substrates and retreatability. It can be concluded that for cavity filling the mix of quick lime with earth is most suitable. For the surface reattachment or cracking filling of earthen ruins without pressure injection, the mixture of natural hydraulic lime with fine earth seems to be to be most effective. Alcohol-based micro lime shows a surprised result to reattach delaminated plasters.*

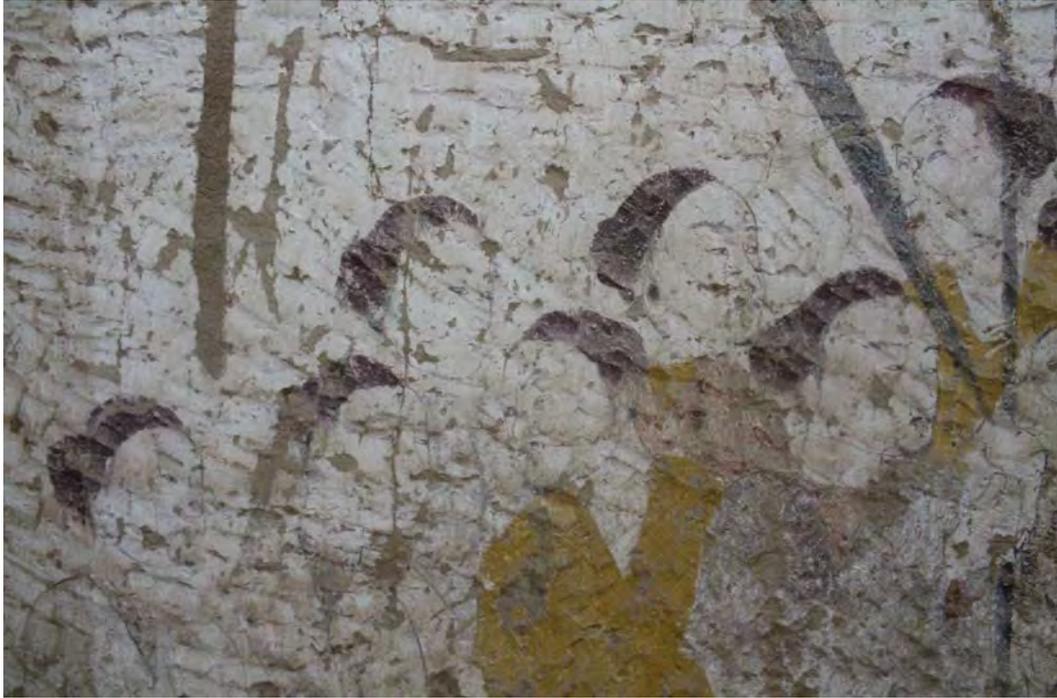
Figure 1: Mural painting on top of lime washed loess earth in Taiyuan

Earthen architectural heritage end ruins are the most relevant cultural heritage in China not only because of construction tradition, but also because of miserable history. Most of remarkable earth-timer architecture were burnt down during the wars and only as ruins passed to our generation. Besides earth castles in Fujian, earthen city wall in Pingyao, which are listed as world heritage, but there are still plenty of architecture in historic towns and streets. It is also known that there are mural paintings were found directly on earth surface.

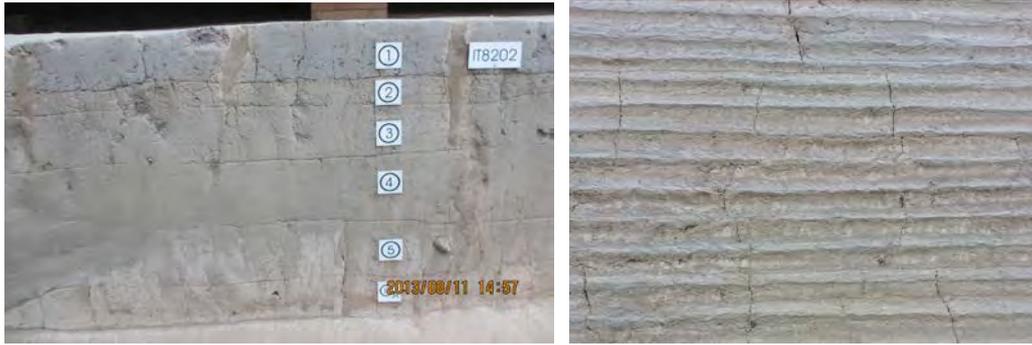
Figure 2: Cracks due to shrinkage  
(Left: archaeological ruin in Chengdu Jinsha Museum, Right: Pingyao City wall from compacted earth)

The most common defects of earthen architecture are cracking and detachments of decorative surface. The typical cracks are caused by shrinkage (Fig. 2)

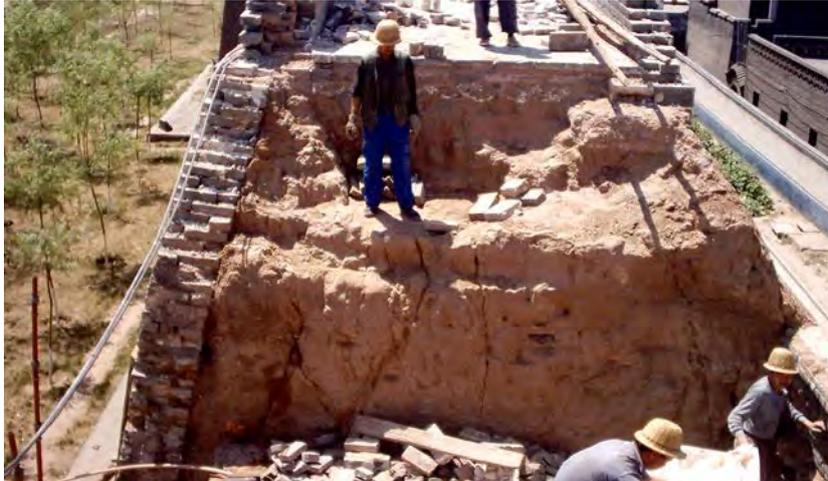
Figure 4: Complicated crack system within the city wall of Pingyao

The second common cracks are of structural performance. A complicated crack system has been identified within the ancient city wall of Pingyao (Figure4) and most of them become rain water channel and may cause collapse of entire wall. One of restoration measures is to fill

such cracks and voids with water resistant fillers, which, however shall be both mechanically and chemically compatible with existing old earth materials.

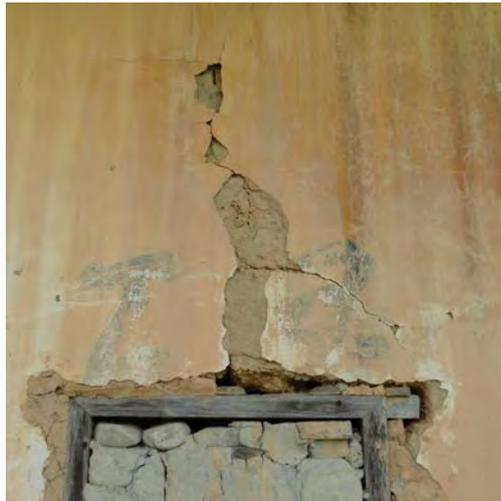
Figure 5: Cracks within hammed earth wall caused by subsequent window opening

It is also not uncommon that cracks are caused by intervention during the function changes (Figure 5).

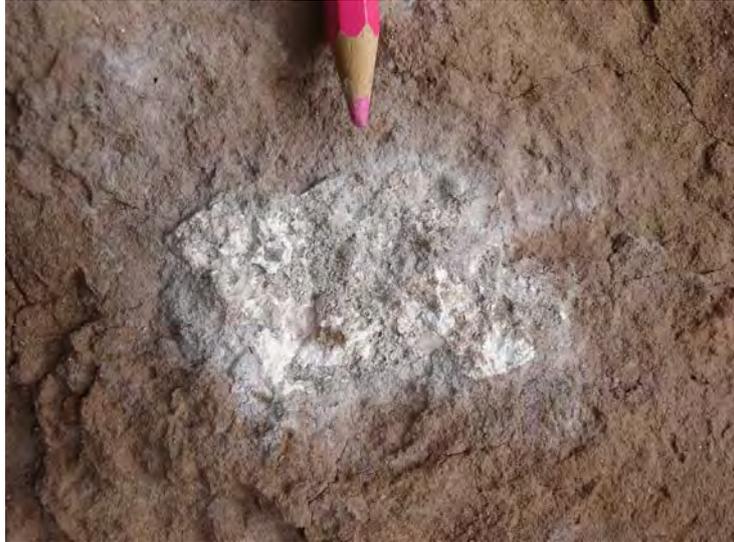
Figure 6: Earth sample taken from City wall top, which restored around 1979 showing migration of lime into earth

Lime is most tradition binder to consolidate earth. Both practical observation (Figure 6) and laboratory tests show that air lime, chemically  $Ca(OH)_2$  migrates and reacts with clay minerals consolating earth micro structure.

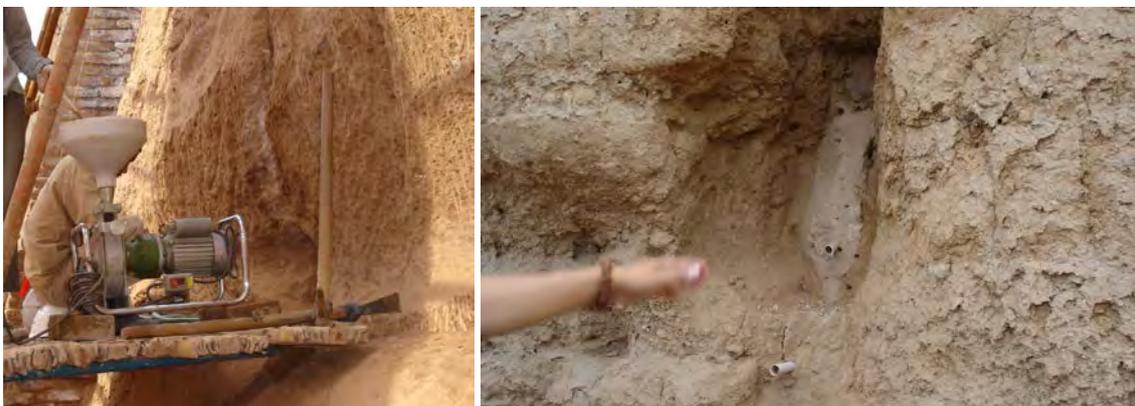
Figure 8: Voids filling with lime earth mix (photo by Li, Y. , personal information)

The injectability, setting time, shrinkage, compressive strength, adhesion between soil and injection grouts of all groups have been tested. The results showed that only the Group D and C can set within reasonable time and injectable. However the mixture of loess soil with quick lime shows less shrinkage than the mixture with cement-based soil stabilizer. The compressive strength loess soil and quick lime ranged from 0.36-0.39 N/mm<sup>2</sup> after app. 35 days, lower than the compacted loess soil, but water resistant. This formulation has been optimized and applied to a pilot trial area in 2007-2008(Figure 8), the results will be evaluated after 1-2 decades.

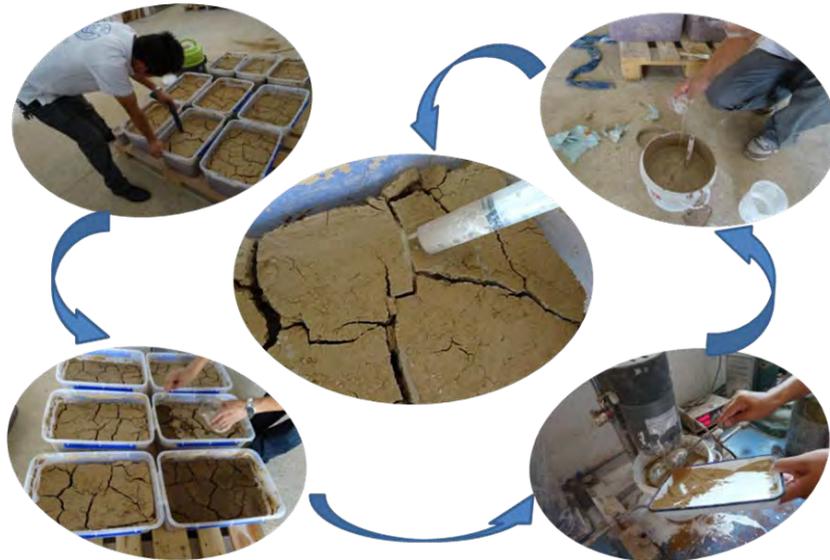
Figure 9: Performance testing of three types grouts into earth cracks simulated to ruins

Three formulations are compared (Table 2). All three grouts are injected with help of syringe into cracks simulated to Grand Bao En Temple ruins. The preliminary results showed that the mixture of modified NHL plus sieved soil adheres well to the earth substrate. The flow property of NHL mixture is also more satisfied than others.
