IN-PLANE EXPERIMENTAL TESTING ON HISTORIC QUINCHA WALLS

Keywords: Quincha, racking test, timber frames

***Abstract.** The historic centre of Lima contains many large residential buildings known as casonas, constructed during the Peruvian Viceroyalty and early Republican periods (1542-1850). The ground floor walls of a typical casona are constructed with adobe, while the upper storeys are built using quincha. Quincha is a traditional Peruvian construction technique consisting of a timber frame infilled with a weave of canes and mud. Although it is widely believed that quincha has positive seismic properties, little experimental data is available to quantify this numerically.*

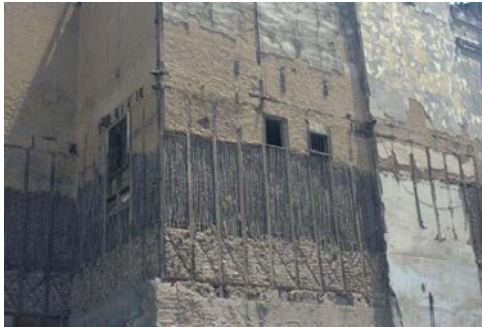
Quincha is a technique found in historic buildings in towns and cities along the coast of Peru. It is comprised of a timber frame infilled with a weave of canes covered with mud and plaster (see Figure 1 and Figure 2). Although a rudimentary form of quincha was used prior to the arrival of the Spanish, the technique was developed and altered extensively between the 16th and 19th centuries. The technique reached its peak after the 1687 earthquake, when a law was passed ruling that quincha must be used for the upper storeys of any building greater than a single storey in height [1]. Today a number of these buildings survive, most dating from the 18th and 19th centuries, with quincha in the upper storeys, and the first storey in adobe or fired brick, but many are in a state of deterioration and their numbers are dwindling.

Figure 1: Exposed quincha on a building in central Lima

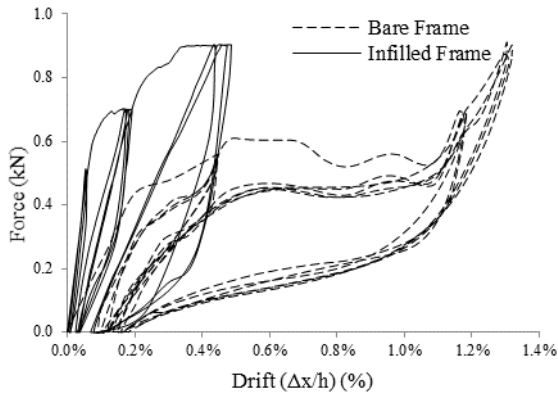
Figure 9 compares the load-drift curves of the infilled and bare frames for the stiffness phase. The hysteresis loops for the infilled frame are quite wide, indicating that it is dissipating a large amount of energy through small cracking in the mud, and friction between mud and frame. This is confirmed by Figure 10, which shows the cumulative energy dissipated by both frames for the same lateral drift.

Figure 9: Comparison between the Stiffness Phase for infilled frame and bare frame

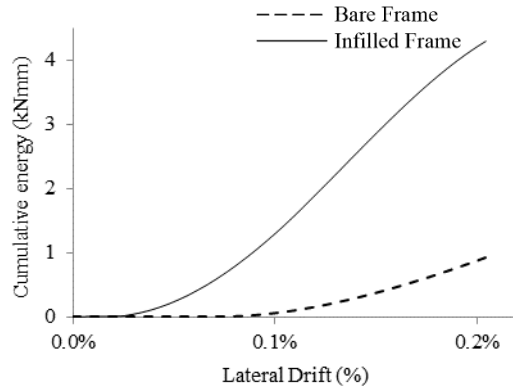
Figure 10: Cumulative energy dissipated for each frame vs. lateral drift for 0.9kN cycle 1.

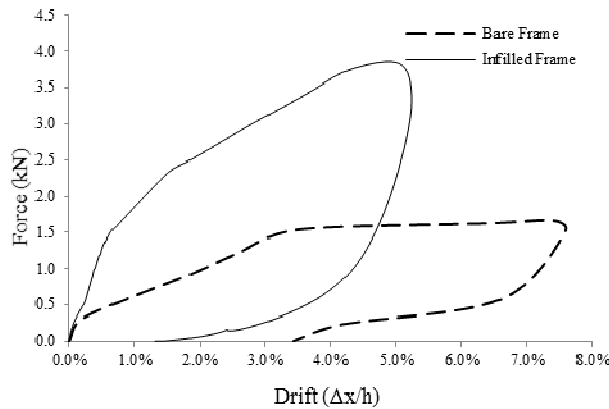
Figure 11 shows the load-drift curves for Phase 3 of both tests. The maximum lateral load taken by the infilled frame is 3.8kN, compared to 1.6kN for the bare frame. For the bare frame, after the initial 0.3kN load, the relationship remains linear up to a load of 1.5kN. Then the frame yields and has very little further uptake of lateral force, although lateral capacity is maintained up to a drift of 7.5%. The infilled frame maintains a linear relationship between load and drift up to a lateral load of 1.5kN, similar to the yield load of the bare frame, before the stiffness reduces. However, the stiffness does not reduce to the same extent as the bare frame.

Figure 11: Comparison between the strength phase for Frame A1 and A2

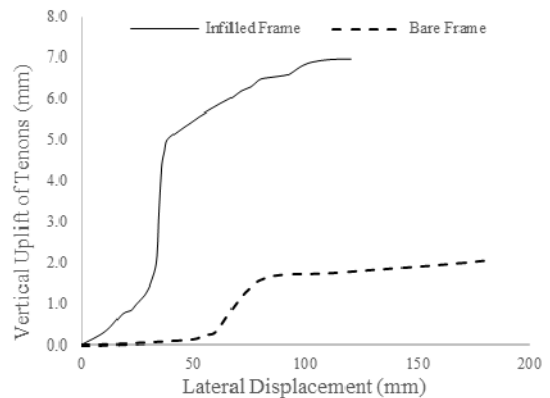
Figure 12: Vertical displacement of the post against lateral force for Frame A1 and A2

A major difference between the two frames is the uplift of the posts (shown in Figure 12). The infilled frame behaviour is dominated by the uplift of the posts, while this is not the case for the bare frame. The maximum uplift of posts measured for the bare frame was just less than 2mm, whereas the same tenon on the infilled frame pulled out over 7mm for the same lateral drift. The angle between the posts and the top of the frame remained relatively unchanged for the infilled frame, with a maximum rotation of 5 degrees, as the infill restrains relative rotation between the beam and post. This is evidence of the prevalent shear deformation of the panel as a whole rather than the flexural deformation shown by the post in the bare frame, reducing the relative rotation between mortice and tenon. In this case, rotation of the posts is resisted by the infill, not just by the tenon, reducing the moment applied to the joint. The bottom tenons on the side of the load pulled out of the mortice while remaining straight. This indicates the formation of a global strut, and a corresponding enhanced response in shear, rather than in flexure, as was the case for the bare frame.

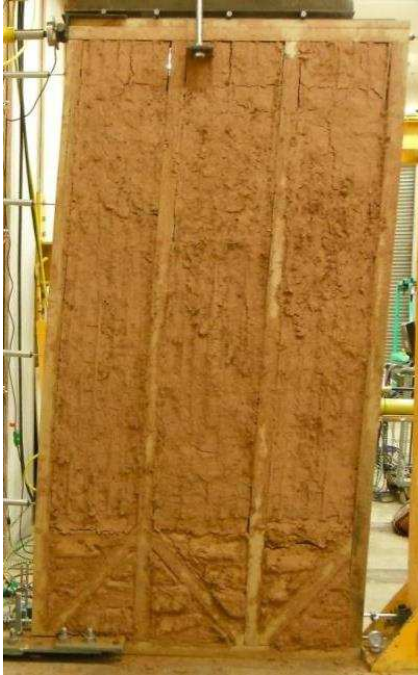
Figure 13: Frame A2 at 4.2% drift

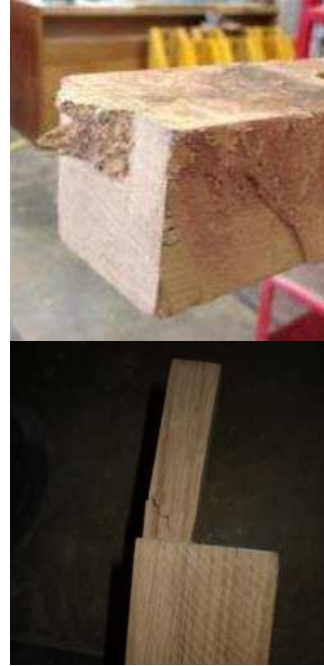
Figure 14: Failure of tenon in A2 (top) and A1 (bottom)

In both tests, a shear failure occurred in one of the top tenons (see Figure 14). This occurred for an estimated drift of 4.9% for the infilled frame and 3.0% for the bare frame. Since the failure occurred in the end tenons, which had been offset, further investigations should be carried out to assess whether this is a realistic failure mode that could occur onsite or exacerbated by the geometry of the tenon used in the tests.

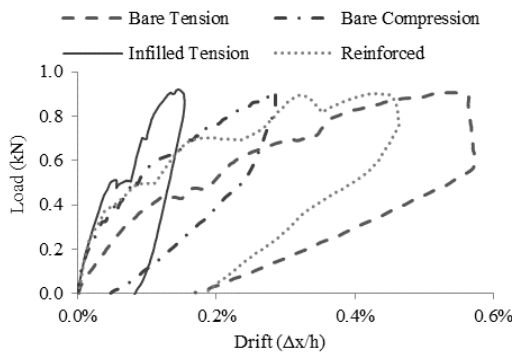
Four specimens representing Frame B were tested; an infilled frame with the diagonal in tension, a bare frame in tension, a bare frame in compression and a strengthened bare frame in tension. The strengthening involved fixing the mortice and tenon joints with an epoxy glue to prevent uplift. Figure 15 shows envelopes for four tests for the stiffness phase. Due to the diagonal brace, and its shorter height, Frame B is stiffer than Frame A and the maximum lateral

drift measured during the stiffness phase was less than 1%. It is also stiffer in compression than in tension and the reinforcement slightly increases the stiffness of the frame. All the tests had a residual drift of less than 0.2% after the stiffness phase, indicating that they were all still within their elastic range. Figure 16 shows the cumulative energy dissipation for each frame for the first 0.9kN cycle. The infilled frame dissipates more energy than the bare frames, but up to a 0.1% drift, there is little difference in energy dissipation between the strengthened frame and the bare frame in tension, as any energy dissipated by friction in the tenons is not accounted for at such a low drift.

Figure 15: Envelopes for four tests.

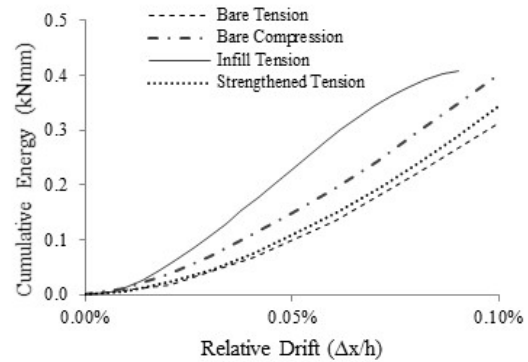
Figure 16: Cumulative energy dissipated for each frame vs. lateral drift for 0.9kN cycle 1.

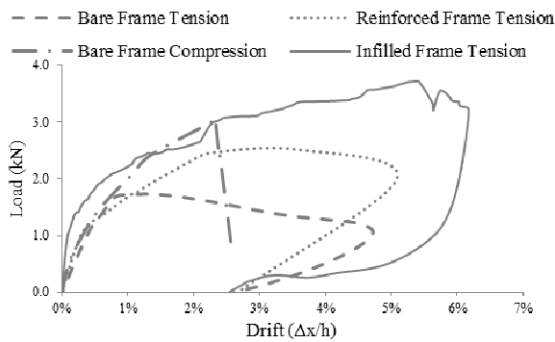
The strength test load-drift curves for all frames are shown in Figure 17. The infilled frame has the highest capacity and the highest initial stiffness. The bare frame in compression has a higher yield strength than the same frame in tension but buckled suddenly at a drift of 2.3% and had no residual capacity. Failure of the frame in tension occurred due to gradual yielding of the nails or timber at the diagonal connection. No tenons were damaged in any of the tests.

Figure 17: Comparison between the Strength Phase for all frames

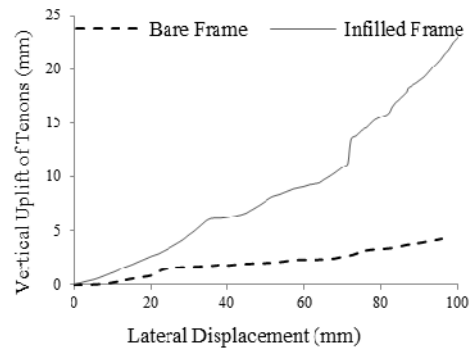
Figure 18: Vertical displacement of the post against lateral displacement for specimens B2 and B3

Figure 18 shows the relationship between lateral displacement and vertical uplift of the posts. The external post of the infilled frame uplifts a distance 4 times larger than the bare frame for the same lateral displacement. This is because the infilled frame behaves more like a rigid body, rocking as the external post lifts up, rather than deforming in flexure like the bare frame. This is further demonstrated in Figure 19 and Figure 20 which show the deflected shapes of both frames for the same drift. The post closest to the load is relatively straight for the infilled frame, whereas for the bare frame it is bowing outwards. The diagonal has much more of an influence on the deflected shape in the bare frame and it is bending itself and causing bending of the internal posts. The external post on the opposite side of the load is bowing outwards, showing that it is in compression, in the infilled frame while it has a slight S shape in the bare frame.

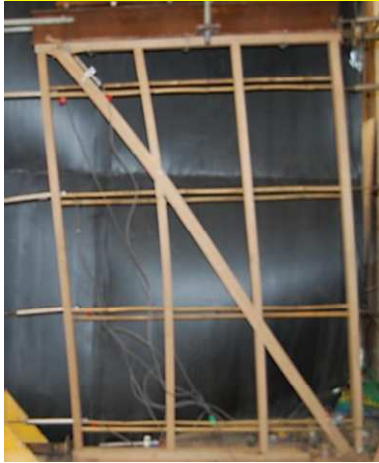
Figure 19: Frame B2 at 5% drift

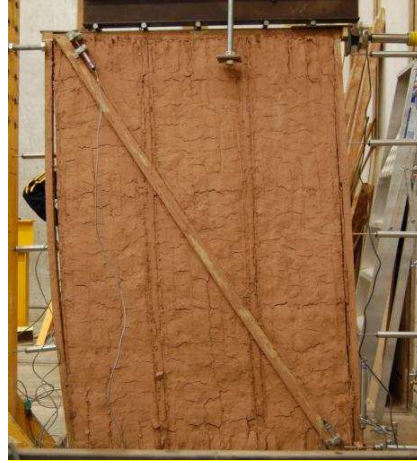
Figure 20: Frame B3 at 5% drift

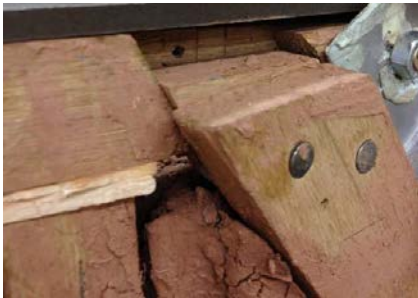
In all tests, failure occurred in the diagonal connection (see Figure 21). Due to the additional depth of the top beam later observed onsite, it is thought that the connection that exists in reality is slightly stronger than was represented in the tests. Assuming that the timber members are all in good condition it is believed that the most likely failure mode involves the diagonal moving downwards along the groove in the top beam, and yielding of the nails as shown in Figure 22.

Figure 21: Failure of diagonal connection in test B3
