HISTORICAL CONSTRUCTION IN ERZURUM IN EASTERN ANATOLIA

Keywords: vernacular constructions, tie beams, Erzurum, Anatolia, Turkey, conservation

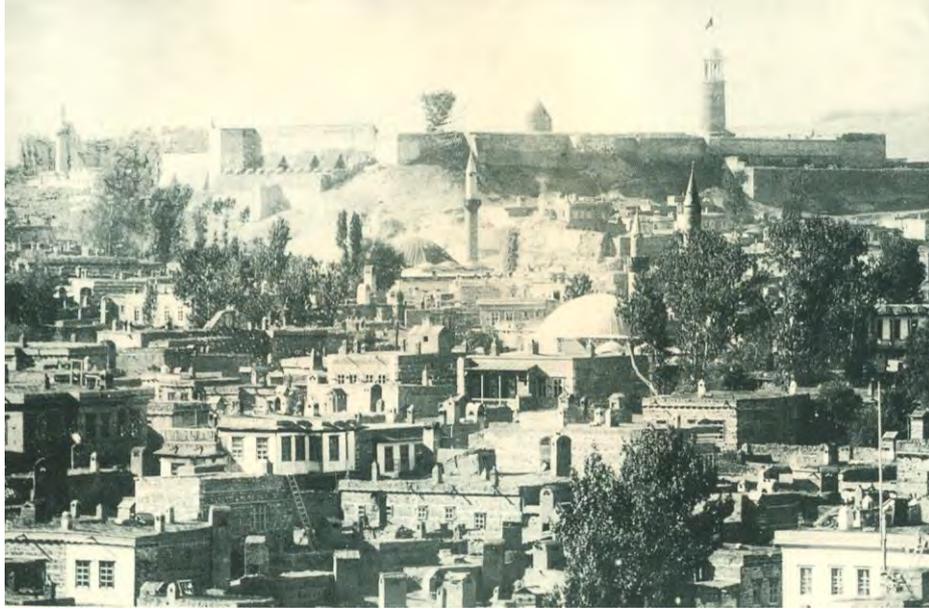
Figure 3: An old photograph of Erzurum Castle in 19th and traditional houses in 19th century [4].

The vernacular settlements are surrounded the castle which is historical ruin that belongs to Byzantium 5th century A.D. Another the most important historical place is Twin Minarets Madrasa (Çifte Minareli Medrese) whose construction traces back to the 13th century. Also near this madrasa many traditional houses are existed. The other neighborhood of the city we can see many historical houses.

According to 2010 data of Erzurum Cultural Heritage Preservation Board there are 91 traditional houses in the list included 340 properties. Mostly remaining structures are dated to late 1850s. The number and date of the houses are related to massive earthquakes damaged the city and its surroundings through the century [4].

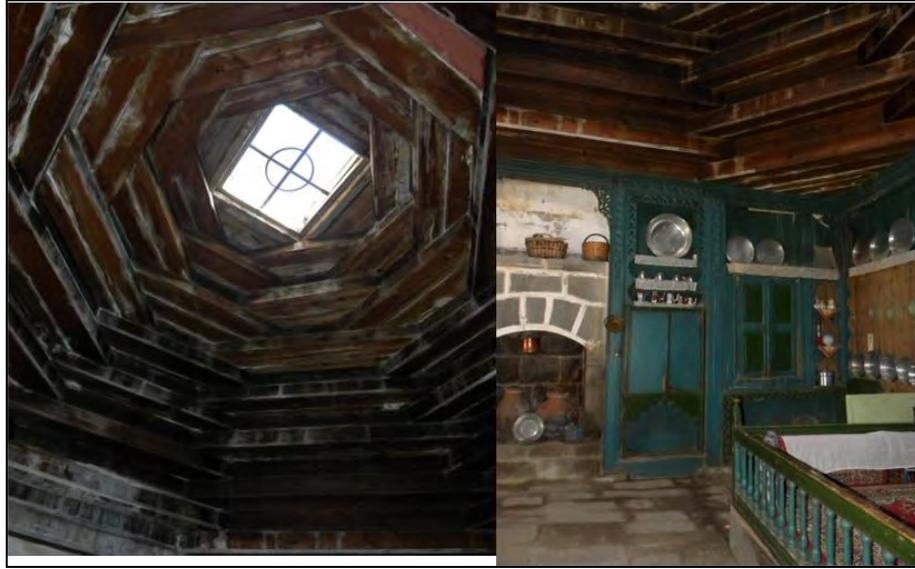
Figure 4: the tandir space and its special roof that is called kirlangıç (İnan, 2012)

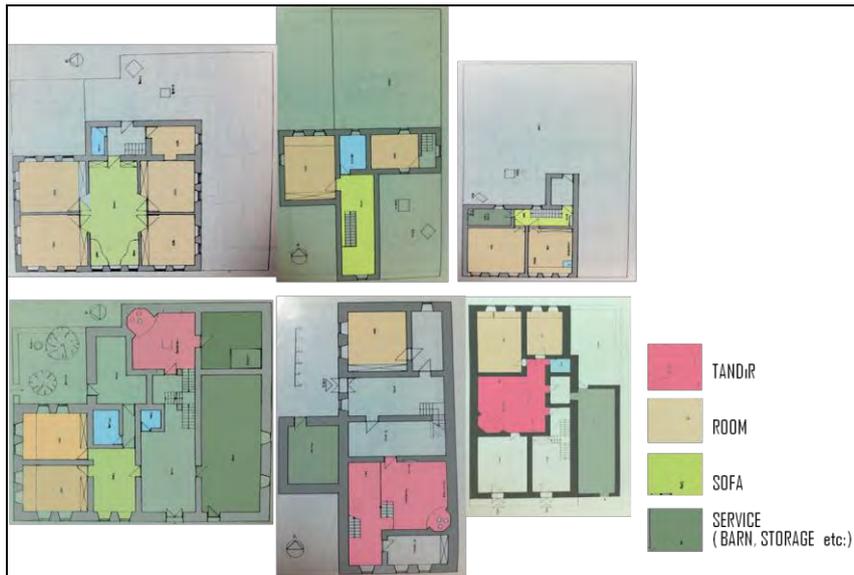
Figure 5: three example of Erzurum Houses plans [4].

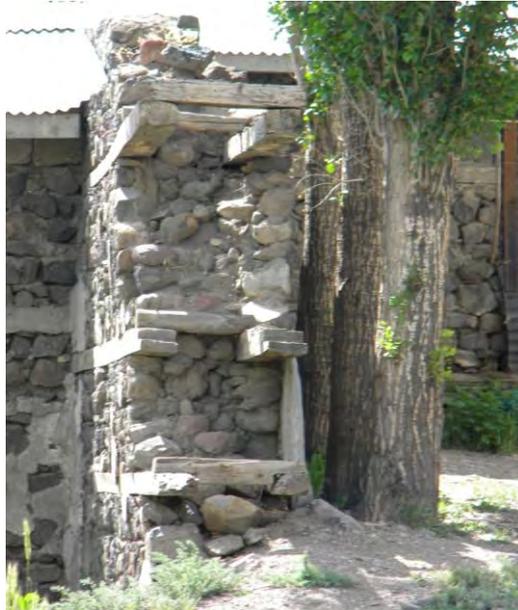
Figure 6: The runner beams at the wall (İnan, 2010)

wall. Generally the rubble wall as construction type is seen. Actually it is also deal with rich host or not. For qualified construction the coinage stone was used. Thereby many wall construction types are seen Erzurum vernacular houses. The type might be change ground storey and first storey or there is no change at two storeys. But the usage of tie beam is seen at every kind of wall. These beams are called hatıl. They are placed several level of the wall. This topic is detailed at 3.5 and 4.2.

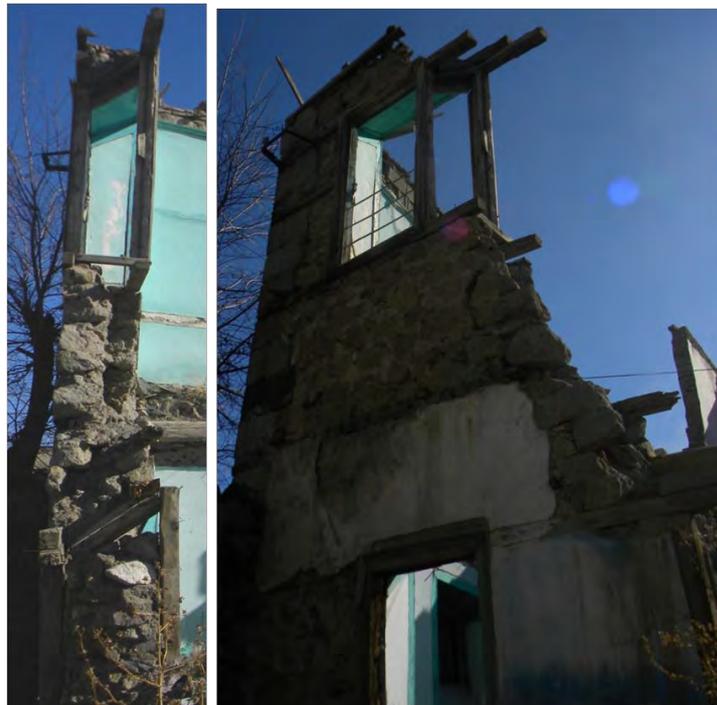
The thickness of the wall at ground floor is approximately 90-100 centimeters. It becomes 50-65 centimeters at first floor. Interior space the partition walls are made of brick and their thickness is about 20-25 centimeters.

Figure 7: the section of the wall (İnan, 2011)

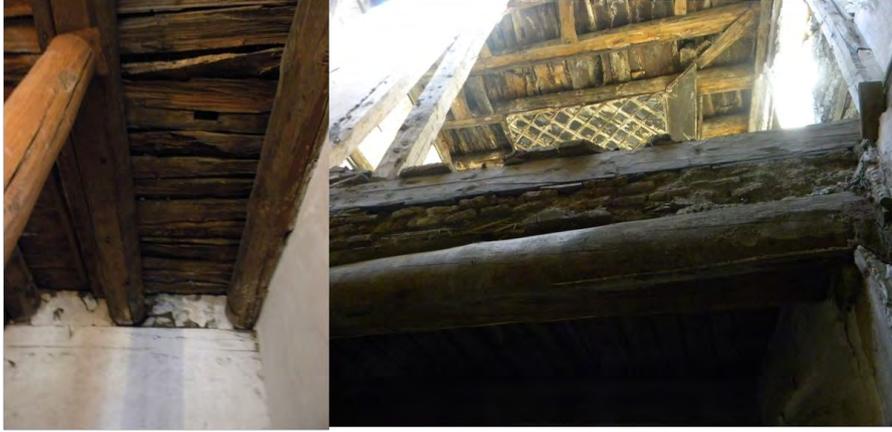
Generally in Erzurum traditional houses ground floor covering is stone at courtyard and hall and wooden at rooms. At upper ceiling the wooden beams as support element pass the space. The secondary beams located on the beams more often. In the mezzanine floor the bricks were used over the secondary beams. It is seen some examples.

Figure 8: The section of mezzanine floor, it is composed of wooden beams and bricks (İnan, 2010)

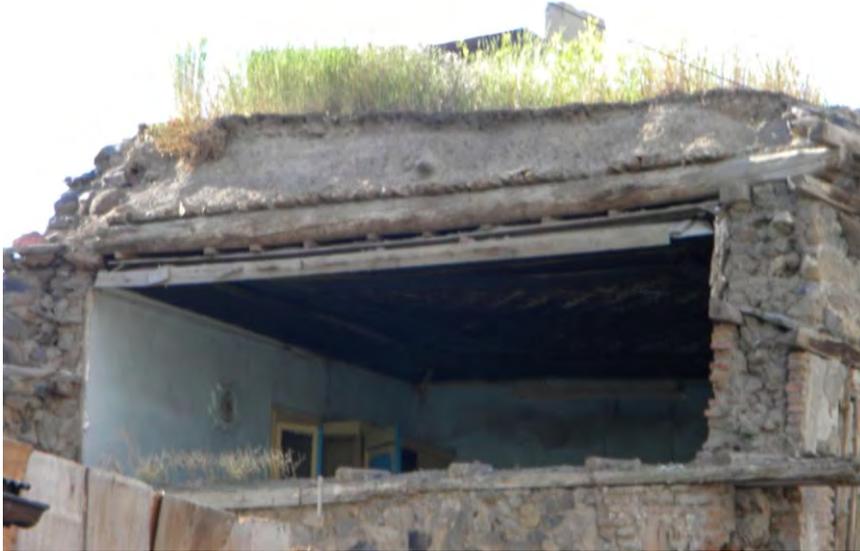
The last ceiling was finished as falt roof. Layer of land fill with clay was over the wooden beams. This layer is about 30 cm. James Justinian Morier who came to Erzurum at 18th century, described the traditional houses were covered with green grass because of vegetation top of the roof.

Figure 9: The layer of flat roof (İnan,2010)

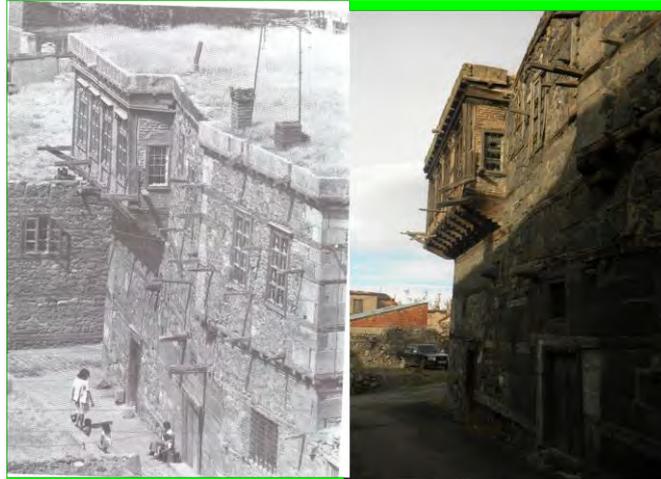
The runner beams are positioned aligned with the edges of the walls. While the runner beams are parallel to the wall, a perpendicular position to this alignment another timber element is used. It is known as püştüvan traditionally. This element links the runner beams and prevents separating from each other. This construct is bedded in the walls regularly. The distance between two püştüvan is approximately 1 meter. Also the tie beams placed at every one

meter level vertically. Sometimes this distance changed. At some examples it is measured 90-130 centimeters.

Figure 10: Only for Erzurum as a peculiar feature, püştüvan was extended approx. 50-70 cm. from out edge of the wall. It is used as scaffold during maintenance

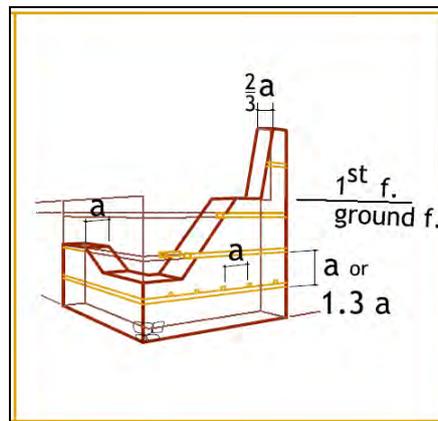
The wall thickness is compared with the distance between two tie beam and püştüvan. According to this; if the wall thickness is defined as 'a', the level of tie beams generally 'a', rarely '1.3 a'. Also the linking wooden element was placed 'a' distance. It means the wall thickness would be a unit to determine the distance tie beams and püştüvans.

Figure 11: The diagram of proportion between wall thickness, tie beam level

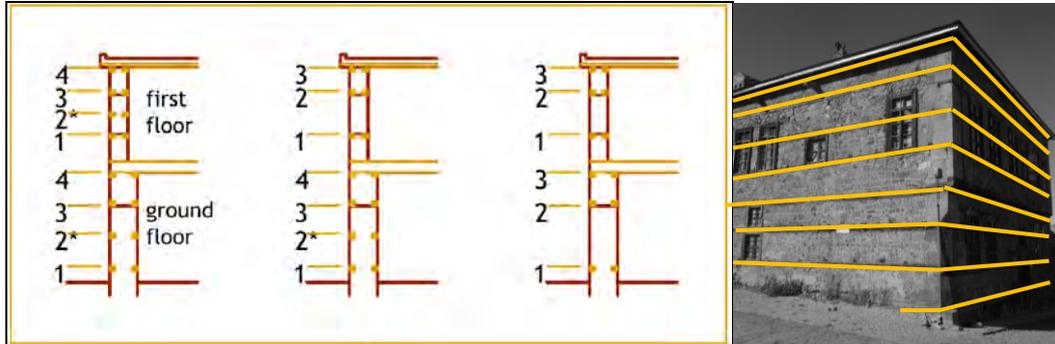
The figure shows us the placement of tie beams at the wall. All levels are defined. According to this;

For ground floor

- 1; below the door
- 2; middle of the door or if there is any window, its down level
- 3; up of the door.
- 4; under the ceiling

For first floor

- 1; under the window
- 2; middle of the window
- 3; up of the door
- 4; under the roof

The level called 2 for each storey is not used a few examples. Except of number 2, all of levels are seen at every traditional house. The position of tie beams deals with the distance of them. Although the tie beams cannot continue at middle of the window, it is seen at level 2. It would be a standard for using at every 1 meter level.

Figure 12: the schema shows the placement of the tie beam at masonry wall

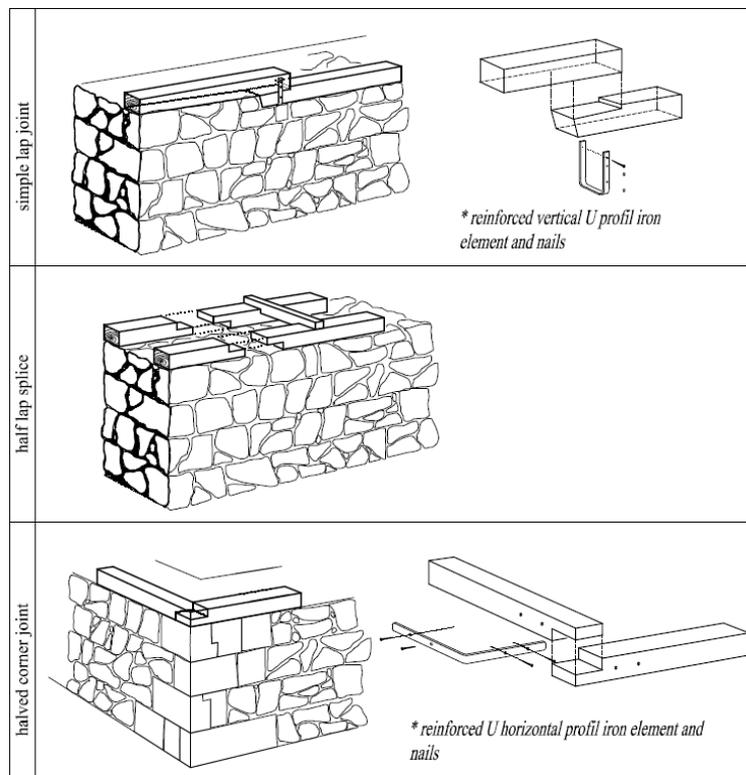
There are two types for combining to wooden tie beams at the same plane. Generally the beams are in same alignment using joint of half lap splice. Also joint of simple lap joint is seen at examples tie beams overlapping the each other. Also in some examples there is iron retrofit around the point of combine.

Figure 13: The classification of the joints which are used at Erzurum Traditional Houses (İnan, 2013)

Combining at corner, always same detail; halved corner joints are used. Commonly iron retrofit around the corner is seen.

Where the required the continuity of the wooden which has a limited length, the elements must be joined together. It is studied that how combine two wooden element which their fibers in the same direction. According to their position it is classified as the corner joints and plane joints.

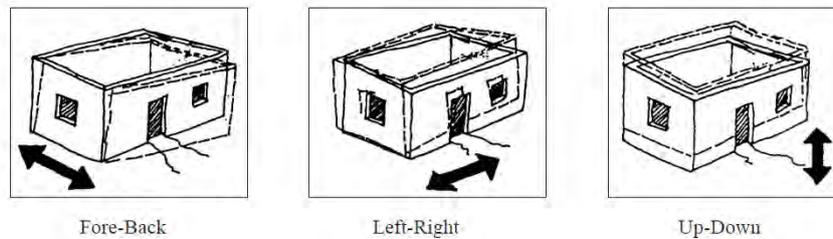
Figure 14: Ground Shaking

Typical damage observed consisted of generalized cracking of the masonry walls, especially between openings and in corners, leading to loss of the superficial plaster and sometimes

causing localized collapses in poor cornices and above window lintels. Floor collapses might have been triggered by out-of-plane deformation of walls and subsequent loss of support for the floor beams [7].

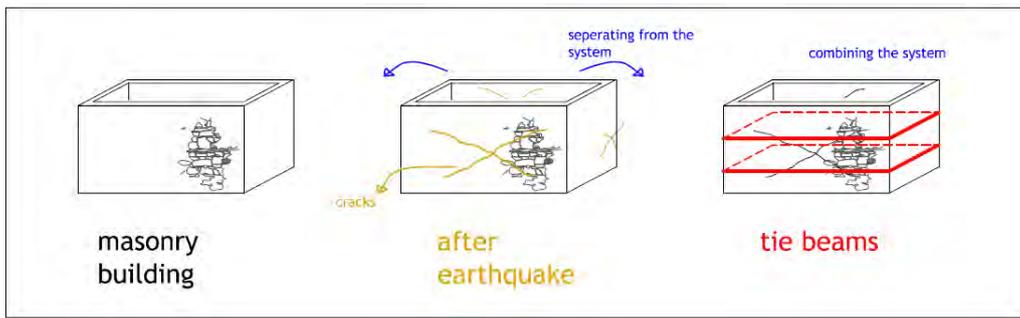
Also usage of tie beams is so important against vertical or horizontal ground movements like earthquakes. The seismic behavior of masonry building during an earthquake generated vibration strongly depends upon how the walls are interconnected and anchored at the floor and roof level. In the case of masonry building where the walls are not interconnected with help of timber, the individual walls tend to separate along joints or intersections.

Figure 15: effect of earthquakes and situation when tie beams are used [7].

Usage of tie beams is so important against vertical or horizontal ground movements like earthquakes. The seismic behavior of masonry building is improved when walls are connected together by means of timber tie beam. In this case, vibrations of the walls are synchronized. The building behaves like a box and all the walls contribute to the resistance of building. Coinage stone at corners and iron retrofit at connection enhance the strength of masonry wall.

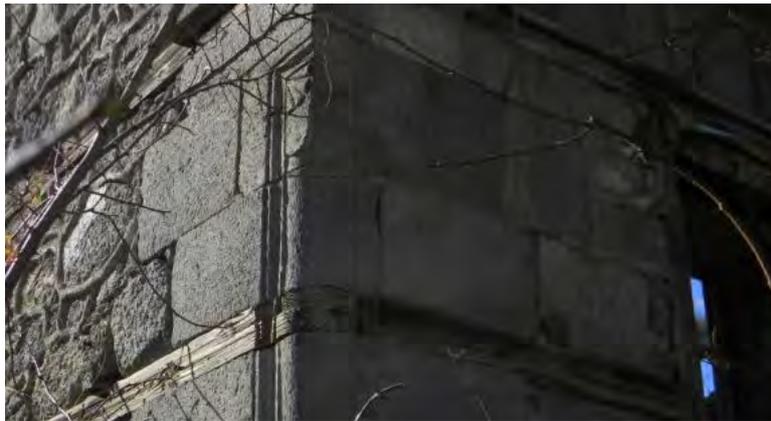
In every kind of wall the tie beams were used in. never usage of tie beams would not given up. Even the houses have ornaments, tie beams are used also they are applied according to decoration.

Figure 16: the tie beams are shaped according to ornaments (Inan, 2011)
