SAHC2014 – 9<sup>th</sup> International Conference on  
Structural Analysis of Historical Constructions  
F. Peña & M. Chávez (eds.)  
Mexico City, Mexico, 14–17 October 2014

## STRUCTURAL CONDITIONS REPORT IN TAMBO COLORADO, AN INCA SETTLEMENT IN PERU

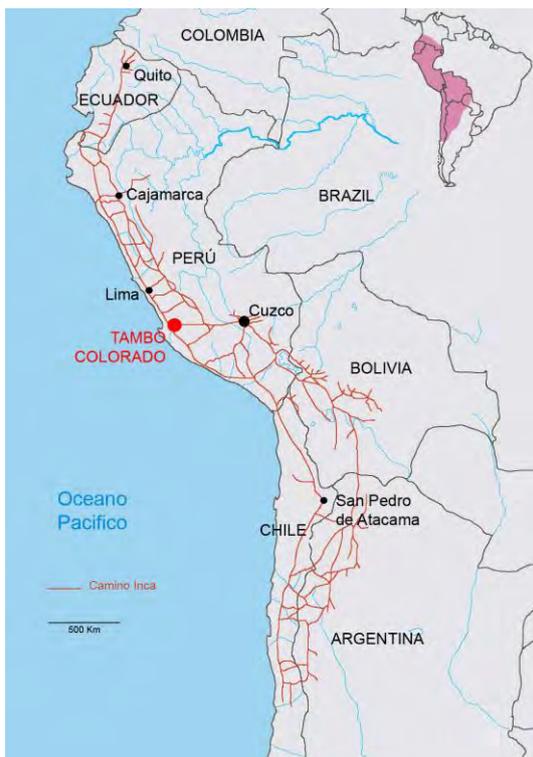
Figure 1. Tambo Colorado location in the Inca empire map (1) and the archaeological complex plane with the North Palace I (2), where the project was focused.

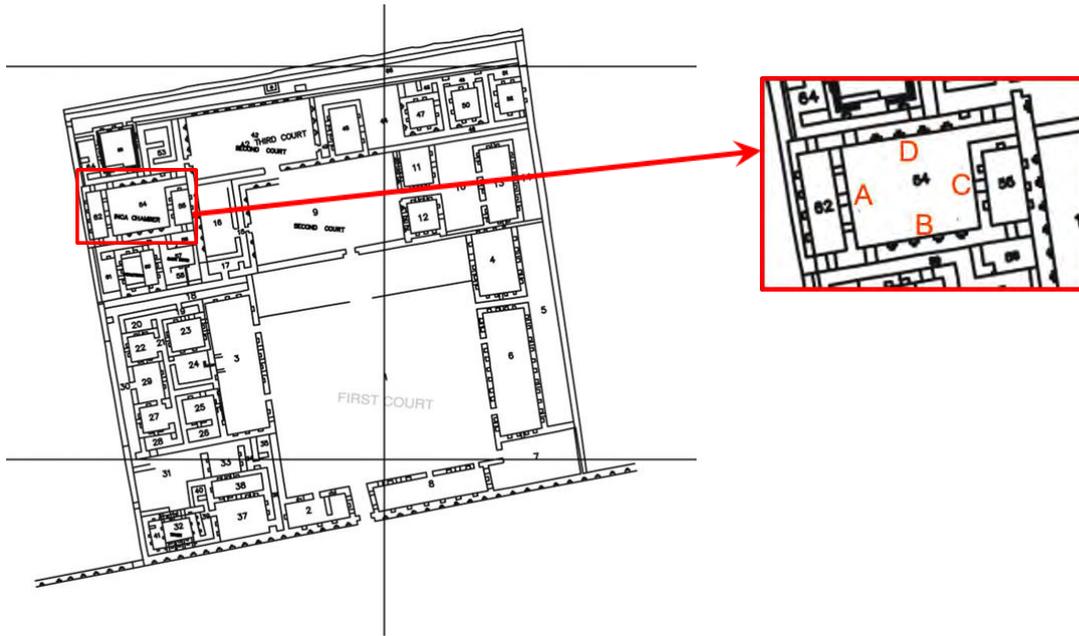
Figure 3. North Palace I (according to Uhle 1901), it shows the letters code system for each wall of the rooms according to damage level. Letter A indicates the wall that needs priority intervention.

All the team work walk together through the 66 rooms of North Palace I, area that has been choose for its condition, color display and architectonic complexity. By using a plan of the site (Uhle 1901 in Protzen J., 2010), were marked the walls that needed to be preserve urgently, these chooses were done according to a list of priority where the structural damages were consider the most important issue, followed by the presence of wall painting and lastly the presence of significant graffiti (with possibility of colonial date). Letter "A" was used for the most damaged wall and B, C, and D for the walls less damaged or in-teresting (Fig. 3).

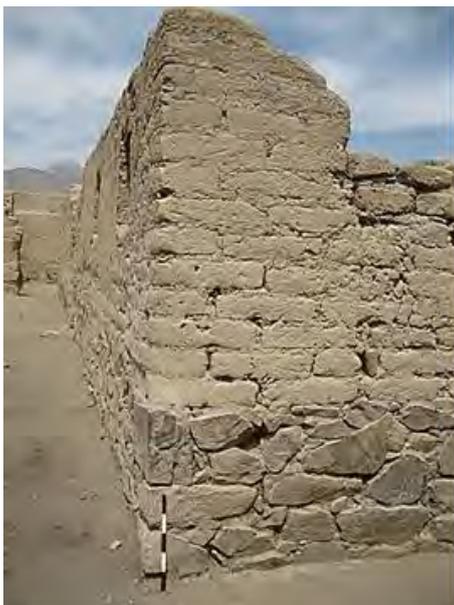
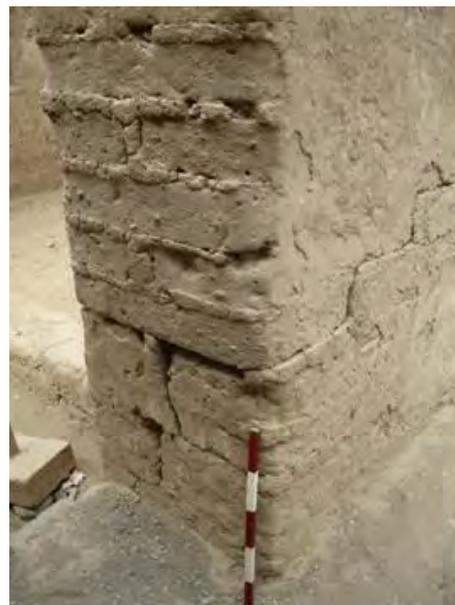
The architectonic complex North Palace I, was built completely with adobe masonry. These adobes have a quadrangular shape and heterogeneous measures, there is no archaeological evidence about the adobes production, but it's possible to establish the use of molds on manufacture (Fig. 4). The walls width is between 65 and 95 cm, and has from 2.40 to 3.00 m heights. Most of the walls' bases were made with stones; the rooms have remarkable niches presence, as well as windows and trapezoidal entries.

Figure 4. Details of the masonry of the archaeological site (© PRTC, 2013).

The adobes used on walls construction have different sizes, and were made with molds. There are adobes 52 cm long, the mortar between each adobe is 2-5 cm and they don't have vegetal fibers or any other additive. The walls' bases are usually built with stones and mortar, and their height is variable.

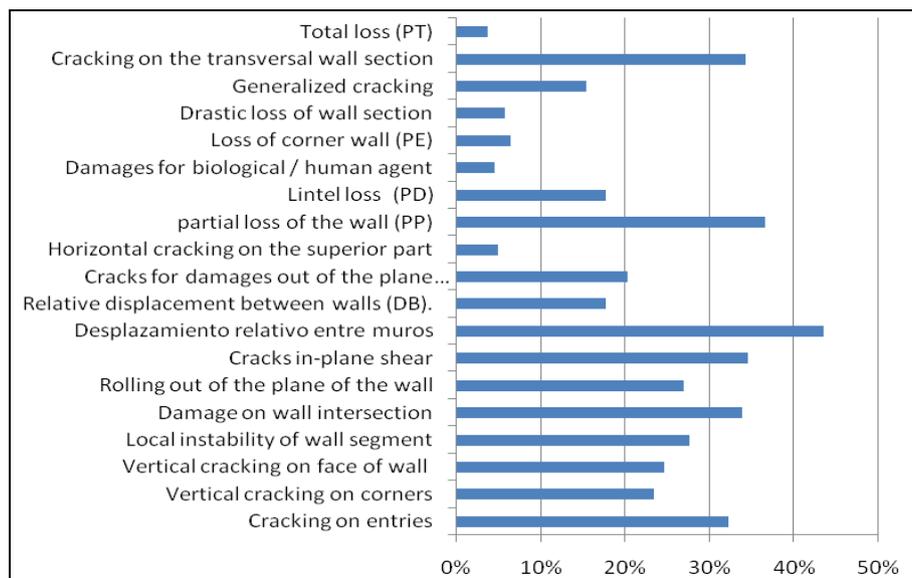
The pathologies records results show that: 35% of the walls have cracks in-plane shear, 37% have partial loss and 34% of the walls have cracks in the cross section. These pathologies show the archaeological site serious condition and demonstrate that is necessary to take corrective actions to reduce in short-term the risk of loss of the structures of the archaeological site (Fig. 6).

Figure 6. Record of pathologies in Tambo Colorado.

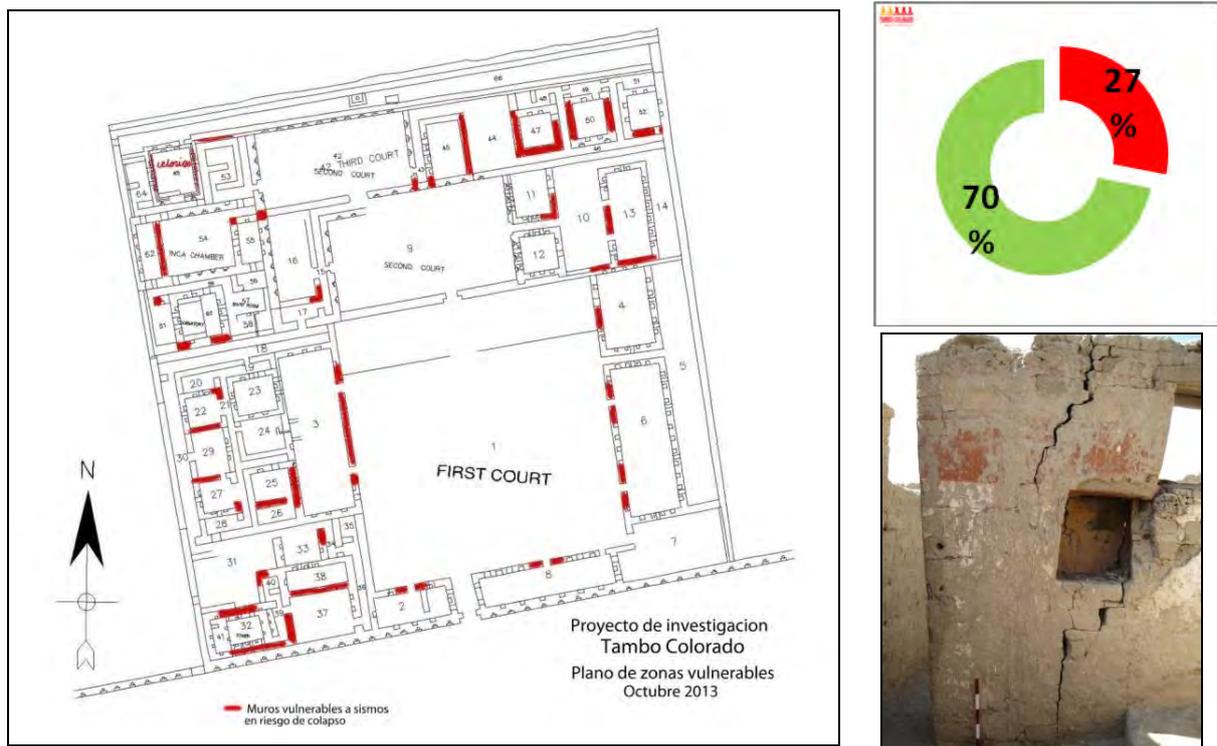
Finally it was made a map of the vulnerable areas with walls or wall segments that have serious collapse risk and that its fall could represent a serious risk to visitors, this plane also allowed us to establish that visitors access from the patios to the enclosures should be restricted in order to safeguard the integrity of the people and the building.

Figure 9. North Palace I vulnerability it shows enclosures with walls in risk of collapse (© PRTC, 2013).

In the other hand, thanks to the first results of the condition assessment, the authorities of Peruvian Ministry of Culture, based on the vulnerability map, has recently restrict the tourism access to the areas diagnoses as the most damages and with collapse risk. This sets an important step on the site conservation, due to the fact there were no protection action taken before.

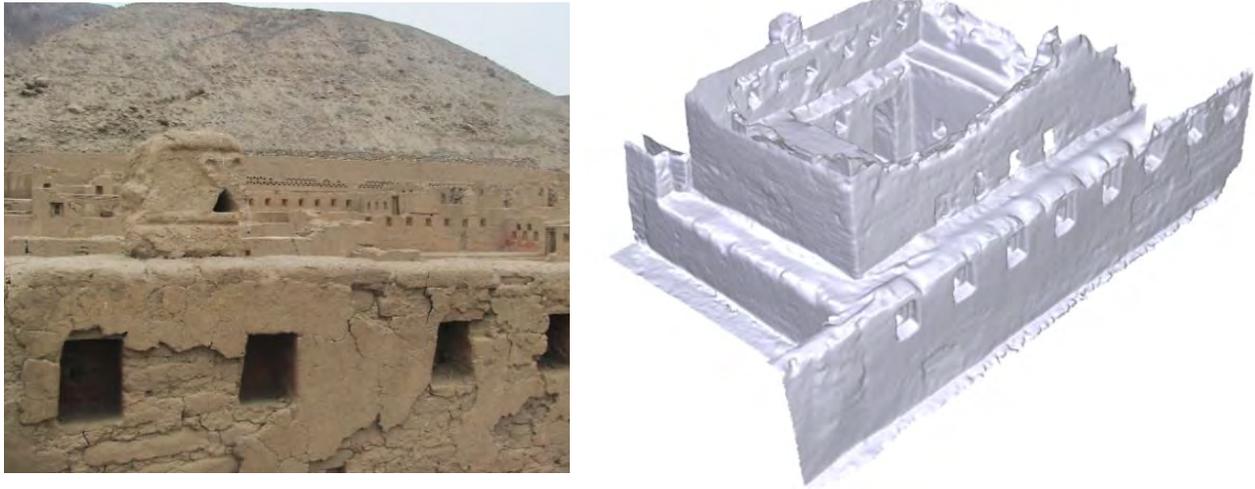
All the data acquired from the condition assessment work, lead us to understand that the area known as the “Torreón” of the North Palace I (rooms 32 and 41) (Fig.10) is the most vulnerable and must be intervened urgently. The photogrammetric survey on this sector gave us the opportunity to record appropriately this area and plan the first stage of our future work.

Figure 10. *Torreón* photography and 3D photogrammetry survey. This area was diagnosed as the most damaged, and will be treated priority (© PRTC, 2013).
