STRUCTURAL EVALUATION OF MASONRY VAULTS

The implementation of the analysis procedure is shown in a case study that evaluates the structural behavior of the former temple of St. Augustine in the city of Zacatecas, Mexico.

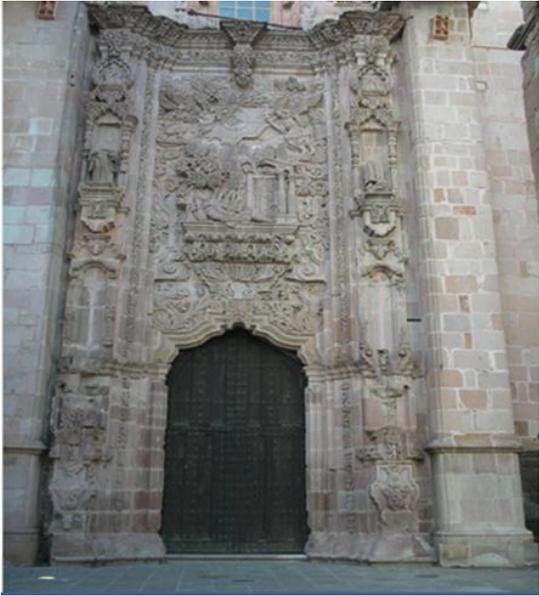
Figure 1: Lateral facade in the north side.

The Saint Augustine ex-temple has had several uses: it was temple, hotel, used for housing and currently is used as art-gallery. During these stages the building suffered different modifications that damaged its walls, the ornamentation in the facades and its structural elements. The aforementioned historical antecedents are explained in detail: 1) the vaults and domes have an age of 232 years counted from the year of 1782 at the conclusion of the construction work of the new temple; 2) apparently to build the new vaulted roof, the original walls were used strengthened with external arcs supported by massive buttresses. Now, the buttresses have ceded due to the thrust of the vaults, this has put the roof system in a situation of risk.

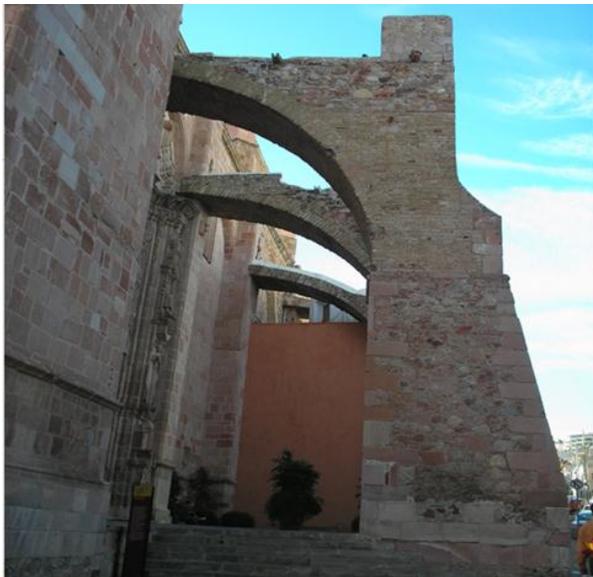
Figure 3: Buttresses in the north wall.

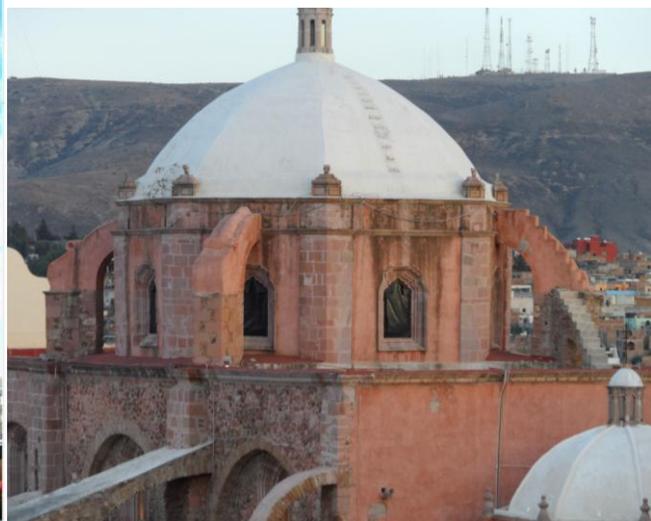
Figure 4: Exterior view of the main dome.

The form of the architectural plant is of a Latin cross. The nave measures 12m x 35m and 17m in height. The inside of the transept measures 25m x 8m. The sacristy is located on the western edge of the temple, and measures 20m x 8m. Figure 2 shows the main facade, it is smooth and without ornaments because they were removed when the building was modified to be a hotel. Figure 3 shows the north facade strengthened with massive buttresses. An exterior view of the main dome is shown in Figure 4. The roof of the main nave consists of three lunette vaults with arches, see Figure 5. The main dome and its drum of lights are shown in Figure 6.

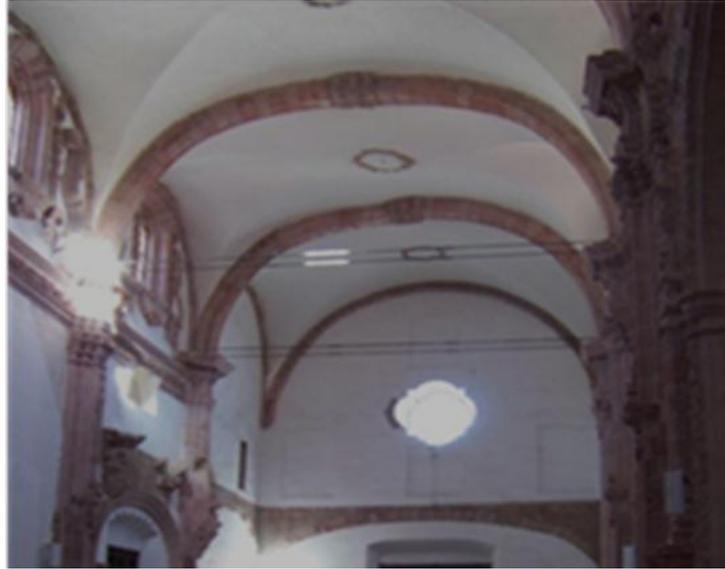
Figure 5: Interior view of the vaults and arches of the main nave.

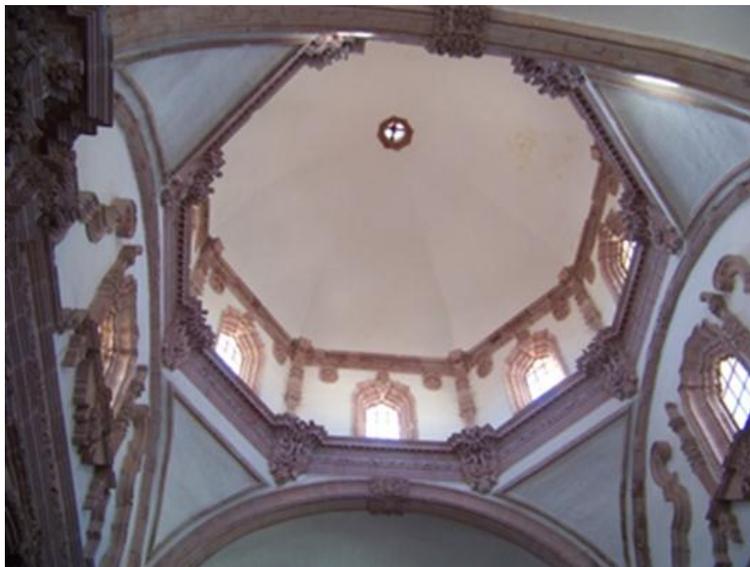
Figure 6: Interior view of the main dome and its drum of lights.

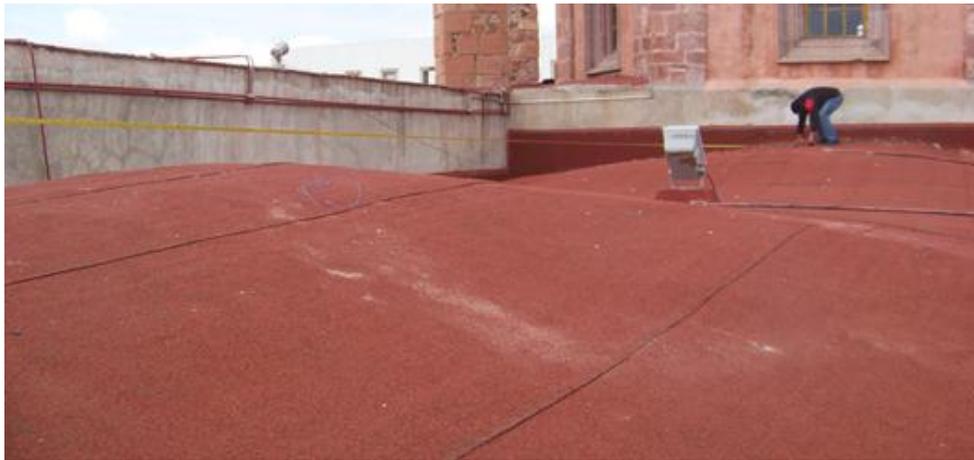
The main problems of the vault roof are its large vertical deformations and the lateral deformations of its supporting walls. Figure 8 shows a view of the exterior surface of the vaults as compared with the graphical representation obtained from the topographical survey. The graphical representation was evaluated using the MATLAB function **TriScatteredInterp** and plotted using the MATLAB function **surf**.

Figure 8: Above) photographic exterior-view of the vaults, below) graphical representation of the vaults obtained from the topographical survey. The deformed vaults are in red and the blue surface represents the assumed original surface when the vaults were built; the large deformations can be appreciated.

The exterior surface of the deformed vaults is in red; the two yellow lines highlight the larger deformation profile in the longitudinal and transverse directions. The blue surface represents the assumed original surface of the vaults, when vaults were built. The blue horizontal line shows the original profile of the keystone of the vaults.

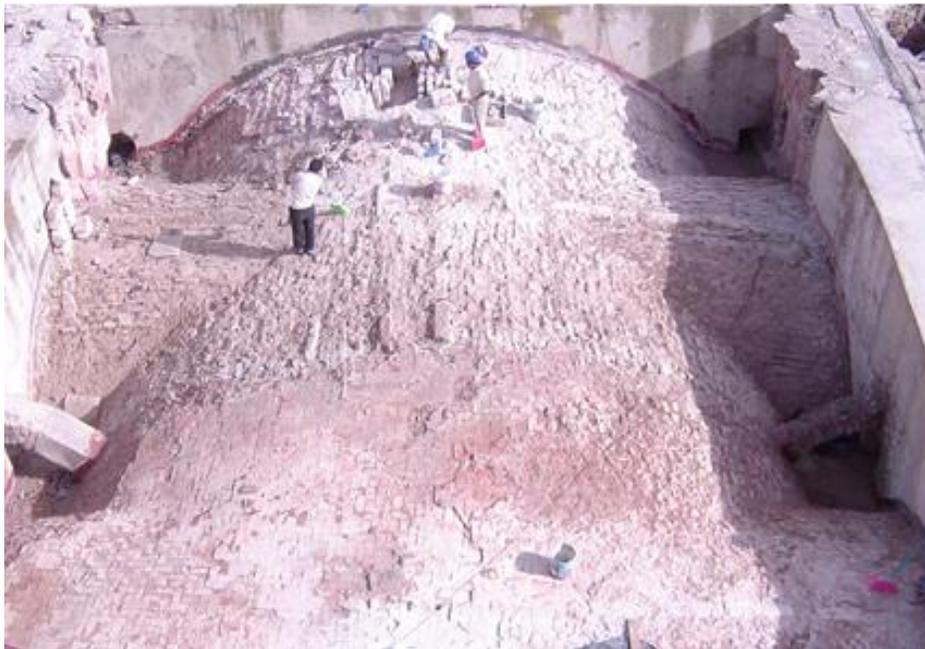
The state of large deformations has induced the formation of extensive cracks on the vaults as it is shown in Figure 10. From this figure it can be seen a large crack in the central vault and the replacement of the bricks in the first vault that had a huge crack in the border with the wall of the main facade.

Figure 10: Exterior view of the vaults when they were repaired on the start of the 1980 decade.
