EXPERIMENTAL CALIBRATION OF IN-SITU SAMPLING AND TESTING OF HISTORICAL MASONRY

Luca Pelà¹, Alice Peverini¹, Lucía Garijo¹ and Pere Roca¹

Keywords: Masonry, Mechanical characterization, In-situ sampling, Cylindrical cores.

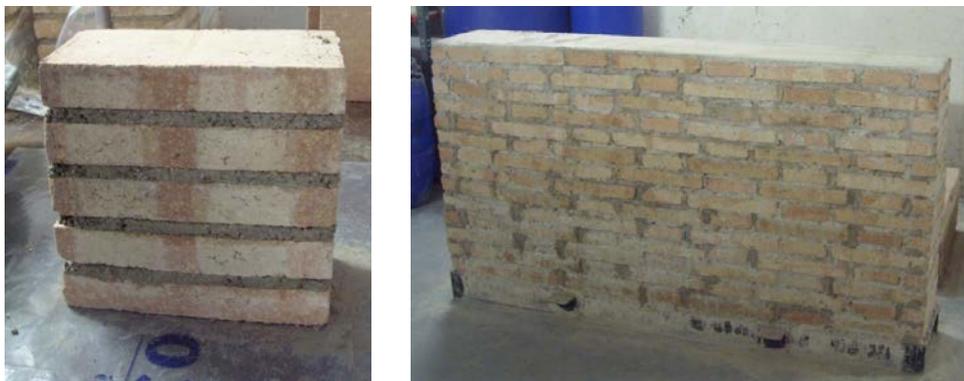
Three masonry stack prisms (see Figure 2a) were built using the materials described above. Each prism consisted of five stacked units separated by four mortar joints approximately 10 mm thick, resulting in a total nominal height of 280 mm. The lowest and uppermost bricks were coated with a layer of high-strength cement mortar, to ensure the flatness of the loading surfaces, as established by EN 1052-1 [5]. Immediately after the construction, the prisms were covered with polyethylene sheets for three days in order to prevent the premature drying out of the masonry during this time. Subsequently, the masonry was kept in laboratory conditions until it reached an age of 61 days.

Figure 2: (a) Stack prism and (b) wall used for core drilling.

A wall with dimensions $1.5 \times 0.75 \times 0.276 \text{ m}^3$ was built using the same materials adopted for the construction of the stack prisms. The Flemish bond was adopted, as shown in Figure 2b. The wall was built over a metal beam to permit its displacement during the following phases of the campaign. Care was taken to maintain a constant thickness of the mortar joints, each approximately 10 mm thick, and the planarity of bricks layers. At the end of the construction, a layer of mortar was placed above the last line of bricks, to permit the location of another metal beam, useful during the phase of extraction of specimens, and the wall was kept in laboratory conditions.

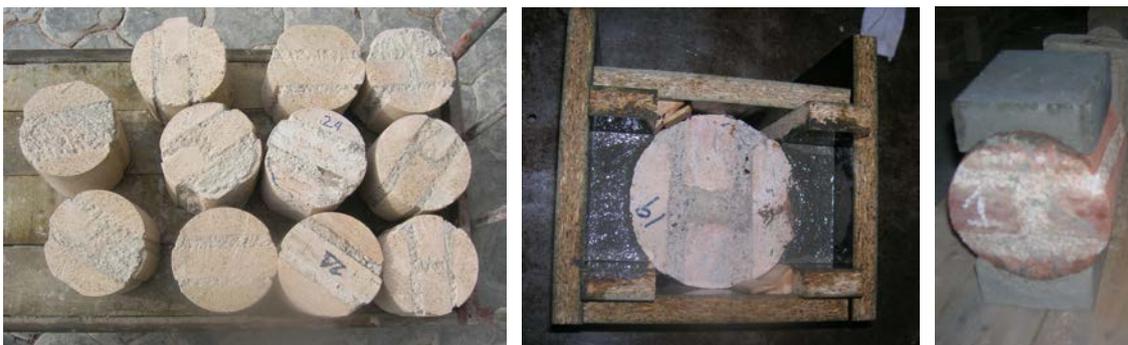
Figure 4: (a) Three and two joint cylindrical masonry samples, (b) mould used for the regularization of the specimens, (c) regularized specimen ready to be tested.

After the extraction, the cores were cut into two parts, obtaining two specimens of a length of 130 mm. A total of 6 samples with two joints and 5 with three joints (Figure 4a) were used to perform a non-standard compressive test. In addition to the compressive strength, the possibility of measuring the masonry Young's modulus and Poisson's ratio was also investigated.

Each specimen was regularized with cement mortar caps, using a wooden mould especially designed (see Figure 4b and Figure 4c). The purpose of this particular kind of regularization is to ensure an optimal transmission of the compression force from the testing machine to the specimen through a cap perfectly adherent, in order to avoid any stress concentration.

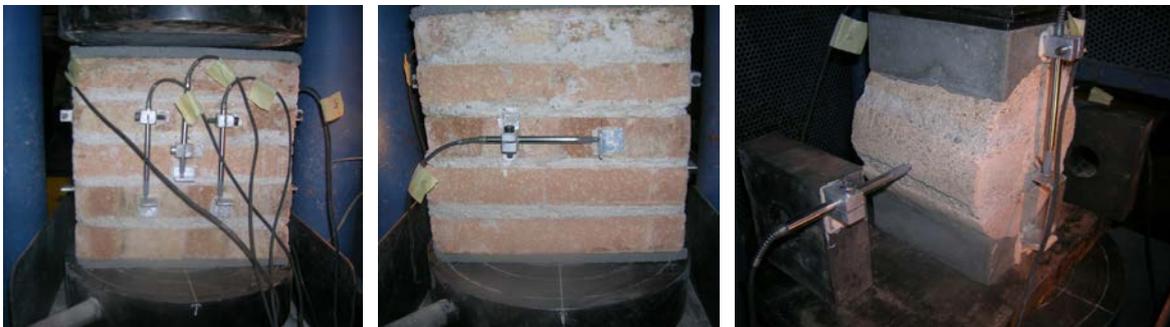
The three stack prisms were subjected to compression test, see Figures 5a-b. Six LVDTs were used to measure vertical and horizontal displacements. Five initial loading cycles under force control were executed in a range of load between 10 kN and 100 kN. The test was then performed under displacement control in order to follow the post peak response of the masonry. The load was applied at a rate of 0.003 mm/sec. The LVDTs were removed from the structure shortly after reaching the maximum load, so as not to be deteriorated.

The cylindrical specimens regularized were tested under compression. The UIC 778-3R recommendations [2] and previous studies [3,4] were taken into consideration to perform the test. The test procedure consisted of applying a compressive load on the regularization caps and perpendicular to the bed joints. Both the vertical and horizontal displacements were recorded through 4 LVDTs. Two LVDTs were disposed vertically, on the bases of the cylinder, attached on the caps of regularization mortars. Two other LVDTs were located horizontally along the diametral direction of the specimen, fixed on two metal supports, see Figure 5c. In all the tests the load was applied under displacement control, at a rate of 0.006 mm/s, until a very low level of residual strength, in order to follow the post peak response of brickwork. The tests were conducted at the same age of the compressive tests on stack prisms, i.e. at 61 days.

Figure 5: (a, b) Stack prisms and (c) regularized cylindrical specimen before the test.

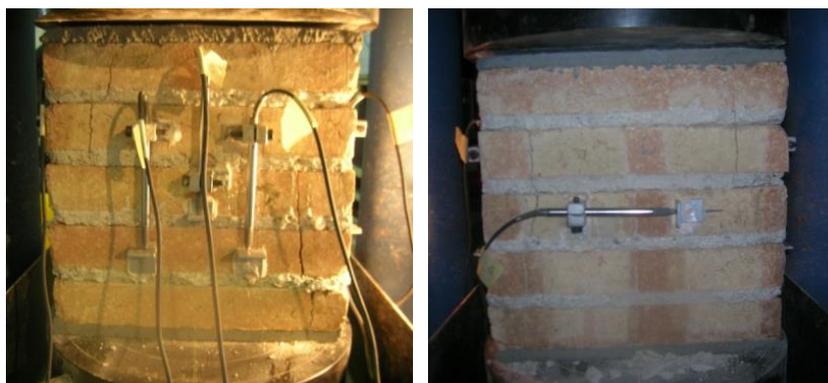
The cracking of specimens was predominantly vertical, as expected from a compression test, see Figure 7. Mortar joint expansion could be clearly observed during the test. The regularization cement mortar proved to be suitable, as it was demonstrated by its undamaged state at the end of the test.

Figure 7: Damage in stack prisms after testing.

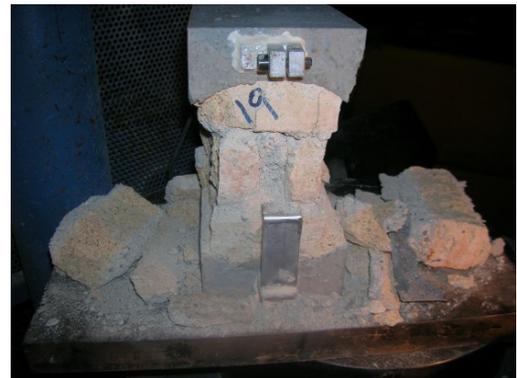
The vertical stress-strain curves of the cylindrical specimens with three joints and two joints are shown in Figures 8a and 9a. As for the three joint specimens, the experimental re-

sponses are similar. It can be noted an initial lineal behavior until about 15% of the maximum strength, followed by a change of slope, with a higher growth of deformation with the load increase. It can be observed the presence of a sudden fall in the initial loading branch, corresponding to the appearance of the first crack. After this point, the cylinder can still resist higher loads, until reaching the maximum compression load. After the peak stress, the unloading branch shows a deformation increase with the decreasing stress. The post-peak part of the curve presents an uneven trend due to the propagation of cracks across the specimen.

Figure 8: Stress-strain curves of three joint specimens (a) and mode of failure (b).

Regarding the failure mode, in both the three and two joint specimens it was essentially the same, as it can be seen in Figures 8b and 9b. The first crack was vertical and collinear with the edge of the upper and lower regularization caps. Then, the crack enlarged and a symmetrical one appeared in correspondence of the other edge of the regularization caps. Finally, the splitting of the lateral parts occurred. Comparing the observation of damage with the graphs in Figures 8-9 it is possible to deduce that such cracking process begins before reaching the ultimate failure load. At the end of the test, the remaining part of the specimen was a prism with upper and lower sections equal to those of the regularization caps, whereas the section at the middle height was smaller. In addition to this main damage, the specimens presented micro-cracks distributed through the cylinder. After testing, the remaining samples were inspected and manipulated and were found to be extremely damaged, which was expected from the fact that the test was continued until a very low level of residual strength. The regularization mortar caps were usually intact at the end of the test, see Figure 10a. Some specimens experienced the cracking of the edge of the cap due to the propagation of the vertical lateral crack previously mentioned, see Figure 10b. The detachment of the lateral portions of the cylinder at failure was also observed in previous studies [3,4]. Such type of failure was due to the lower confinement to which they are subjected, since the width of the regularization caps is lower than the diameter of the cylinder. Nevertheless, in the current study neither the opening of the vertical joint nor the net debonding between the brick-mortar interface were observed, as opposite to previous studies [3,4].

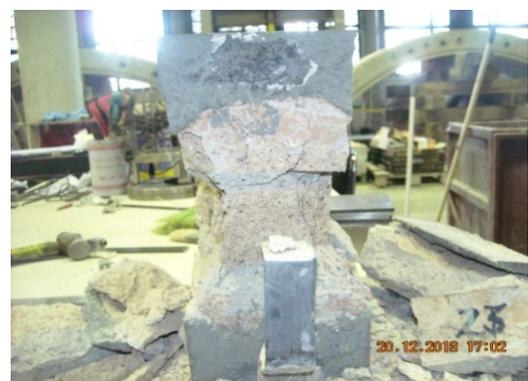
The curves of the two joint specimens show also similar overall trend, even if they differ in the initial response. The curves of the specimens 21a, 23a and 23b show an initial lineal behavior until about 15% of the maximum strength, while specimens 21b, 24a and 24b show an initial non-linear branch, probably due to an accommodation of LVDTs, followed by a linear branch until about 35-40% of the maximum stress. After this different initial part, all the curves show a change of tendency, with higher growth of deformation with the load increase. As in the curves of three joint specimens, it can be noticed a sudden fall of load which indicates the initiation of cracking and a subsequence strength recover until reaching the maximum compression load. Only the specimen 24b does not show a clear peak and descending branch. All the curves show an uneven trend after the first crack appearance, more pronounced than in the three joint specimens. The deformation increases gradually with the stress decrease in the unloading branch. It was not possible to evaluate the unloading branch of the specimen 21b because the LVDTs detached from the supports.

Figure 9: Stress-strain curves of two joint specimens (a) and mode of failure (b).

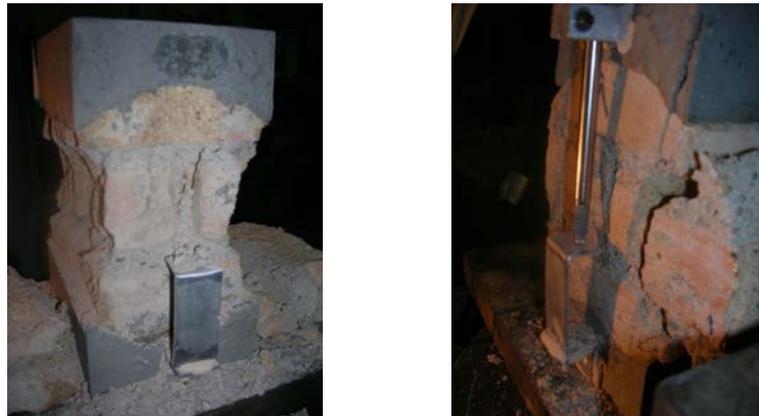
Figure 10: Typical regular failure at the end of the test (a) and failure with crack involving the cap (b).
