PRE-COLUMBIAN EARTHEN CONSTRUCTION TECHNOLOGY AND ITS APPLICATION TO CONSERVATION

Keywords: Earthen architecture, Bitumen, Humid Tropics, Preservation, Archaeology, Field test

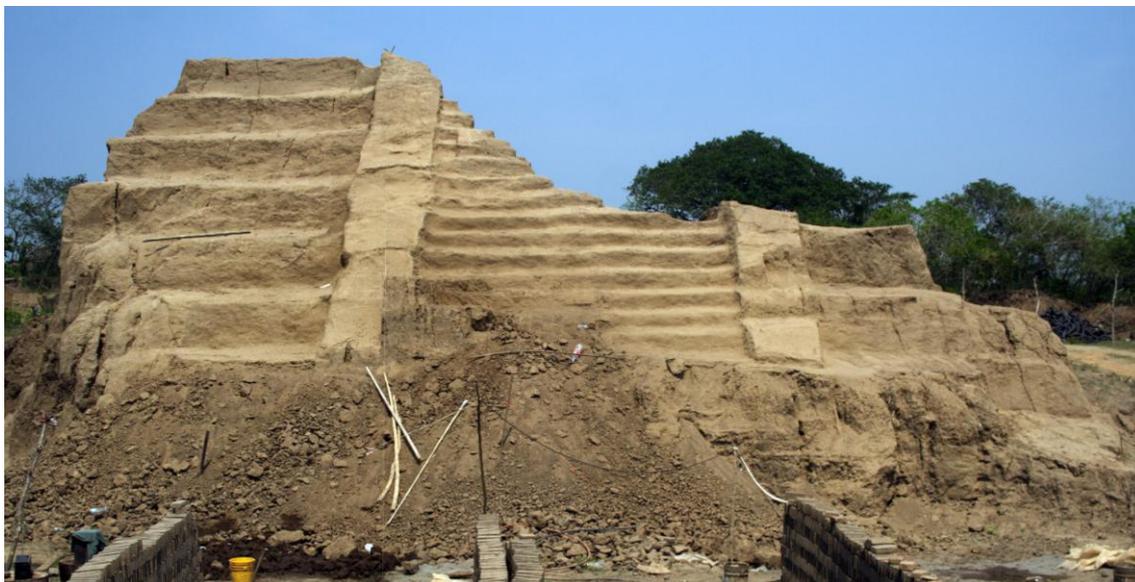
Figure 1: Pyramid of La Joya during the excavation process (Photo: Daneels, May 12, 2008).

The archaeological project at La Joya, begun in 2004 as a salvage excavation, took a turn with the discovery that the so-called archaeological “mounds” were actually monumental architecture conforming to the common Classic period Mesoamerican standards: stepped pyramids with wide staircases, palaces, shrines and ball-courts (Figure 1). Extensive excavations of three remaining buildings, a pyramid and two palaces (The North Platform and the East Platform) showed several technical solutions to control internal pressures of an amorphous material (Figure 2). The earliest fill system consisted in horizontal strata of stamped earth (loamy sand), covered by layers of sherds (to facilitate compression); the outer casing, in which the architectural forms were modeled (tiers, staircases), consisted of a thick layer of clayey loam. The lack of internal casing made for a squat building profile with 27° slopes, the angle of natural stability. A later, more effective strategy consisted of a superposition of large blocks of clay (more than 6 x 6 x 1 m) placed in a checkerboard pattern, with the intervening squares filled by sand; the clay contained the sand, while the sand controlled the expansion

and contraction of the clay blocks through the seasonal humidity cycles, and also allowed for a vertical and unimpeded drainage of pluvial penetration and evaporation of groundwater. This technique permitted a much steeper incline of the construction, with 45° slopes in the case of high buildings, like the 25 m high pyramid, or 80° slopes in the case of low platforms.

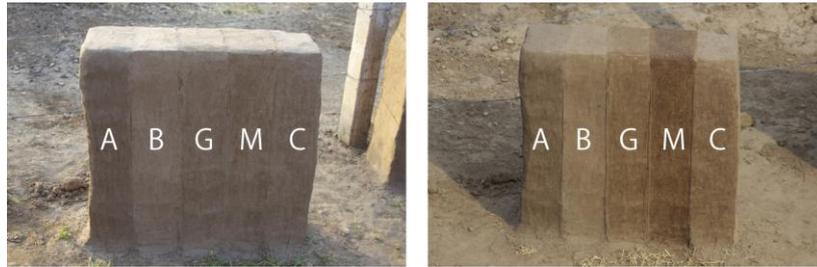
Figure 3: Oxidation of M (Mallow) and G (Guacima) renders a month later (Photos: Kita, March and April, 2013).

Test walls were completed in March, 2013 and in a month, strong sunlight oxidized the vegetable extracts and the color of renders (M and G) changed remarkably (Figure 3). The control wall (C) started to collapse with the first rains of July. The renders with vegetable extracts (M and G) were totally washed away in September. The renders and walls with bituminous products (B and A) resisted quite well to the tropic humid weather for a year (rainfall between March 2013 and March 2014: 1550 mm) (Figure 4).

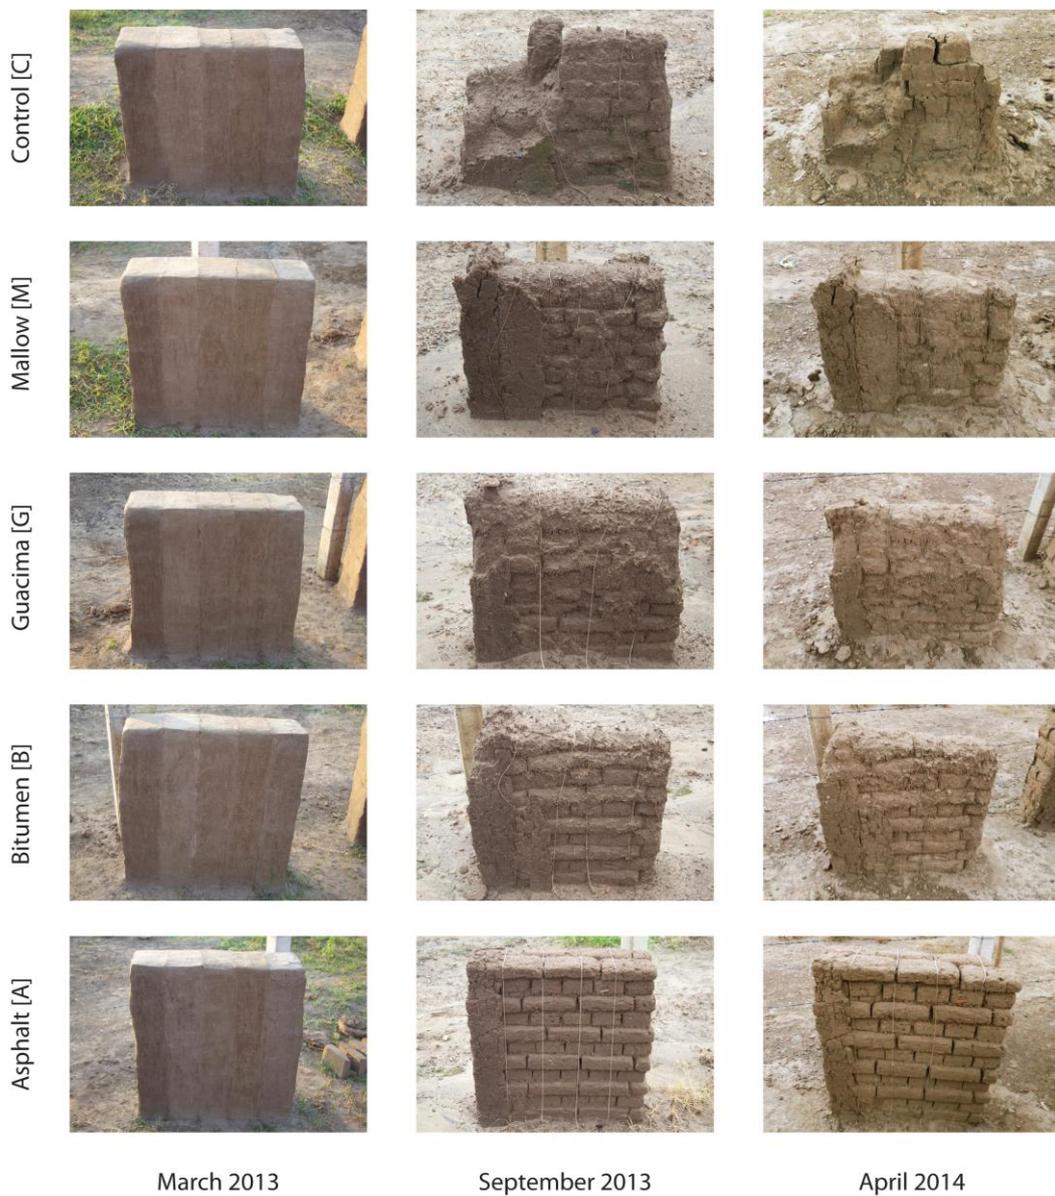
Figure 4: Monitoring of Phase 1 test walls (Photos: Kita).

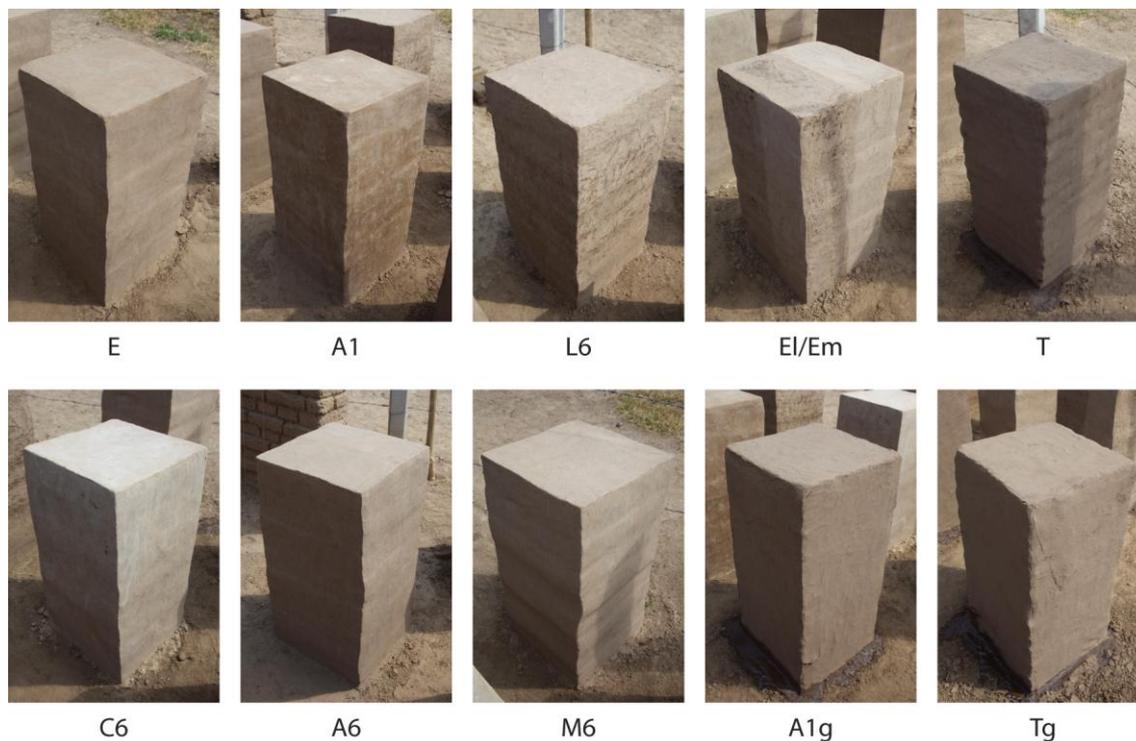
All the fine renders applied directly to the walls did not present deep cracks compared to the renders applied to the geotextile. The cracks on A1g and Tg were caused by the poor cohesion of geotextile to the wall, which needs additional applications of renders. (Figure 5)

Figure 5: Phase 2 test walls (Photos Yuko Kita).
