MECHANICAL MATERIAL PROPERTIES OF MARBLE AFFECTED BY HIGH TEMPERATURE CAUSED BY FIRE

The scope of the present study is, as a fundamental research, to describe the mechanical material properties of marble stones used for constructions of ancient Greek temples, affected by high temperature caused by fire.

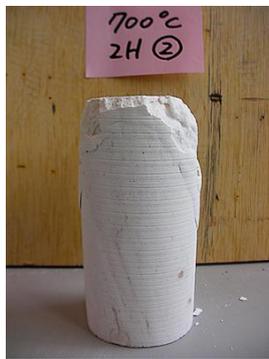
Figure 7: Deterioration of specimen with time. (After 60 hours from the end of heating at 700°C for two hours)

Apparent deterioration of the specimens at heating temperature of higher than 700°C was remarkably observed (See Fig.7 and 8). By heating the specimen over 700°C, such deterioration of the specimens were corresponding to the density reduction that was caused by chemical reaction given by Eq. (1). Moreover, deterioration of specimens significantly proceeded during exposing to the air after heating. For the test case of heating temperature at 800°C for 2 hours, a thin surface layer (thickness = 1-2mm) of the specimen was first exfoliated along the axis. Next, distortion was gradually caused at the inner part of the specimen and extended to whole. Furthermore, the surface layer of the specimen was separated at several parts of the specimen. During exposing to the air, the strength of the specimen was getting lower and finally reached to collapse, while cracks were developed.

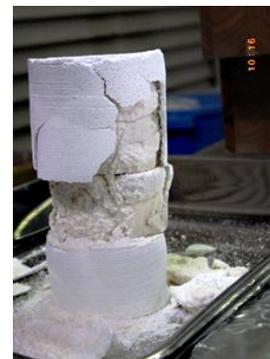
Figure 8: Surface layer of specimen exfoliated. (After 120 hours from the end of heating at 800°C for two hours)

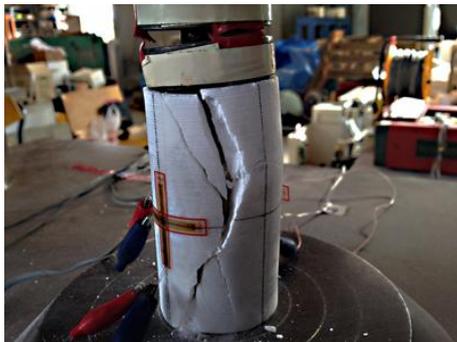
Figure 10: Failure mode (un-heated specimen)

Fig.10, 11 and 12 present the specimens after the compressive tests of the specimens of heating at and, respectively, in order to show the fracture mode. Most of the specimens showed shear failure mode regardless of degree of temperature, shown in these photos. However, there found a difference in failure characteristics between the heated and un-heated specimens as follows. The heated specimens suffered circumference cracks before compressive tests, which caused separation between inner cylindrical part and outer surface deteriorated

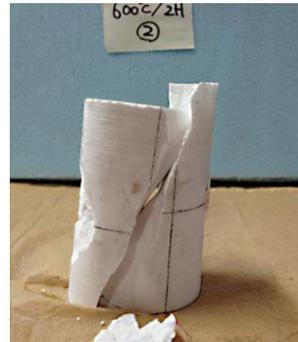
Figure 11: Failure mode (heated specimen at 600°C)

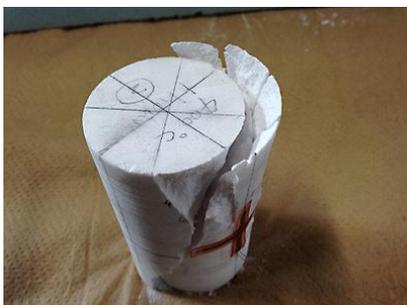
Figure 12: Detail of failure mode (heated specimen at 400°C)
