## PORTLAND CEMENT COCCIOPESTO MORTAR FOR REPAIRS TO OUTDOOR PAVEMENTS

**Abstract.** *Repairs to outdoor pavements at historic castles have been carried out with the use of mortar from natural hydraulic limes or cements prepared from aerial lime mixed with hydraulic sands, e.g. crushed slag. Modifications based on latent hydraulic materials, for example metakaoline, have resulted in mixtures with sufficient strength and appearance to be acceptable to the conservation authorities. However, they exhibit rather significant wear and limited frost resistance. New mixtures taking advantage of the properties of white Portland cement were therefore suggested by Mlázovský, and the durability and other material characteristics of this material were studied in the laboratory after one year of in situ application at Karlštejn, a Czech Royal Castle. For the mechanical characterization, the small sample-small specimen test methodology developed by Drdák was utilized, including the prolongation of short specimens for bending tests by means of prothesization. In addition to tests of other relevant physical characteristics (capillary water uptake, specific weight and surface wear by grinding), a c

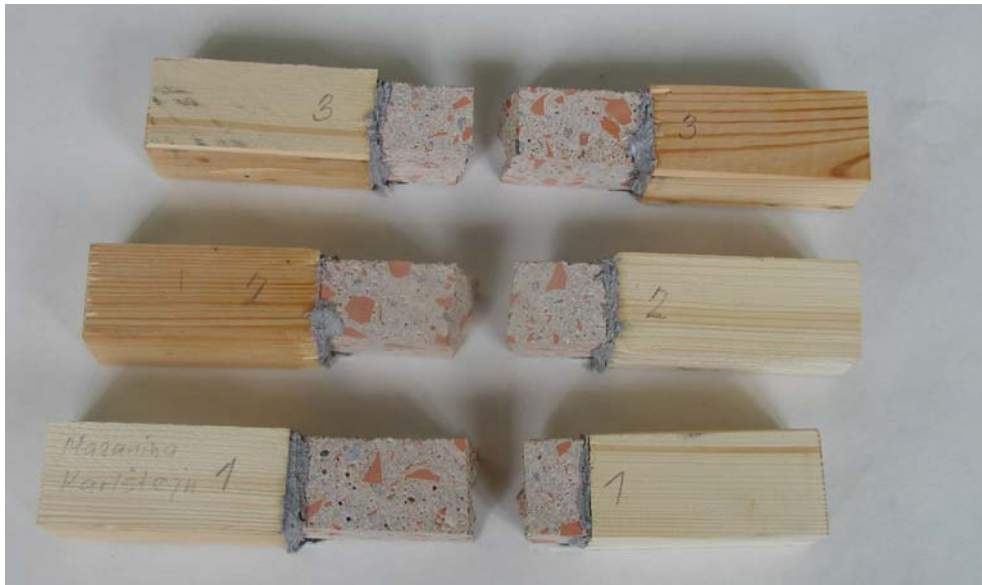
Figure 2: Test specimens after three-point bending tests.

The test results confirmed that the cocchiopesto performed very well. The mechanical characteristics are presented in Tables 2 and 3, and the specimens after bending are presented in Fig. 2.

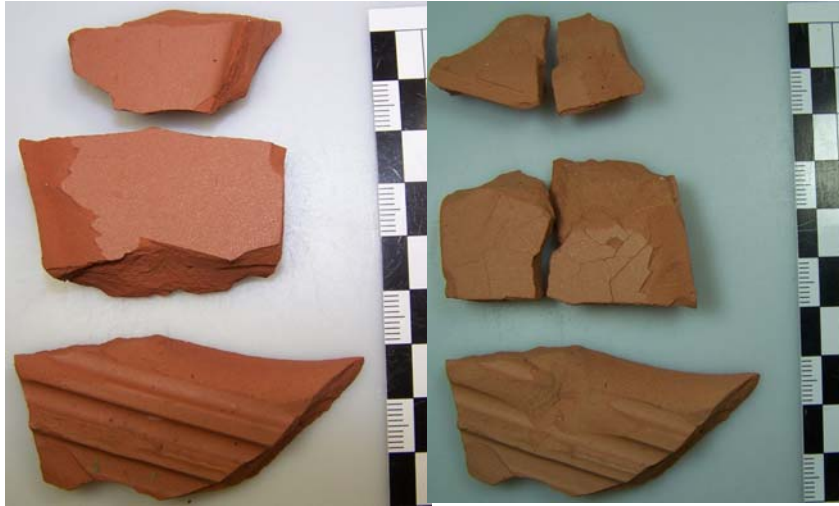
Figure 6. Brick specimens B1-B3 before (left) and after (right) 25 cycles of freezing/thawing tests.

Freezing/thawing had a much more severe impact on the brick specimens, which cracked and started to spall after the 3<sup>rd</sup> cycle. The more rapid degradation of the brick specimens is caused by several factors, namely material softening and loss of strength due to water saturation, the size of the pores and also defects that originated when the brick specimen was cut.

Figures 5 and 6 illustrate the state of the test specimens before and after the frost resistance tests.
