BEHAVIOR OF TEXTILE REINFORCED LIME COMPOSITES UNDER FLEXURAL LOADS

Erman Y. Tuncel¹, Işıl Polat- Pekmezci², and Bekir Y. Pekmezci³

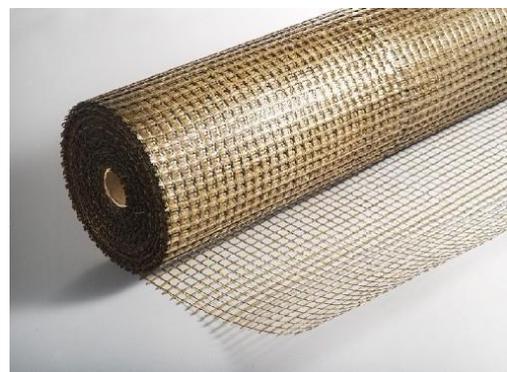
In the experimental study, two different type continuous fiber reinforcement textile material, glass textile and basalt textile, were used with a hydraulic lime-sand-pozzolan matrix. Unit area weights of glass and basalt textiles are measured as 145 g/m^2 and 180 g/m^2 respectively. Pictures of the glass textiles and basalt textiles used are given in Figure 1(a) and (b). For the matrix mixture, 0 - 400 μ quartz sand with a specific gravity of 2.61 g/cm^3 , natural hydraulic lime and pozzolan were used. Natural pumice powder finer than 200 μ particle size was used as pozzolan. The specific gravities for lime and pumice powder were measured as 2.58 g/cm^3 and 2.40 g/cm^3 respectively.

Figure 1: Textile types used as reinforcement: (a) Glass textile (b) Basalt textile.

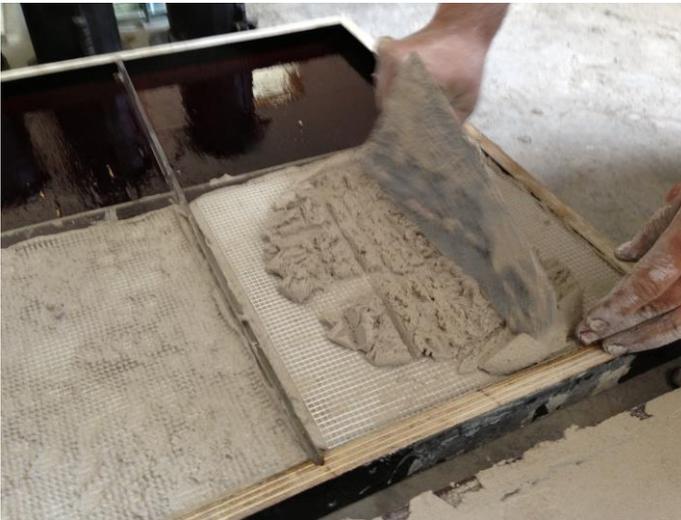
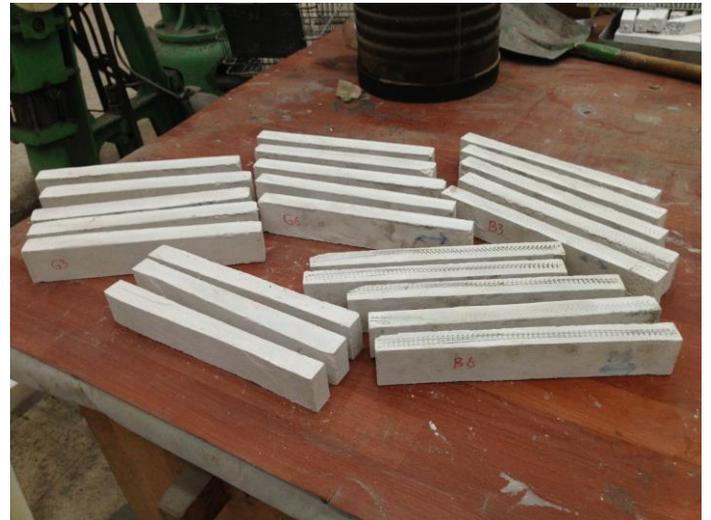
With the aim of observing the effect of the reinforcement rate, two different textile ratios were selected and specimens were produced including 3 or 6 layers of glass or basalt textiles. Mixture proportions and the materials used for composites are given in Table 1. Mixtures were poured in 30x30x250mm slab molds and in order to get flexural beam samples, they were cut into 5x30x250mm prisms before the tests (Figure 2). In the process of specimen preparation, a thin layer of mortar was poured into the base of mold at first. A textile reinforcement layer was placed onto the base mortar layer. Then, some mortar was added onto this textile reinforcement in a way that passed through the textile and covered it. This process was repeated 3 or 6 times according to the textile reinforcement quantity in the specimen. The thickness of the mortar layers between textile reinforcements were tried to be kept constant. For the comparison of the flexural behavior of textile reinforced lime composites (TRLC) with plain matrix, flexural beam samples without any reinforcement were also prepared. For determining the compressive strength of the matrix, cylinder samples which have $\phi 100$ mm diameter and 200mm height and 40x40x160mm beam samples were cast to test under uniaxial compressive loads.

Figure 2: Specimens prepared for flexural tests.

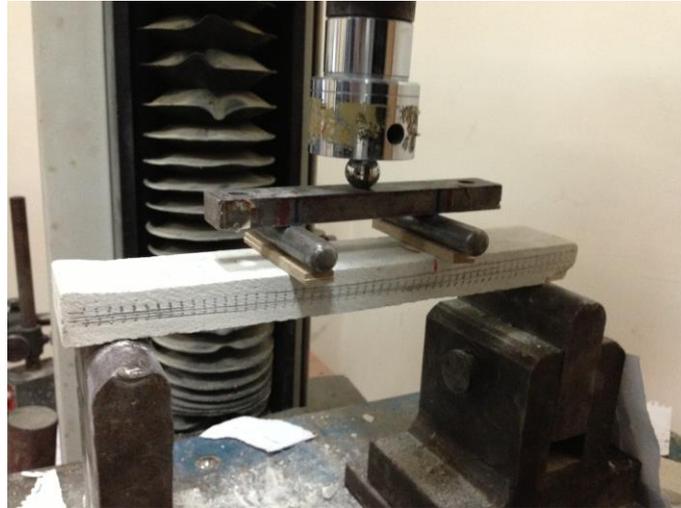
The tests for the determination of specific fracture energy were performed in accordance with the recommendation of RILEM 50-FMC Technical Committee using a closed-loop testing machine (Instron 5500R). Flexural properties of TRLC samples were determined using simple beam four-point loading where the span length was selected as 255mm. The specific fracture energy (W_f) was calculated based on the area under the load-deflection curve of the

specimens. Flexural loading test setup is given in Figure 3. Five beam specimens of each mixture group were tested under the flexural loading and at least three results were evaluated as seen in the Table 2. The letter in specimen code represents the type of the mixture (Plain, glass textile reinforced or basalt textile reinforced). The number near the letter indicates the layer quantity in the composite (3 or 6). Last number that comes after the dash denotes the specimen number.

Figure 3: Flexural loading test setup.

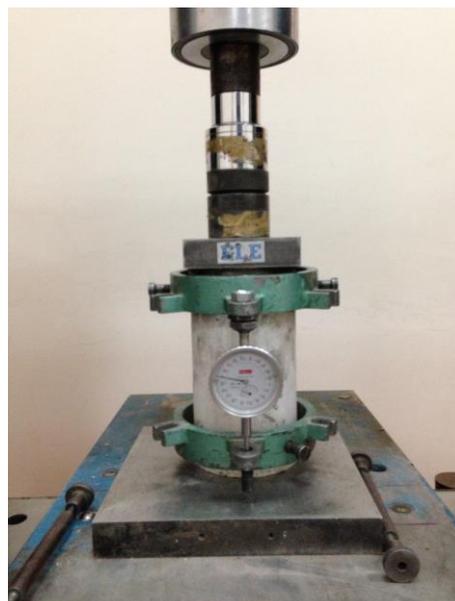
Average compressive strength of plain mortar mixtures determined under uniaxial loading was found as 2.0MPa. Modulus of elasticity of the matrix was also determined with a steel frame including an extensometer attached to the sample. Setup for the compressive test is shown in Figure 4. Average value of the modulus of elasticity of the three cylindrical specimens was obtained as 810 MPa.

Figure 4: Test setup for compressive tests.

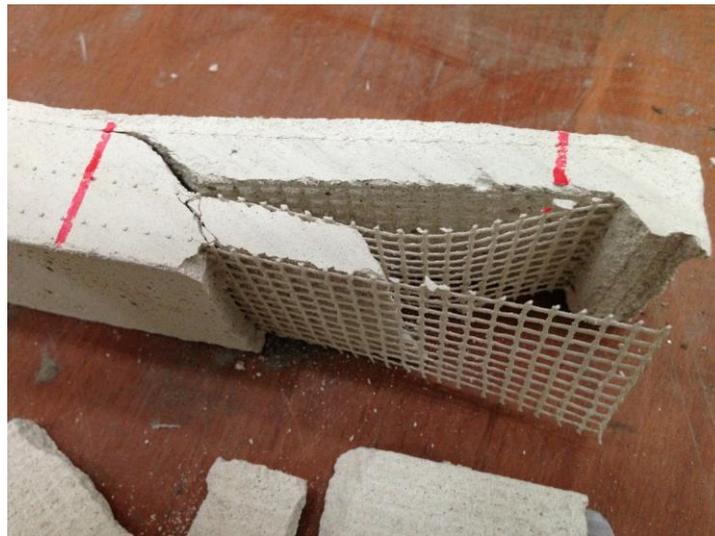
When the specimens visually inspected after the test, it was seen that there was no abrasion or tearing in the textiles embedded in mortars. This situation is shown in Figure 9. If the adhesion between textile and mortar is ensured, higher flexural performance can be expected from the composites.

Figure 9: A glass textile reinforced lime composite specimen after test.
