MECHANICAL PROPERTIES OF ADOBE MASONRY OF HISTORICAL BUILDINGS IN PERU

Abstract. *Within the frame of the “Seismic Retrofitting Project” a joint research Project between the Getty Conservation Institute, University College London and Pontifical Catholic University of Peru, more than 250 primary tests for the characterization of heritage building materials have been performed in the laboratories of the Catholic University in Peru. Building materials from houses of the Historical Center of Lima, historical church in Cusco and historical church in the Peruvian coast have been collected and tested in order to obtain quantitative and qualitative data necessary to perform adequate studies of structural evaluation and diagnosis in order to prevent damage by seismic events. Even though the main attention of the project was given to earthen buildings, in all buildings studied, stone and brick masonry were found combined with the adobe masonry either in the foundations or in the walls. This paper presents a summary of the experimental results of compression test on adobe piles; diagonal compression test on adobe wallets; shear-compression test of adobe/adobe, adobe/fired brick and adobe/sto

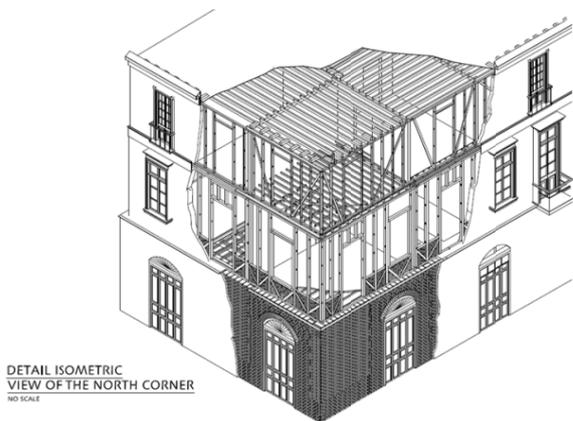
Figure 2: Isometric view of the structural configuration of Hotel Comercio. First floor has adobe walls [1].

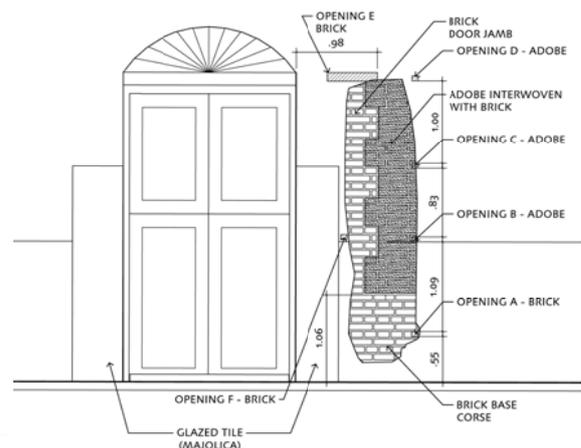
Figure 3: Prospection in Hotel El Comercio. Fired brick masonry surrounds the openings in first floor and also conforms the base course[1].

Brickwork composed by fired brick and lime mortar was used as a traditional reinforcement of adobe walls. Indeed, brickwork is surrounding the openings in the historical buildings; also was used as basement and base course of the adobe walls.

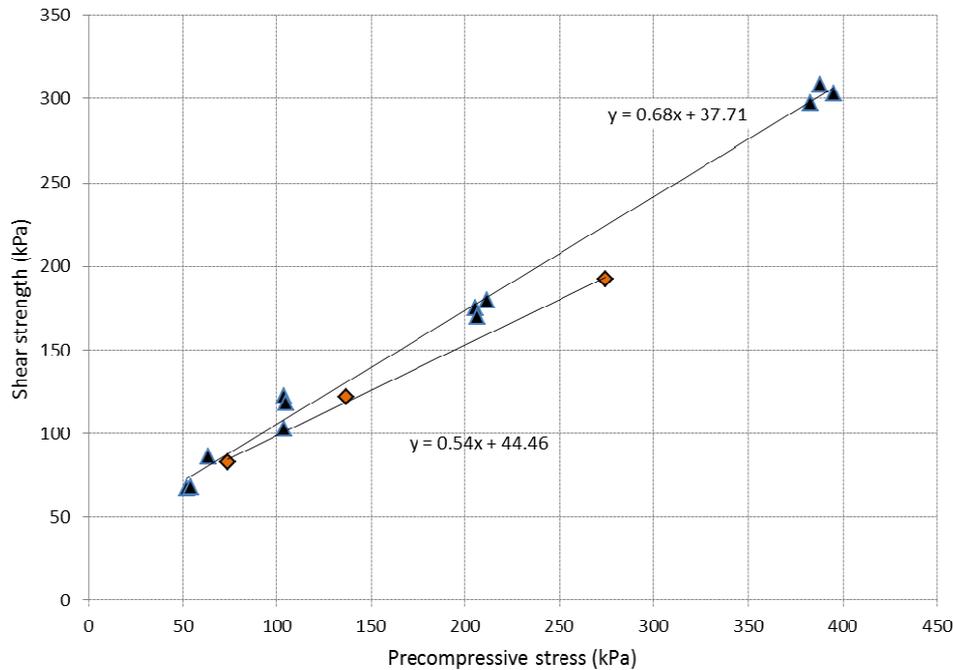
Figure 7: Shear vs Compression curve for adobe-adobe triplets.

Fifteen specimens were constructed assembling three units of adobe (triplets) to be tested in shear/compression to obtain the angle of friction and the cohesion for the masonry. Twelve triplets were constructed with new material adobe and mortar and three triplets were constructed using original units and historical material from Ica Cathedral. There is not much difference between the new material and the historical one. The cohesion and the friction angle for the new masonry have values of 37.71 Kpa and 0.60 rad respectively. The specimens with

historical material from Ica Cathedral have a cohesion value of 44.46Kpa and a friction angle of 0.50rad. The results are shown in Figure 7 and Table 3.

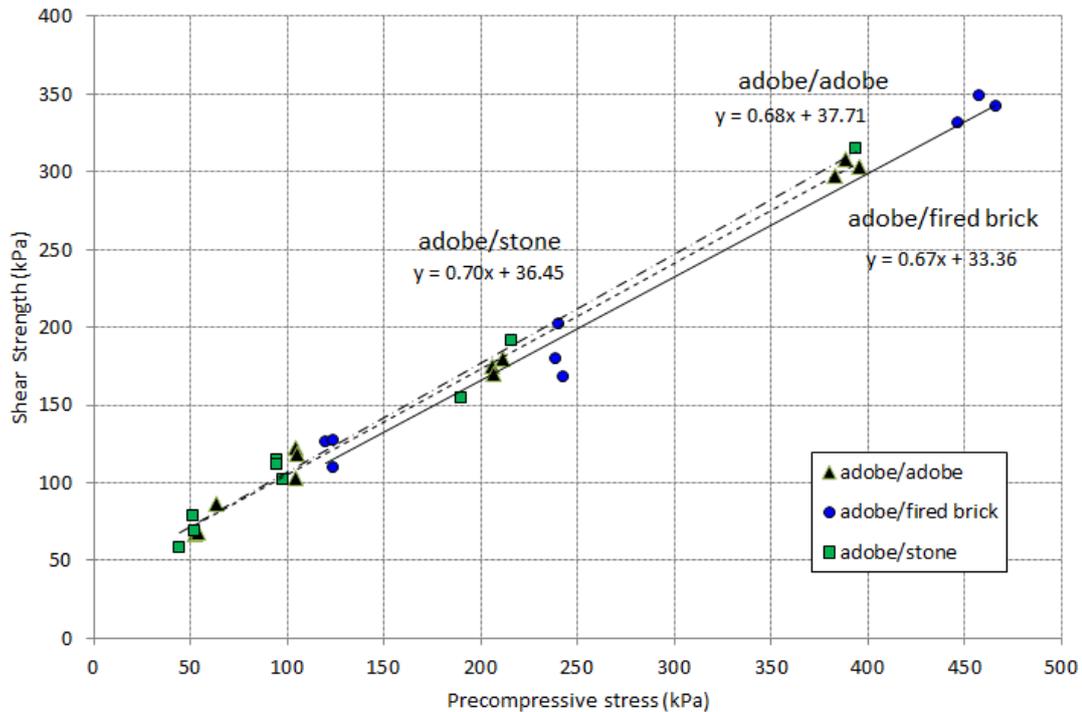
Figure 8: Comparison of curves for triplets.

The comparison between the values of shear compression testing of adobe/adobe, adobe/fired brick and adobe/stones are shown in the Figure 8 and Table 4.

The values about cohesion and internal friction angle are quite similar between the triples of the adobe/adobe, adobe/fired brick and adobe/stone. Due to the fact that the failures, in all the cases, were produced in the mud mortar joint between the blocks, the shear strength is governed by the resistance of the mortar and the cohesion and internal friction are almost constant.

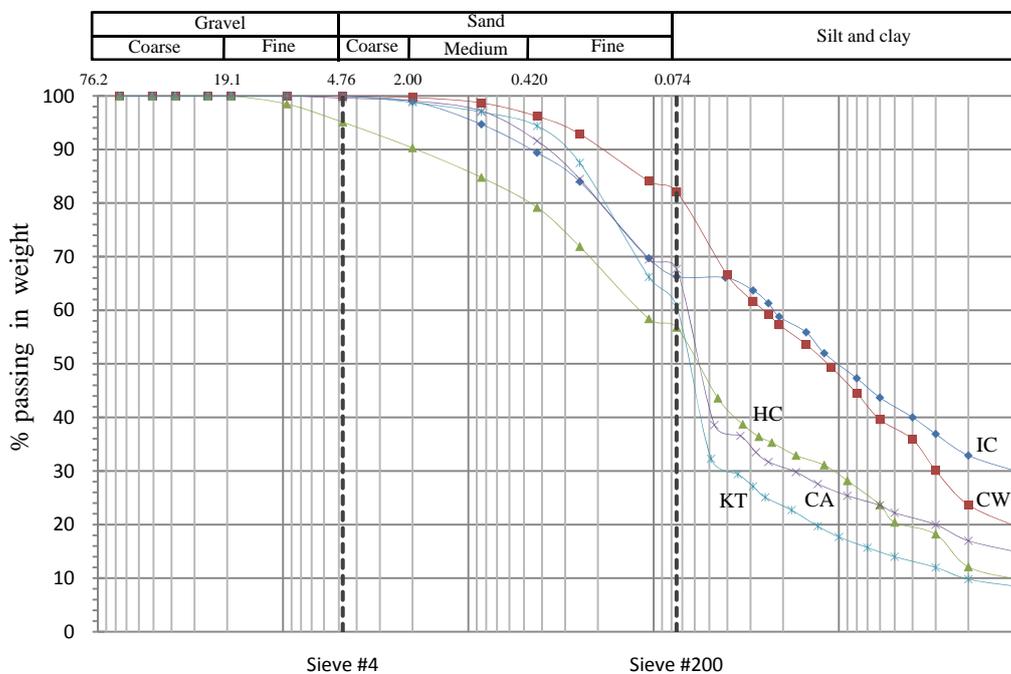
Figure 9: Granulometric curve for historical adobe bricks. Abbreviations: IC, Ica cathedral; CW, Casa Welsch; HC, Hotel El Comercio; CA, Casa Jr. Ancash; KT, Kuño Tambo church.

Soil classification by granulometric analysis was performed for 5 different adobes bricks and 5 different mortars coming from historical constructions. Figures 9 and 10 show the granulometric curves of adobe block and soil mortars used on this work.

Laboratory tests show that soil composition for adobe units and mortar is the same which may implies that it was a usual practice to use the same material source for both functions. Coarse and fine material content is similar in all cases: between 30 and 40% coarse material and between 60 to 70% for fine material content. In the Casa Welsch, the fine content is greater than the rest of the sites (80%). In general the soil composition of units and mortars present low plasticity clays with a greater presence of silt is in the soils from Ica Cathedral. The LL are between 27% - 32%, the PL between 17%- 20%, and the SL are between 12% - 15%. The specific gravities are between 2.64 - 2.67.

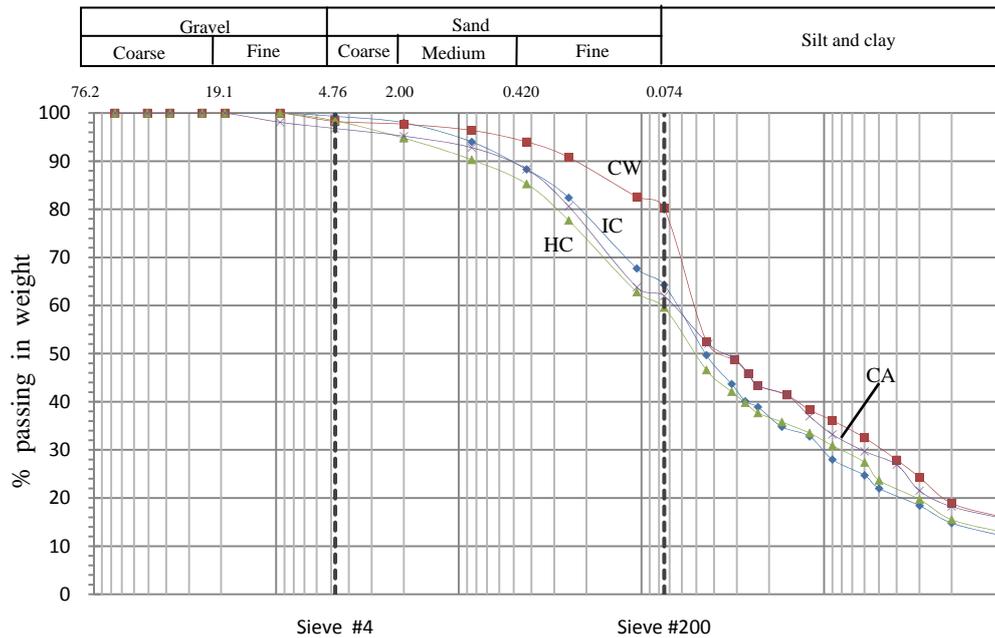
Figure 10: Granulometric curve for historical mortars. Abbreviations: IC, Ica cathedral; CW, Casa Welsch; HC, Hotel El Comercio; CA, Casa Jr. Ancash; KT, Kuño Tambo church.
