## PERFORMANCE OF THE CHRISTCHURCH, NEW ZEALAND CATHEDRAL DURING THE M7.1 2010 CANTERBURY EARTHQUAKE

**Abstract.** *The Catholic Cathedral is classified as a category 1 listed heritage building constructed largely of unreinforced stone masonry, and was significantly damaged in the recent Canterbury earthquakes of 2010 and 2011. In the 2010 event the building presented slight to moderate damage, meanwhile in the 2011 one experienced ground shaking in excess of its capacity leading to block failures and partial collapse of parts of the building, which left the building standing but still posing a significant hazard. In this paper we discuss the approach to develop the earthquake analysis of the building by 3D numerical simulations, and the results are compared/calibrated with the observed damage of the 2010 earthquake. Very accurate records were obtained during both earthquakes due to a record station located less than 80 m of distance from the building and used in the simulations. Moreover it is included in the model the soil structure interaction because it was observed that the ground and foundation played an important role on the seismic behavior of the structure. A very good ag

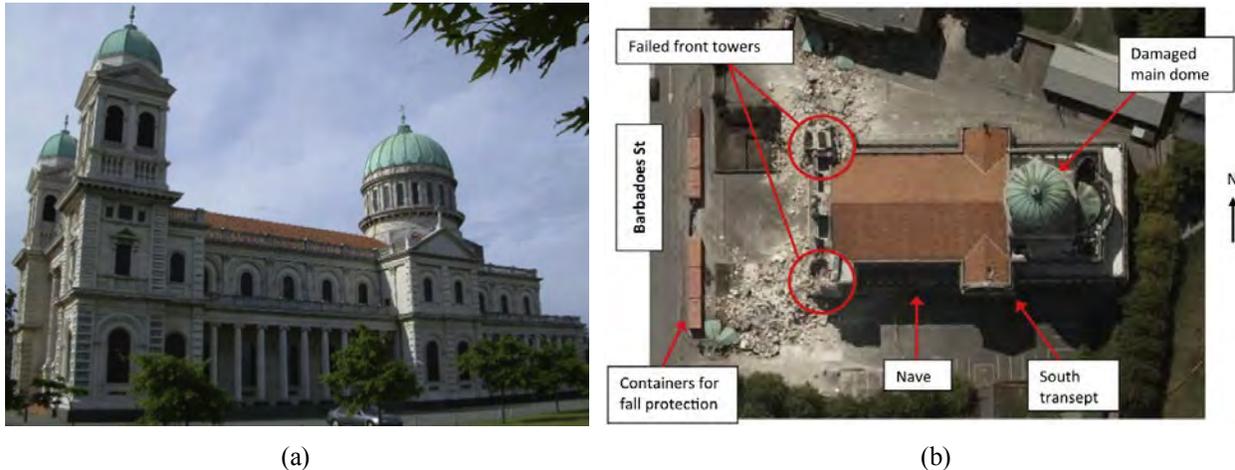
Figure 1. Christchurch Cathedral; (a) general view and (b) 2011 EQ damage [1]

The Christchurch Cathedral was significantly damaged in the recent Canterbury EQ of 2010 and 2011. The building experienced ground shaking in excess of its capacity leading to block failures and partial collapse of parts of the building, which left the building standing but still posing a significant hazard. Compared to the 4 September 2010 seismic event M7.1 (epicenter 35 km away), the EQ of 22 February 2011 M6.3 was the most damaging of all the EQs at this site to date (Figure 1b). This M6.3 event was centered 7 km from the site, at a depth of 5 km, and produced severe shaking across Christchurch city with the maximum recorded horizontal acceleration of 1.41 g at the Heathcote Valley site (1 km from the epicenter). The ground shaking experienced at the site was severe, even though the high acceleration was only for a short period of time. [1] affirms that the magnitude of accelerations that the building experienced was significantly greater than the previously evaluated building capacity for a low period structure and similar to the design level for an Importance Level. The M7.1 2010 event caused some damage to the Basilica, which was generally limited to minor damage to the facing stone, damage that was noted consisted of minor to moderate cracking to the underside of the first floor diaphragm all around the nave and the main dome, minor cracking and displacement of stone in the west wall of the sacristy, and evidence of out-of-plane movement of the middle column of the north bell tower eastern elevation. Access to the building was restricted following this event until engineers could assess the damage and evaluate the remaining seismic capacity. The M6.3 2011 event caused severe damage to the building, inducing a complete collapse of the top section of the South and North bell tower above the main roof level, and an unstable wedge of the western wall above the

first floor level left leaning outward, but still attached and significant damage to the main dome drum, including the entire keystone section of the supporting north arch having dropping out and significant cracking to the south arch. Moreover the collapse of a large section of the first floor roof around the main dome on the north side.

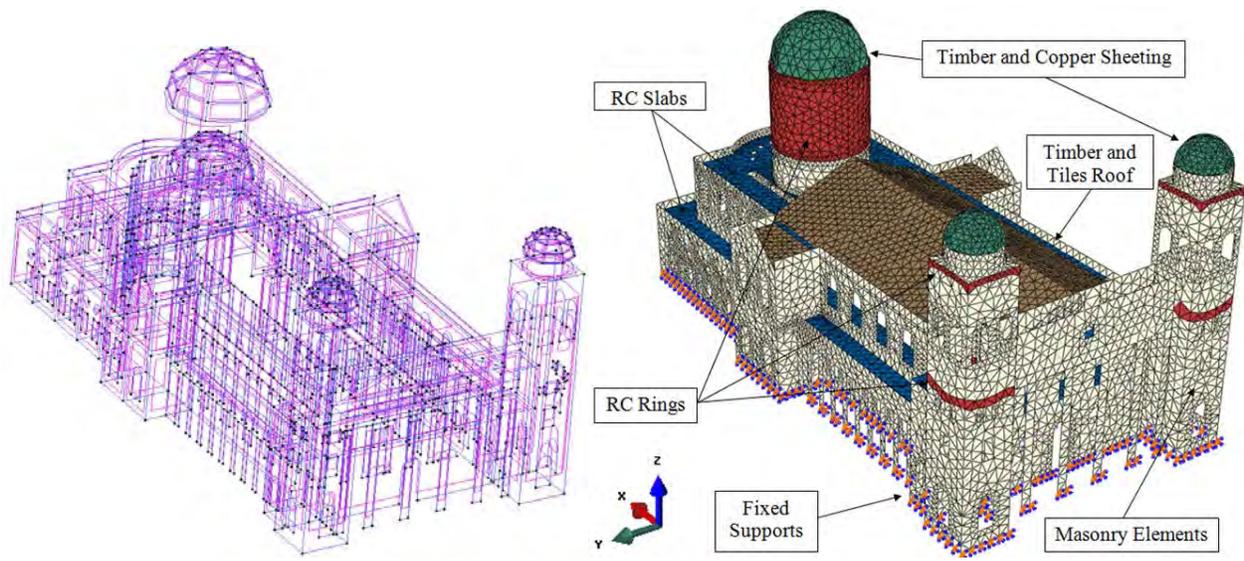
Figure 2. Full 3D geometrical and meshed model including the 2002 retrofitting scheme

for assigning surfaces to all structural elements to be meshed by selecting element sizes and types as depicted in Figure 2. It is worth noting that the 3D FE model of the Cathedral was meshed with a non-structured mesh. It is well known that 4-nodes quadrilateral elements are more efficient in terms of numerical approximation. However, due to the geometrical complexity of the structure, it was decided to use an automatic meshing of triangular elements to simplify the process. Moreover, this meshing technique is easily developed and adapted to irregular geometry and openings. It is important to take into account that for linear elastic analysis the size of the mesh elements does not have a huge impact on the results and nor in the computational time. The main issue is during the nonlinear analyses with refined meshes, where convergence problems and calculation time are substantially increased. However, based on own expertise, the size of FE elements in nonlinear analysis does not play an important role since it is enough to identify generalized zones of plastic deformation to determine crack patterns or the final failure modes. One recommended FE size in literature and most used is 1x1 m. Refined meshes are mainly used in small structures, macro-elements or contact areas in linear elastic analyses.

structured as reliable and accurate as possible by including all the different materials and thicknesses of all structural elements even those that are not of interest in the damage assessment as timber roof and upper parts of domes and towers. To increase the reliability of the model it was implemented the former retrofitting measures applied in 2002 to address key building areas identified to be most vulnerable to EQ damage (Figure 2 on the right).

The selected FE for all structural elements is a general purpose triangular shell (S3R), which has three nodes and three thicknesses with six degrees of freedom (DOF) at each node. This element could represent the in-plane and out-of-plane behavior and has plasticity capabilities. The 3D model (see Figure 2) is integrated by 25024 shell elements and 14577 nodes with 87462 DOF and a total mass of 6922 Tons (vertical force of 67911 kN). In the generation of the FE model the following main assumptions were considered: as a first approach all base nodes are assumed as fixed, the materials and thicknesses are described in Table 1, as well as their respective linear elastic parameters and strengths. The main mechanical properties of the three layers masonry were proposed taken into account an equivalent layer with average properties.

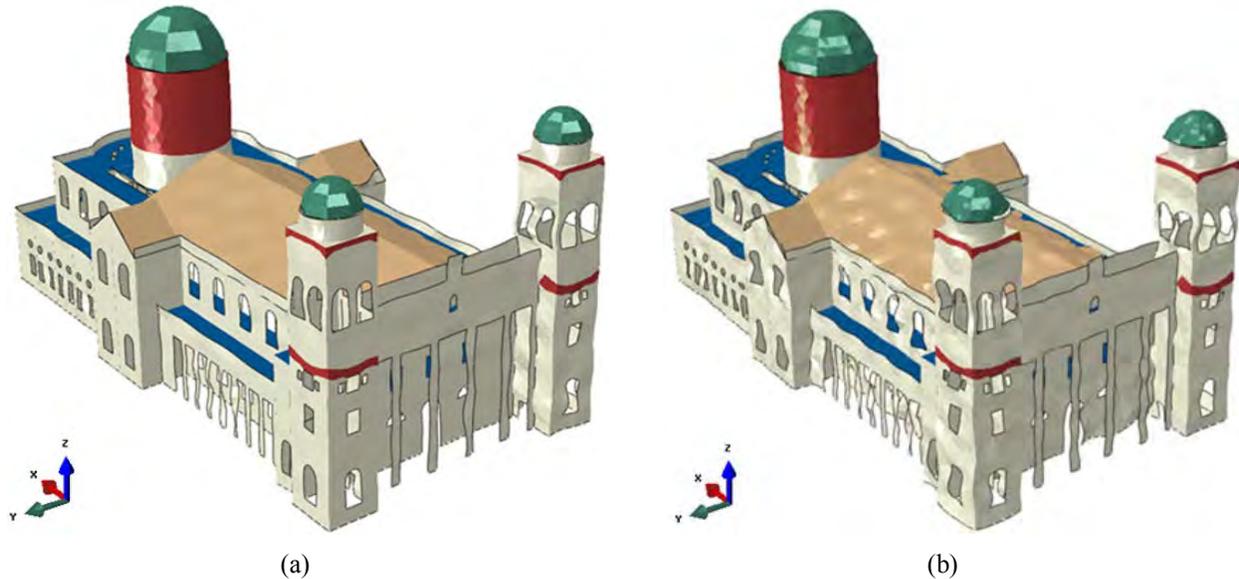
Figure 3. Fundamental vibration modes and natural frequencies of the 3D FE model: (a) N-S  $f = 2.105$  Hz ( $T = 0.475$ s) and (b) E-W  $f = 3.145$  Hz ( $T = 0.318$ s)

To obtain a first estimation of the vibration response of the Christchurch Cathedral, the linear investigations are extended to dynamic analysis. As in the case of the vertical loading analysis, the modal evaluations of FE models are relatively fast due to the progress of recent decades on computational tools. The fundamental vibration modes and their respective natural frequencies (in Hz) and periods (in sec) are illustrated in Figure 3. It is worth noting that the global dynamic behavior of the building is governed by a lateral vibration in the transversal direction (N-S) and longitudinal (E-W) respectively. The observed dynamic behavior on this building by following the theory of small displacements in the linear range is characteristic of massive masonry Cathedrals. To compare the dynamic characteristics of this historical building under study, the Cathedral of Colima, Mexico may serve as an example because has similar dimensions, materials, distribution and structural elements such as two towers and a heavy and tall dome as described in [2] and [3]. The only difference is on the top roof system which is integrated by masonry vaults. This Cathedral was seriously damaged after the 2003 EQ (M7.5) and presented similar failure mechanisms like those observed at the Christchurch Cathedral in 2011. The Cathedral of Colima was also strengthened with RC rings at towers and RC on slabs and replacement of damaged units as rehabilitation. Afterwards was subjected to detailed investigations both numerically (3D limit analysis and 3D FE) and experimentally in-situ regarding dynamic behavior by assessing the first natural frequencies with vibration equipment (accelerometers) and taking into account the excitation induced by the ambient and traffic. The first experimental and numerical natural frequency was measured at the dome level and was 2.200 Hz, which is in good agreement with the one obtained numerically at the Christchurch Cathedral of 2.105 Hz.

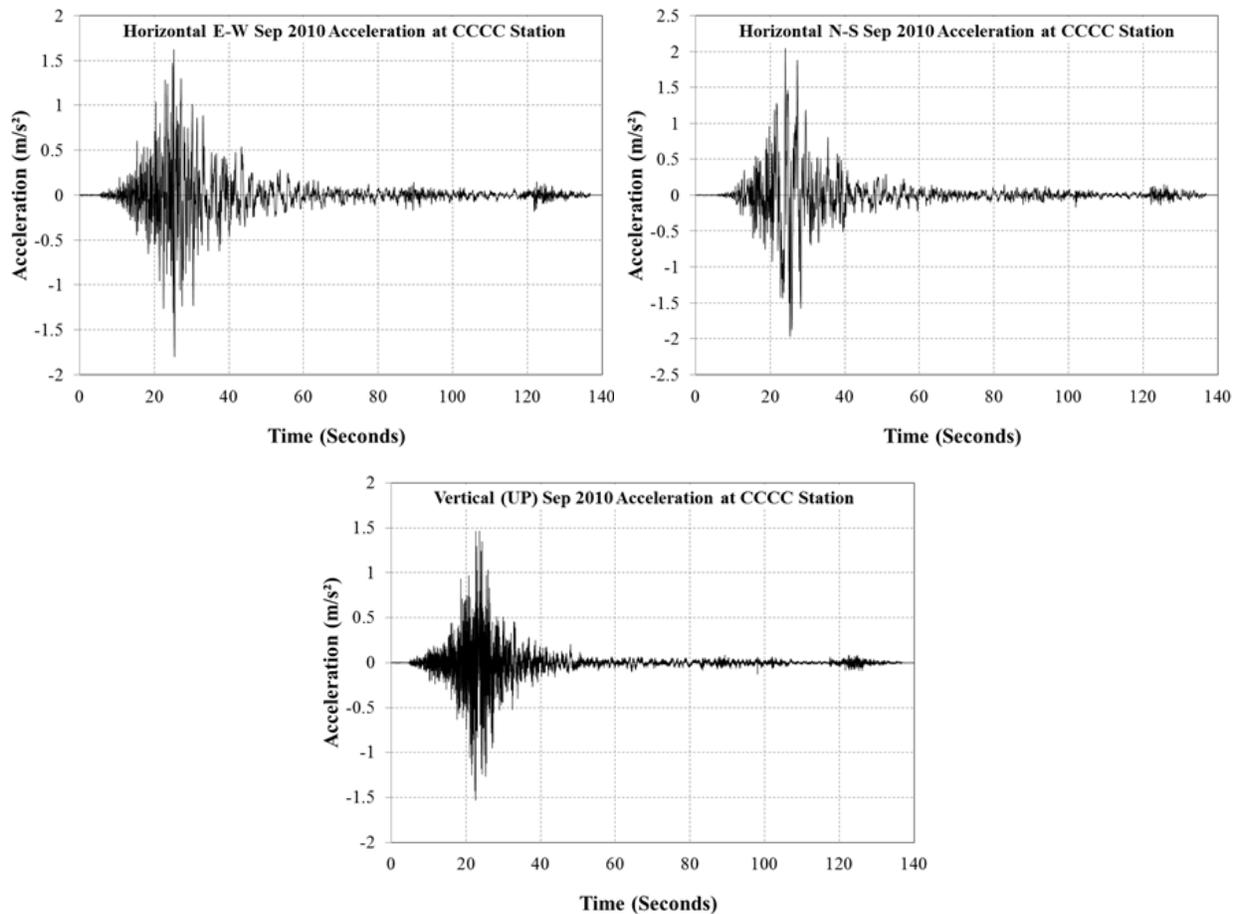
Figure 4. The 4<sup>th</sup> of September 2010 acceleration ground motion measured at the CCCC Station

A common procedure to include the seismic input into the 3D FE model for seismic analysis is by selecting the intensive phase of the EQ, disregarding the initial and final parts where the acceleration starts and ends. This procedure is also named EQ window and is developed to reduce the computational time and to focus on the response of the structure subjected to the important part of the EQ. The total duration of the record is of 140 seconds and peak ground acceleration (PGA) higher than 0.15g as illustrated in the three components of acceleration in Figure 4. For subjecting the Christchurch Cathedral to initial linear dynamic analyses it was selected the three components (E-W, N-S and Up) of the September 2010 EQ in terms of acceleration. The selected EQ window has a duration of 20 seconds and is worth noting that the strong motion record presents large impulses in the range of 0.10g to 0.20g.

The 3D seismic input based on acceleration (see Figure 4) was applied at the base (foundation and soils springs) of the FE model of the Cathedral as shown in Figure 5a. After developing the linear dynamic analysis, it was verified that the seismic input was correctly applied by verifying that all the components of acceleration at the springs base are the same as the applied. As a second stage it is verified that the model behaves as a structure under EQ conditions by presenting the characteristic deformation and transmission of inertia forces. As a final verification the structural seismic response in terms of acceleration is measured at a control node at the highest part of the building corresponding to the bell towers. The aim of measuring the acceleration at a top node is to verify that the acceleration is higher (amplified) than the one of the terrain (see Figure 5b).

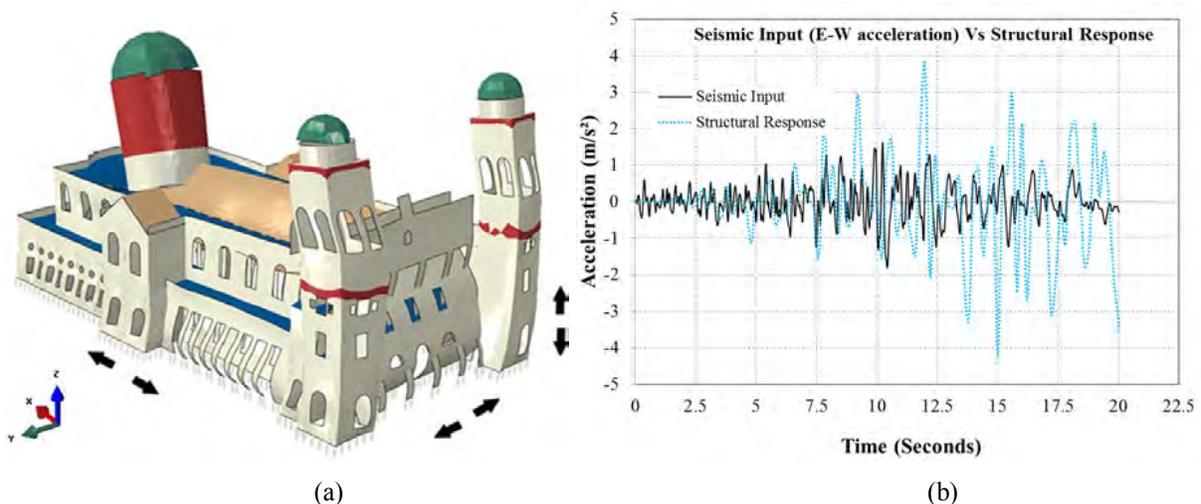
Figure 5. Seismic input verification and analysis of FE model response; (a) 2010 M7.1 EQ applied in three directions (E-W, N-S and Up) and (b) EQ vs. structural response at a control top node of bell-tower

[8] affirms that due to the natural bending behaviour and the high inertia forces of masonry towers generate that the structure vibrates in a different way of that of the terrain, leading to top amplifications of about 2.3 times. This trend could be observed in the comparative between seismic input and structural response of Figure 5b, where the top left bell-tower presented a maximum acceleration of 0.43g. By comparing the PGA (0.17g) of the acceleration input (E-W) with the response, it is worth noting that the tower presented an amplification factor of 2.5 which is in

very good agreement with the aforementioned. Analyzing the state of vertical stresses at the point of the analysis where the structure presented the maximum response, it was observed the elastic deformation (see Figure 5a) of vertical elements as columns and even more obvious the presented the bell-towers. The positive values at the contour represent tension and are present in large parts of the structure. This could be interpreted as zones of cracking due to the fact that masonry structures have zero resistance to tensile stresses. By means of the analysis of a recorded video it is possible to visualize the complete behavior of the Cathedral during the intensive phase of the EQ corresponding to 20 seconds.

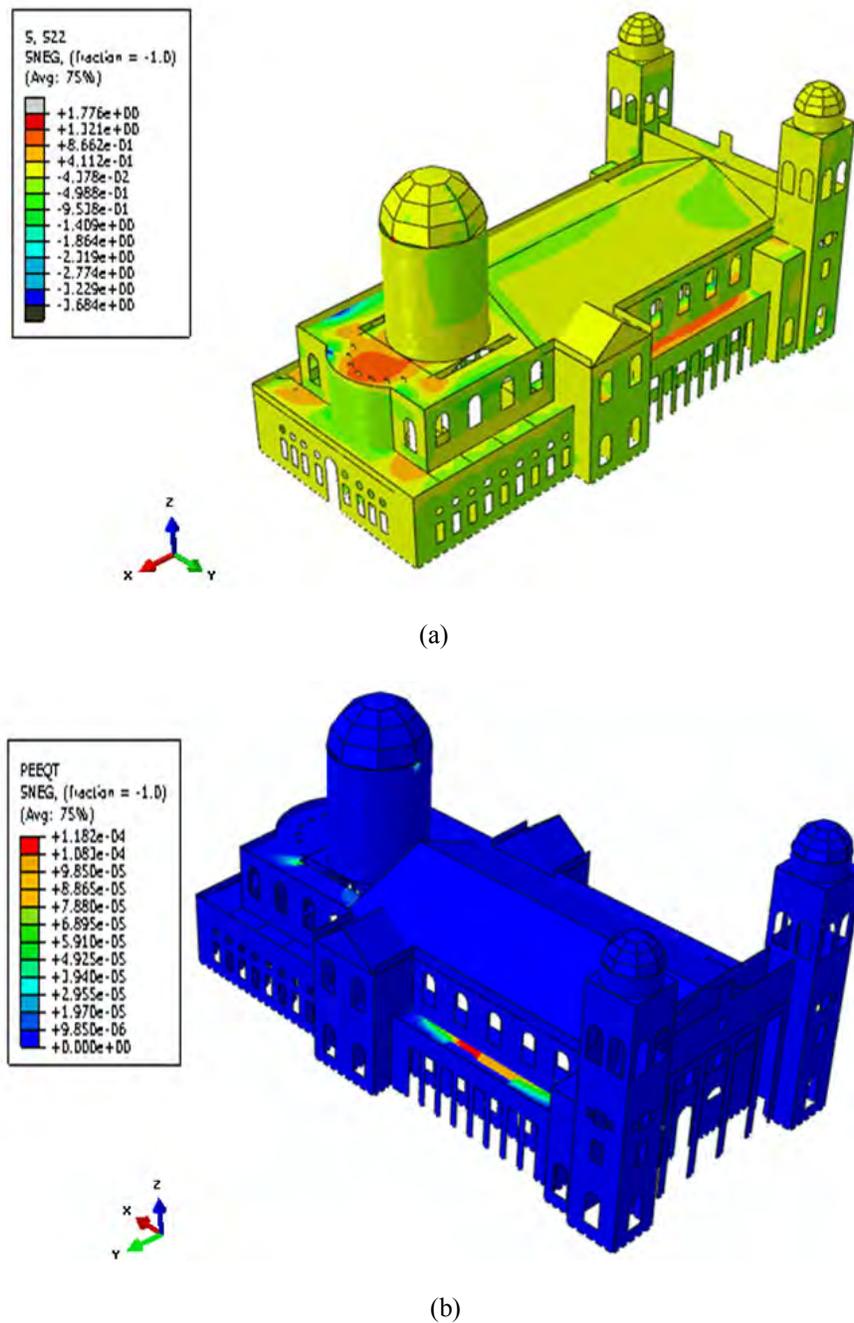
Figure 6. Crack pattern after the 2010 M7.1 EQ ranging from slight to moderate damage during the intensive phase; (a) distribution of vertical stresses and (b) inelastic deformation (cracking)

This comparison between simulated and real behavior is quite helpful to calibrate the model. Figure 6 depicts the results of the full nonlinear dynamic analysis of the Cathedral due to the 2010 EQ. The acceleration was applied in 3-directions, including the soil-structure interaction represented by vertical and horizontal springs. The springs were proposed due to the poor soil conditions, which played an important role on the seismic amplification and observed damage. It is worth noting in the crack pattern of Figure 6 that the damage is limited and corresponds to the described in previous paragraphs, minor to intermediate damage with some cracks at the cover at the back part of the main dome and concentration of cracks at both lateral façades at the concrete floor level. Both bell-towers did not present damage due to the absence of inelastic deformation and reduced lateral displacement of 20 mm, practically remaining in elastic conditions. This lateral displacement may be compared with the different damage states in similar bell-towers investigated by [2]. The arches that support the dome presented large inelastic deformation and rotation. During the intensive phase of the EQ, the main dome presented a maximum lateral displacement of 300 mm, which explains the large damage at the arches and surrounding concrete slab.
