SEISMIC ASSESSMENT OF FAÇADES OF MEXICAN COLONIAL CHURCHES

Keywords: Seismic Assessment, Façades, Masonry, Rigid Element Method.

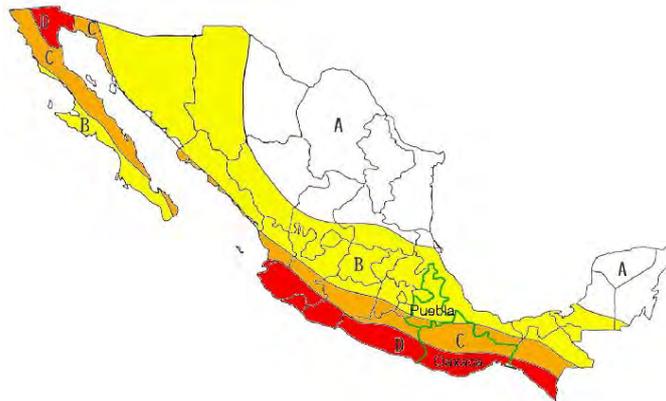
Figure 1: Seismic regionalization of Mexico [1].

The seismic activity of Mexico can be divided in four big zones: A, B, C and D (Fig. 1; [1]). These zones are delimited with base in the frequency of occurrence of the earthquakes in the different regions and the expected maximum ground acceleration in a century. The zone A is a zone where it has not been reported earthquakes in the last 80 years and it is not expected ground accelerations bigger than 10% of the gravity acceleration. The zone D identifies the places where earthquake occurrence is very frequent and the ground accelerations can be higher than 70% of the gravity acceleration. It is here where the historical big earthquakes were registered. The B and C zones are intermediate regions where earthquakes are not registered frequently and the ground accelerations recorded are not greater than the 70% of the gravity.

The experience of the ancient builders about the seismic activity of the Country allowed to develop different typologies of churches depending on their location. The center of Mexico (Mexico City and surroundings) is located in the seismic region B (Fig. 1). This area is hit by the earthquakes generated in the Pacific coast, but it is rare the earthquake with epicenter in this zone. Thus this study takes into account two typologies of churches of the center of Mexico (Fig. 2). The first one corresponds to churches built near to local active faults which are located at the north of Mexico City (Naucalpan). The second typology corresponds to churches built far away of the local faults, located at the south of Mexico City (Morelos). However both zones suffer frequent earthquakes generated in the Pacific coast. The façades of the first typology are low-rise and have thick walls and some buttresses. The façades of the second typology are taller and slender. Two churches were selected for each typology. Saint Bartholomew Apostol (Barth) and Saint Mary Nativity (Nativitas) correspond to the first typology; while Ocuituco and Tetela del Volcan (Tetela) are of the Morelos typology (Fig. 3).

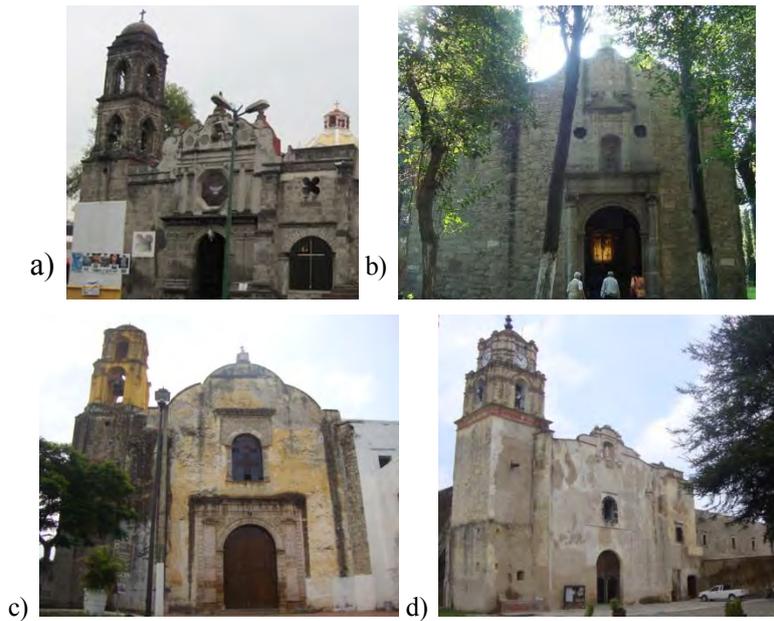
Figure 3: Façades of: a) Barth; b) Nativitas; c) Ocuituco; d) Tetela.

Table 1 summarizes the dimensions of the four selected façades. It can be seen that the façades of the first typology are smaller than the second typology. The height of the bell tower is almost the half of the height of the second typology.
