## REDISCOVERING EARTHQUAKE-RESISTANT KNOWLEDGE IN CHILEAN UNREINFORCED MASONRY HERITAGE

**Keywords:** Earthquake-resistant, Traditional Knowledge, Unreinforced masonry, Chilean architectural heritage.

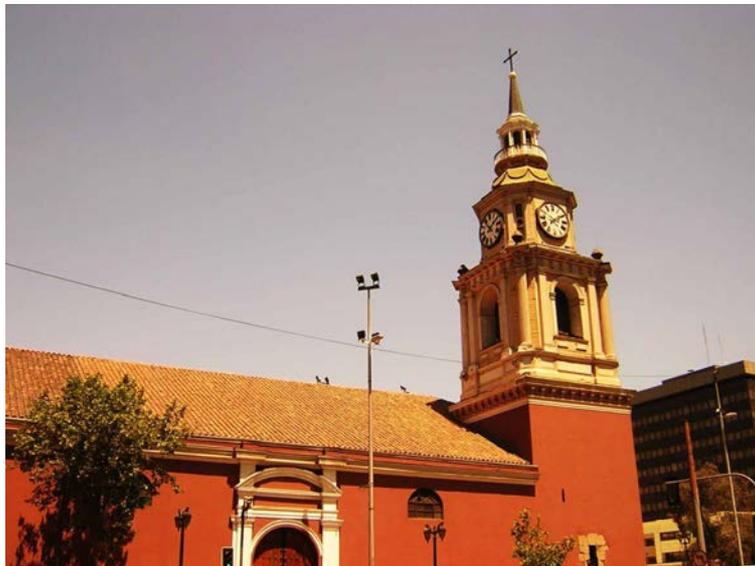
Figure 2: San Francisco church, Santiago.

Since the founding of Santiago in 1541 until the arrival in 1780 of the most important architect of the Colonial period, the Italian Joaquín Toesca, there were 200 years of experimentation and improvement of traditional construction technologies. This was driven by the two largest earthquakes of the Colonial period: the earthquake of 1647 and in 1753, after which there were no surviving buildings in Santiago besides the church of San Francisco (Fig. 2), which is the oldest building of Santiago [6]. This building because of its importance has been included in the tentative list of the UNESCO World Heritage List Nominations since 1998 [7].

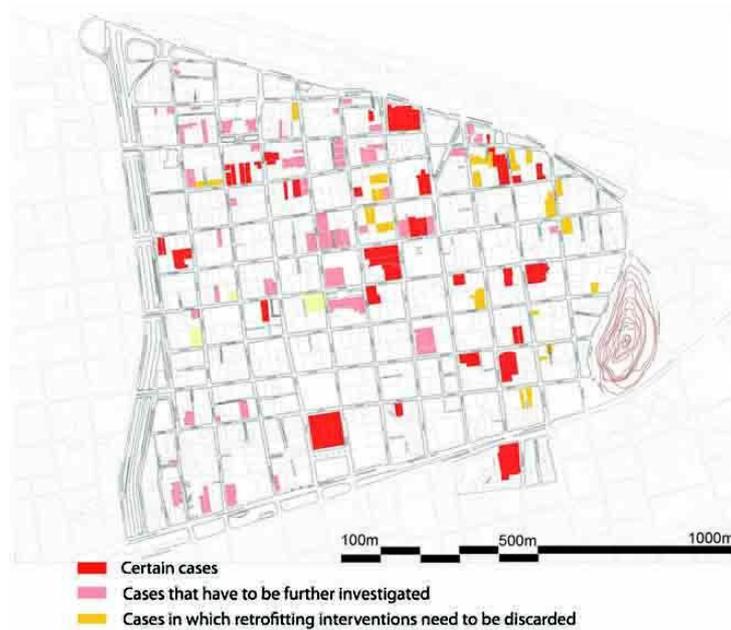
Figure 3: A map with the study cases.

All the identified buildings were located on a map and were photographed.

From this first visual identification the main issue was that a large number of the cases appeared to have been built before 1860 in unreinforced masonry. However there was some doubt as to the actual construction process as in actual fact they could have been built afterwards using industrialized technologies and imitate historical architecture or they could have suffered strong retrofitting interventions which questions their value as case studies. Thus, from this first approach, a map with three categories of buildings were made: a) Certain or definite cases (red color); b) Cases whose building system and construction date have to be further investigated (pink color); c) Cases in which retrofitting interventions need to be discarded (orange color) (Fig. 3). “B” and “C” categories required further investigation which was conducted both through the collection of historical information and a second deeper field analysis. With this first range of case studies more maps were elaborated including; map of building uses, map of architectural typologies, and a map of building systems.

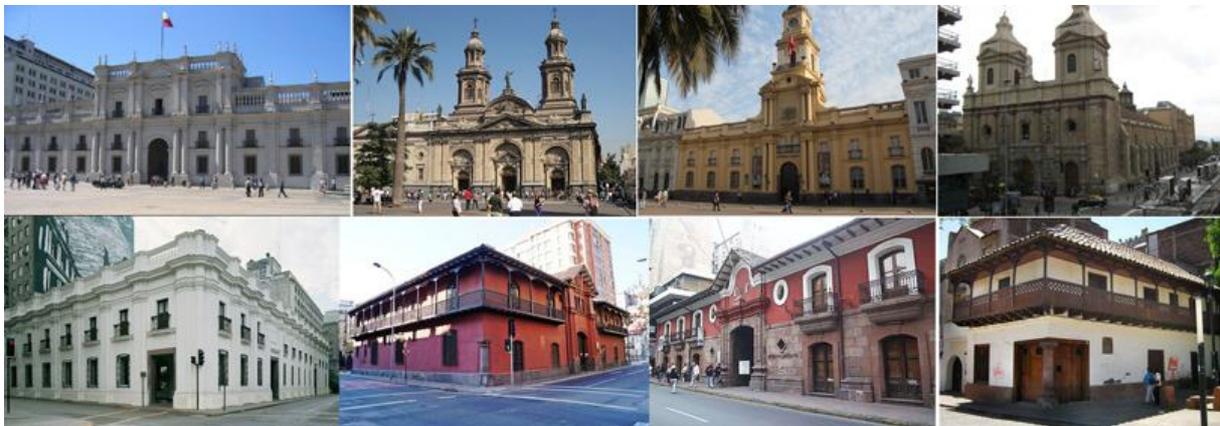
Figure 4: Some of the most important Santiago’s unreinforced masonry buildings.

Around 25 “pure” unreinforced masonry historical buildings were found through this integration of field analysis and historical information, among which the most important are: the Cathedral of Santiago, The Moneda Government Palace, the previously mentioned San Francisco church, and several other churches and colonial houses (Fig. 4).
